Riparian Zone Monitoring Report

Results for Stability, Sediment Loads &
Revegetation Survival from Conservation
Practices 2008-2011

Marin Resource Conservation District
P.O. Box 1146, Point Reyes Station CA 94956
(415) 663-1170, [http:// www.marinrcd.org/](http://www.marinrcd.org/)

December 2011

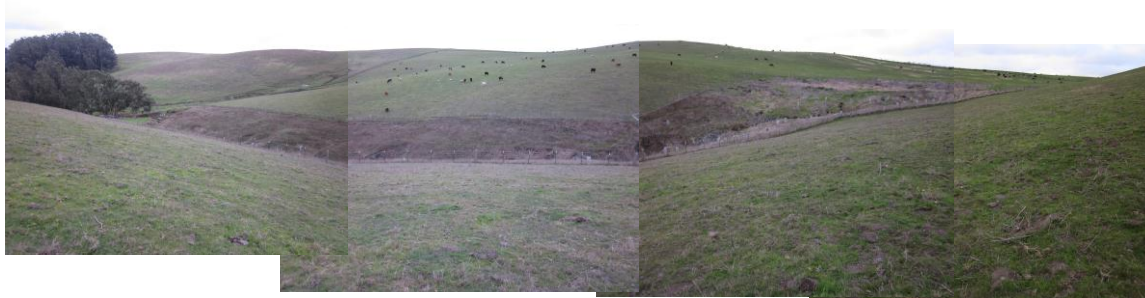
Two cross-sections were measured in 2010 by PCI and STRAW above each grade stabilization structure to quantitatively document the volume of erosion, if it occurs. The accompanying new water trough, tank, pipeline and pump provide clean water to cattle, pigs and chickens (located near the center of animals in top of photo, below).

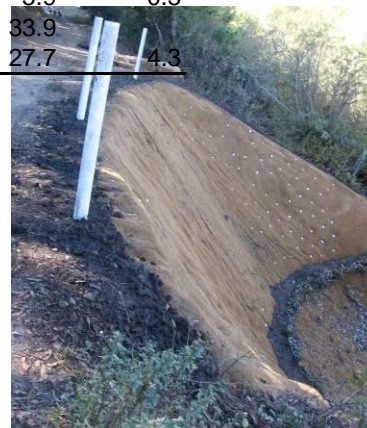
important ranch access driveway with biotechnical willow wall and fascine in addition to a diverse species mix with shade-tolerant native grasses to ensure long-term stability (right, before planting). As shown by the 99% reduction in potential sediment volume and vigorous survival (below), the project site was highly successful. Because of the steep slope and proximity to ranch road (right), the site will also be qualitatively monitored by the landowner for signs of instability and success of revegetation was critical for long-term success. Though total survival was low, the density and diversity of the revegetation design ensured the establishment of adequate cover to accomplish the biotechnical targets (below).

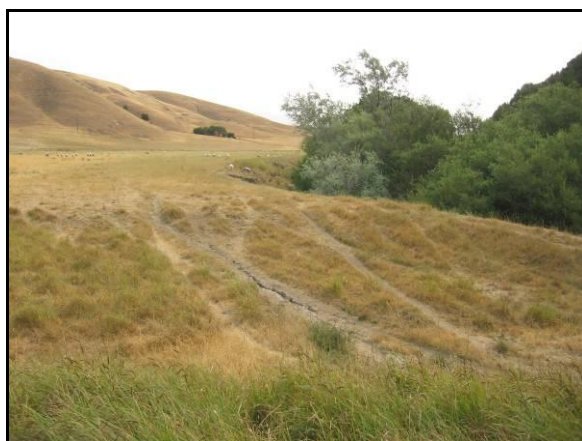
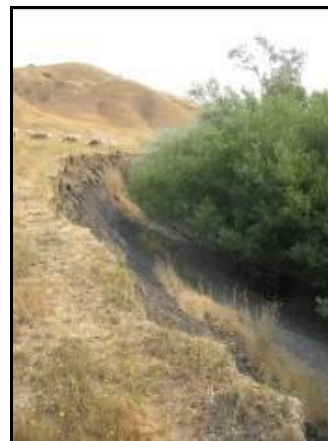
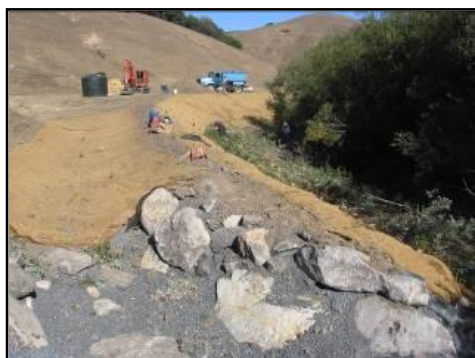
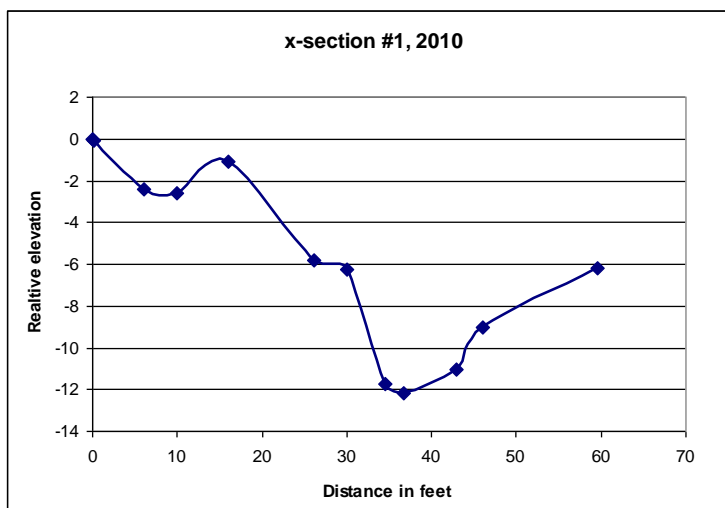
The sheep field site was monitored as five subsections within the riparian fence based on the location of specific conservation practices, geomorphology and existing vegetation. The biotechnical willow fascines have grown slow because of poor soil conditions and deer browse; however, numerous shoots are above browse height and 99% is alive with sedge and rush established at the base of streambank. The 98% reduction in erodible sediment volume was the result of successful design and construction of grade stabilization structure to repair headcutting tributary swale, sloping back the streambank and continuous willow establishment. A couple rocks slumped at the top of the headcut repair and will be monitored further.

Photographs show the sheep field biotechnical streambank stabilization site before (above) and during implementation of grade stabilization structure and willow fascines (below). Cross-sections were measured by PCI and STRAW (example below).

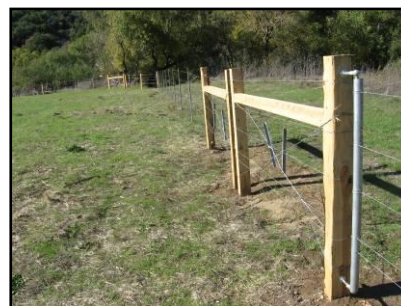
The Gallagher Ranch implemented numerous conservation practices with NRCS and Marin RCD including water development and replacing a circa 30 year-old riparian fence to control cattle access to Lagunitas Creek. Because of the active floodplain pasture location, a break-away and easy-to-takedown design was constructed (right).

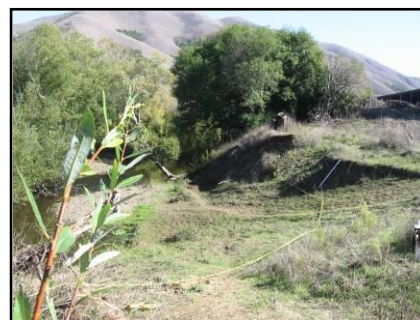
Similar to the previous site discussed, the majority of riparian area (2000 ft) has existing native trees, low potential erosion (14-100 CY) and fairly stable streambanks (82-93%). As a result, mutual goals exist to both preserve existing resources and restore habitat by increasing streambank stability and riparian vegetation cover for coho salmon. However, a 190 ft open section of the site was devoid of riparian vegetation (right) so it will continue to be monitored with line-intercept transects into the future. Though not directly planted, willows are naturally regenerating and ground cover improved while streambank stability increased to provide moderate sediment savings from 2008 to 2011. The lower section with 100 CY potential sediment volume will be qualitatively monitored because the decadent box elders could topple down allowing the streambank to unravel. This section has shallow flat water aquatic habitat and is an option for instream enhancement practices such as large woody debris.

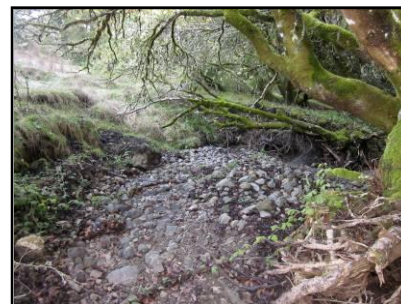
John West Fork Creek was fenced for less than a half mile to exclude livestock from important spawning and rearing coho salmon habitat. Water developments were implemented and a stream crossing was installed downstream of the riparian fence between exclusionary fences. The site is forested with deep shade of Douglas fir, bay, buckeye, oaks and willows with large woody debris aggrading the channel for most of the site, except for a 300 ft upper section which was monitored in 2009 and 2011 with no significant change in sediment saved. However, two unstable potential landslide streambanks are precariously held together by trees that are leaning over with undercut roots (right). In addition, cape ivy, poison oak and California blackberry slightly increased in cover.

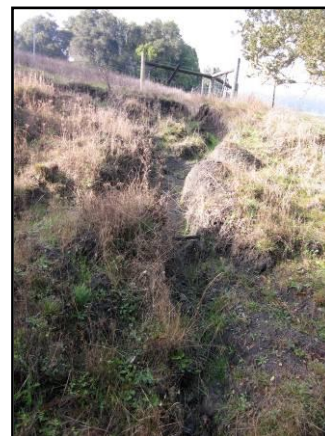
The stream crossing was moderately successful – stable but poor in appearance with rock settling to expose the underlying geotextile fabric. West of the crossing in 2009, rills and small headcuts were developing in the sensitive, blue-goo type of soil and PRNS staff successfully used brush and fencing to divert livestock and vehicle traffic; however, a 1.5 ft headcut remains caused by overland flow down the trail parallel to older fence (right). Small willow walls and/or brush mattress may suffice to stabilize the 10 to 70 CY of potential sediment erosion near the headcut.

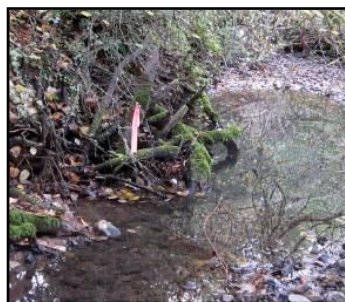
The stream channel in middle section of the site is aggrading with a wide, dynamic floodplain until the transition point delineating the lower site where multiple trees have fallen in to stabilize the channel bed which will be qualitatively monitored. The lower section of the site enters a slightly incised alluvial valley with perennial pools maintaining coho salmon over summer where the habitat and population monitoring begins conducted by PRNS (left, pink flagging marks coho habitat use). This site is an example of where one agency’s monitoring program ends is where another program begins. The monitoring results will be discussed between partners to prioritize future conservation projects.

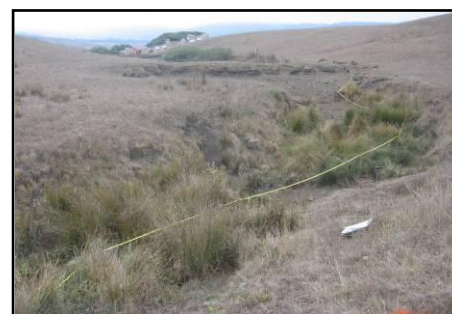
The gully at Furlong Ranch has two old earthen dam stockponds and one spillway was highly unstable with 800 to 1800 CY of potential erosion. An active headcut downstream of the spillway could have delivered an additional 180 to 250 CY and jeopardized the spillway repair. The project effectiveness rating is Excellent on the Project Assessment Checklist (PAC) and the rock work completed for lined waterway and Grade Stabilization Structures (GSS) was very stable and beautiful.
