California Department of Fish and Game
Petaluma River Watershed
Stream Habitat Assessment Reports
San Antonio Creek
Surveyed 2007

STREAM INVENTORY REPORT

San Antonio Creek

Surveyed: Summer 2007

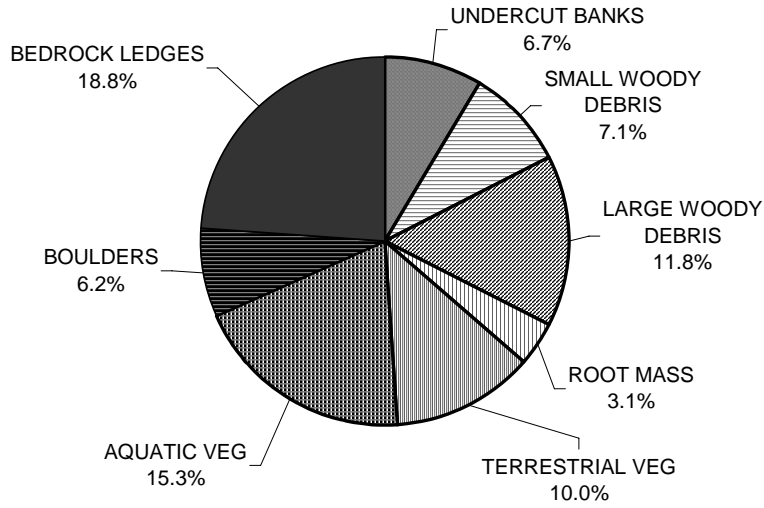
GRAPH 7

Table 5 summarizes mean percent cover by habitat type. Bedrock Ledges are the dominant cover types in San Antonio Creek. Graph 7 describes the pool cover in San Antonio Creek. Bedrock Ledges are the dominant pool cover type followed by aquatic vegetation.

- 4) Increase woody cover in the pools and flatwater habitat units. Most of the existing cover in the pools is from Bedrock Ledges. Adding high quality complexity with woody cover in the pools is desirable.
