## PROJECT HIGHLIGHTS, 2012-005

<b>Project:</b>	2012-005
<b>Watershed:</b>	Walker Creek, Subwatershed Chileno Creek
<b>Practices:</b>	<b>Fence, Road improvements, Culvert Replacement &amp; Repair (9 total)</b>
<b>Project Partners:</b>	<ul style="list-style-type: none"><li>▪ Marin Resource Conservation District (Marin RCD),</li><li>▪ 319(h) State Water Resources Control Board (SWRCB)</li><li>▪ United States Department of Agriculture Natural Resources Conservation Services (NRCS) Environmental Quality Incentives Program (EQIP)</li><li>▪ Prunuske Chatham Inc.</li><li>▪ Landowner</li></ul>

**Project 2012-005****Rangeland Roads and Water Quality Improvement Project**

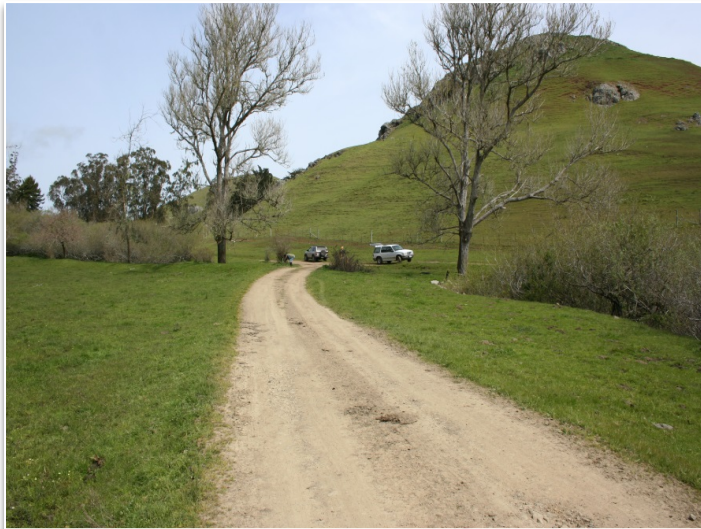
Pre-construction photo of project site area taken from Photo Point #5.

Project site area prior to ranch road enhancements, implementation of the stream crossing and fencing.

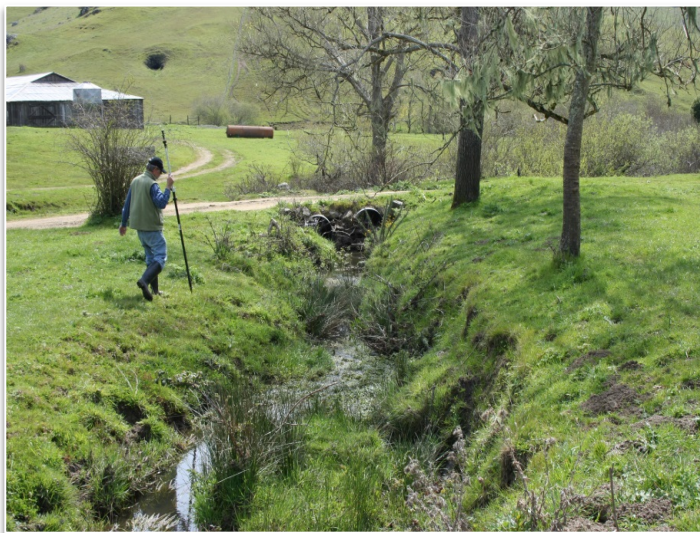
Pre-construction photo taken from Photo Point #1.

The image displays a downstream view of 2 culverts to be replaced and sidebank of stream

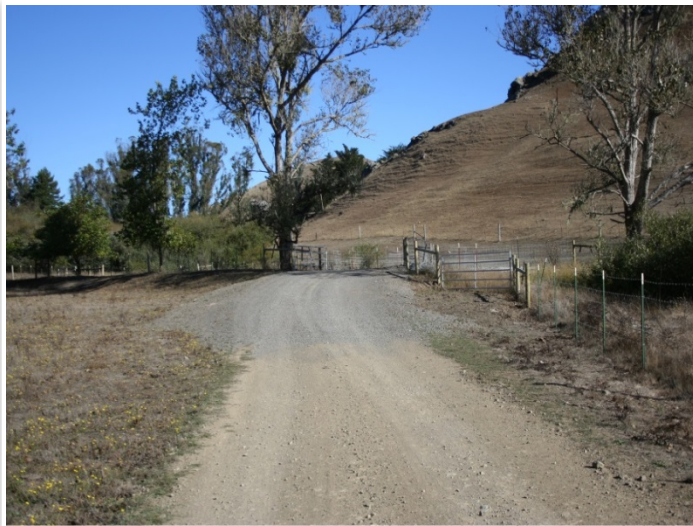
Post-construction photo of project site area from Photo Point #5.

This image shows the ranch road enhancements and the fence line constructed along the project site.

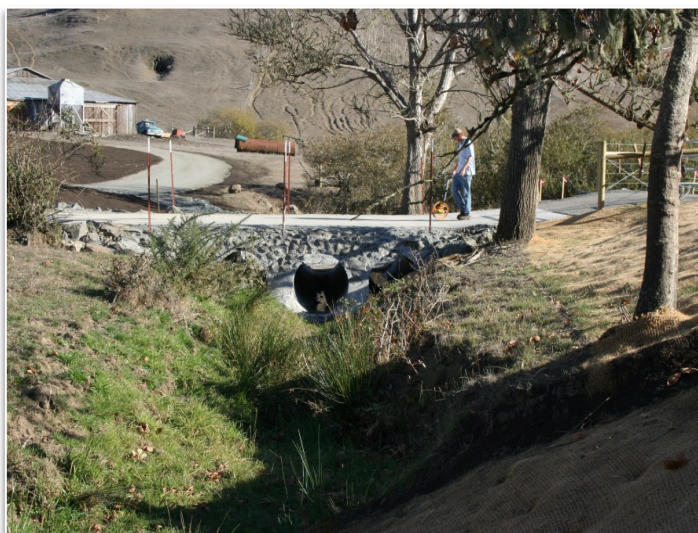
Post-construction photo taken from Photo Point #1.

Erosion control repairs, upstream, from the wet crossing approximately 80 linear feet of the left bank was stabilized using a fabric-reinforced earthen fill (FREF), was showing no evidence of erosion. Although, the FREF was visible, but appeared secure only lacking established vegetation most likely due to the dry season. Just upstream from sidebank repairs there is historical cattle trailing, existing pre- project and will continued to be monitored as a part of the fence enclosure.

Photo displays the stream crossing and restored sidebank.

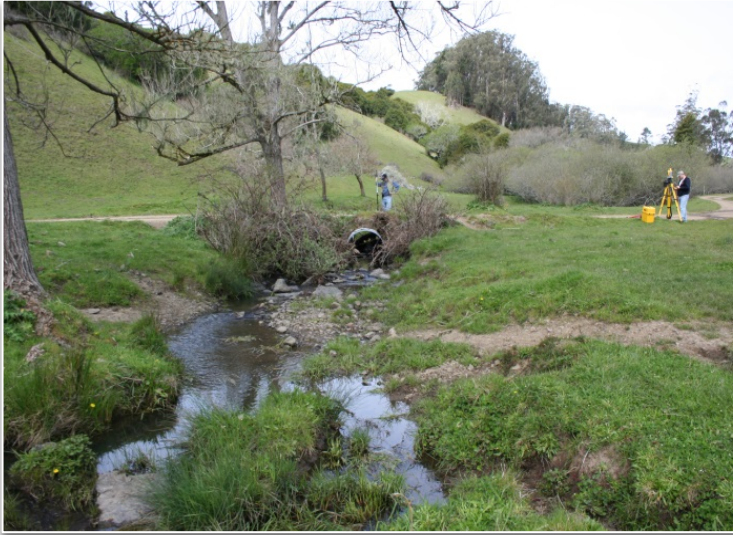
*Pre-construction photo of landscape from Photo Point #4.*  
Project site area prior to construction photo viewing upstream.

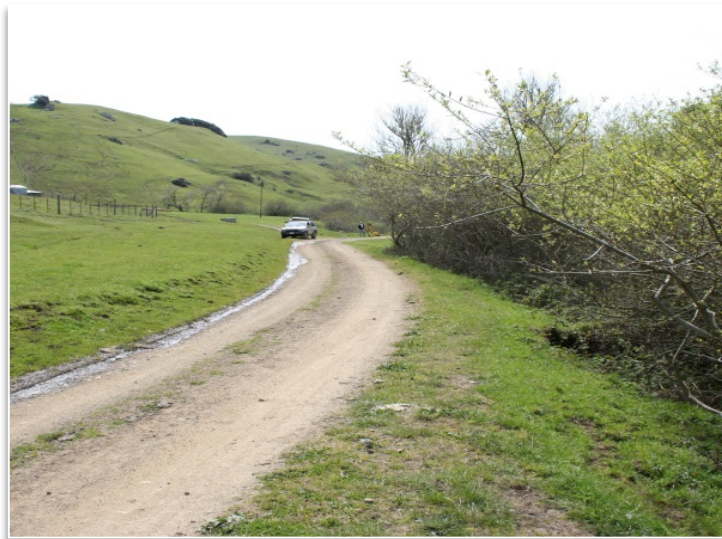
*Pre-construction photo taken Photo Point #3.*  
Project site area prior to road improvements and construction.

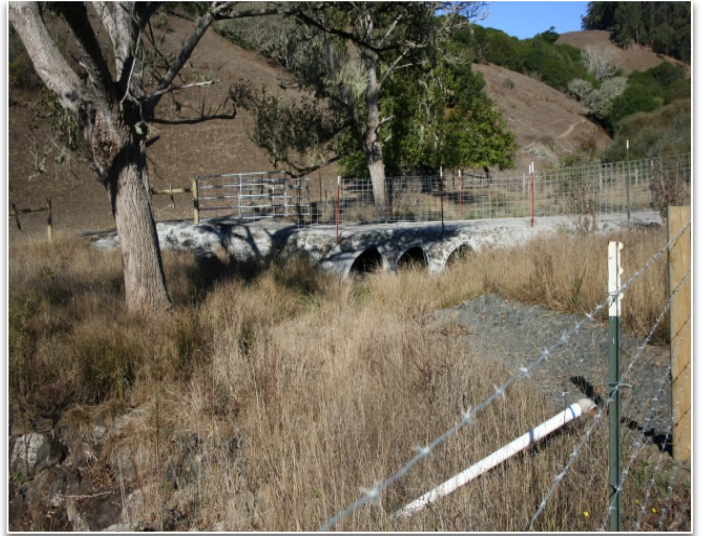
*Post-construction photo taken from Photo Point #4.*  
The image displays the fence and stream crossing repairs looking upstream.

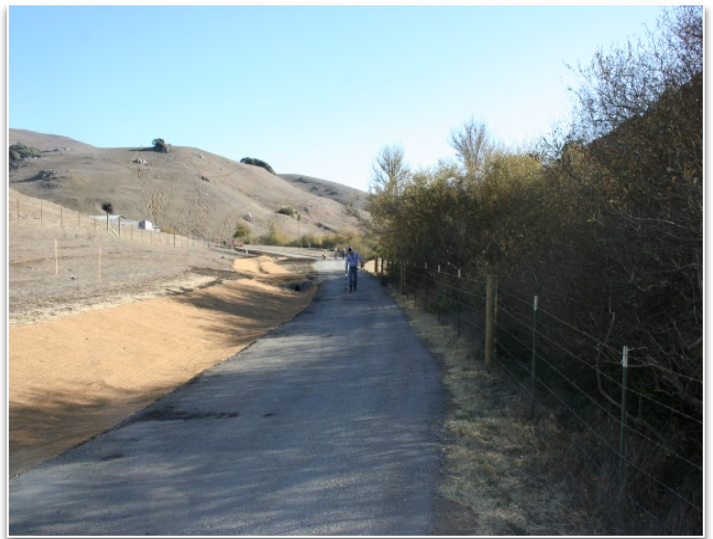
The road improvements, culvert crossing, culvert and rocked water waterway were all functioning as planned and in excellent condition. No visible erosion surrounding the new structures or debris obstructions surrounding the culverts. The constructed grassed waterways and berms appeared to be in fair condition. Due to the drought the grasses have not established although the reinforced fabric is still in place stabilizing the surface area.

*Post-construction photo taken Photo Point #3.*  
Photo displaying ranch road enhancements, fencing, and the grassed waterway.
