MARIN COASTAL WATERSHEDS PERMIT COORDINATION PROGRAM ANNUAL REPORT 2016-2017

JULY 2017

# Marin Coastal Watersheds Permit Coordination Program

# **Annual Report Executive Summary**

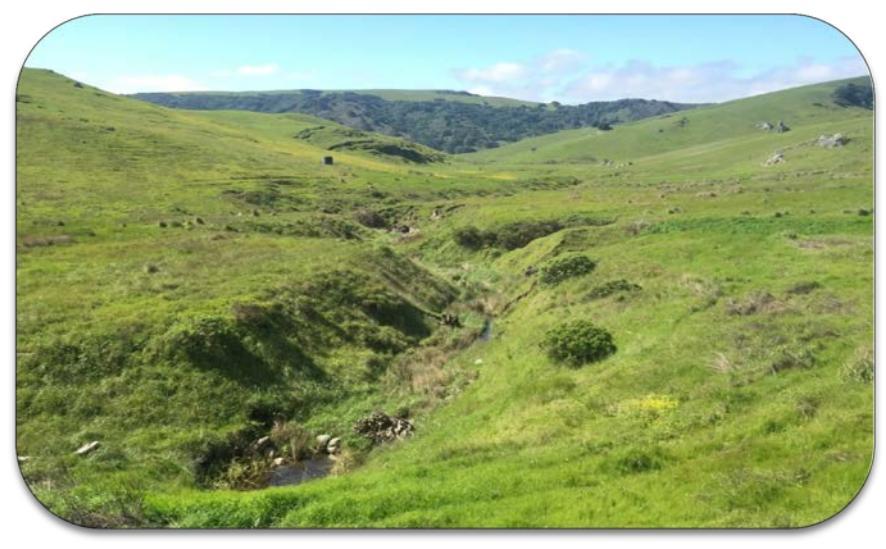
View from the top of the pond damn looking downstream at the tributary to Chileno Creek thence Walker Creek (03/2016).

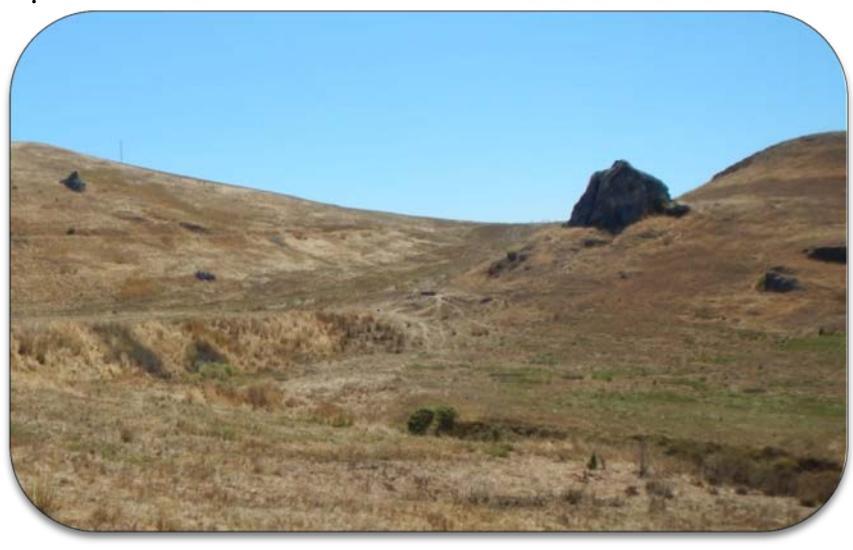
Pre-construction photo of circular trough below rock and the pathway of the riparian fence (7/2016).

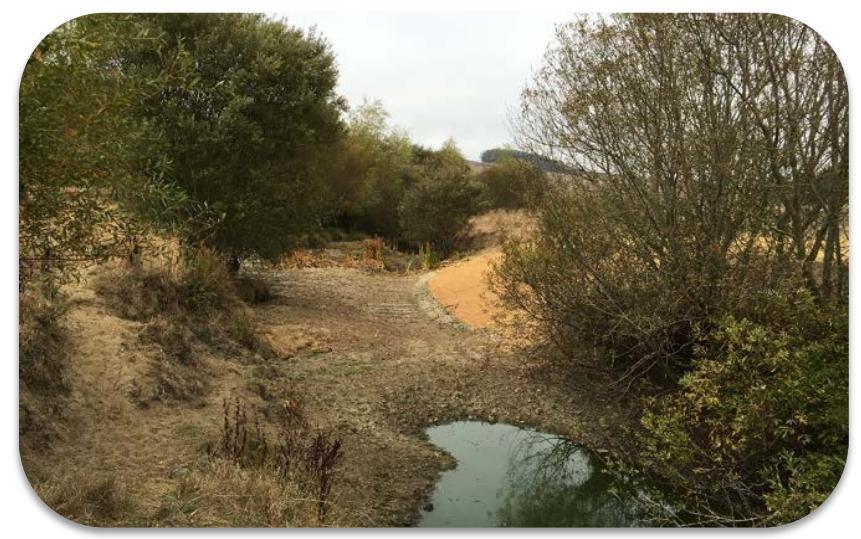
Downstream view located above the recently repaired site (09/13/17). Construction waited until creek pools were low enough and before the winter rains.

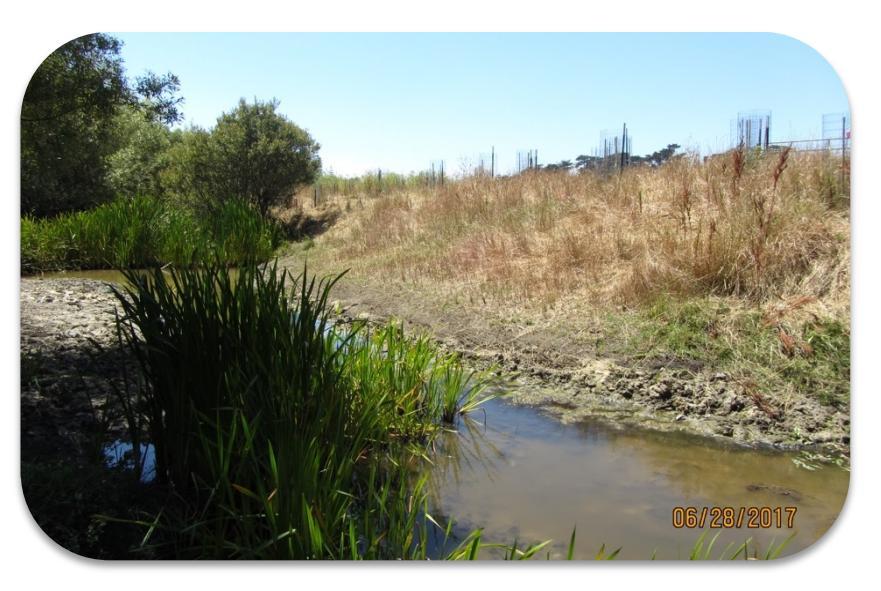
Post-construction (06/28/17) downstream view located above project site. The graded repair held up after a wet winter and several flood stage events.

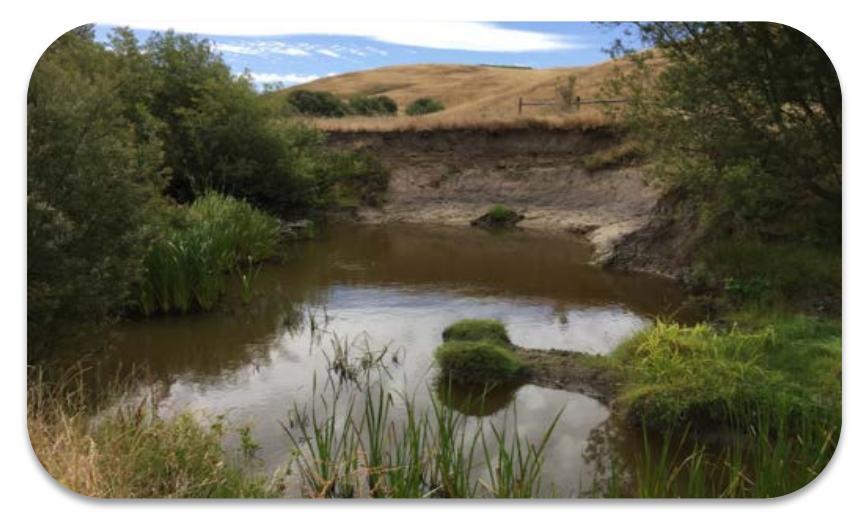
Pre-construction (7/2016) view of eroding bank caused by the historical pile of riprap. This bank will be planted.

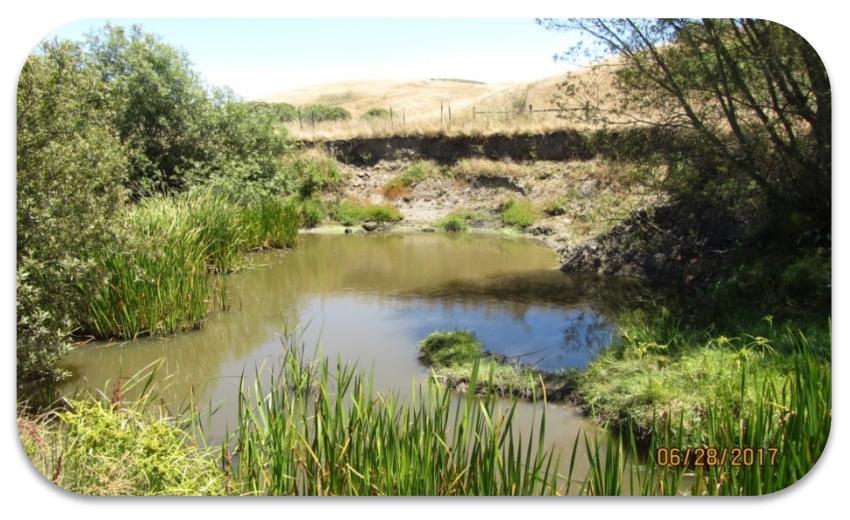
Post-construction (06/28/17) view of eroding bank with willow stakes installed at top of bank.

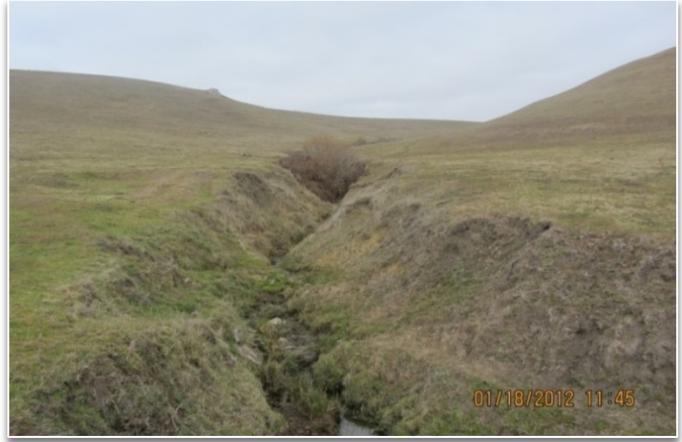
**Pre-construction Photo 02/2013** View of livestock culvert crossing and active side gully headcutting before construction.

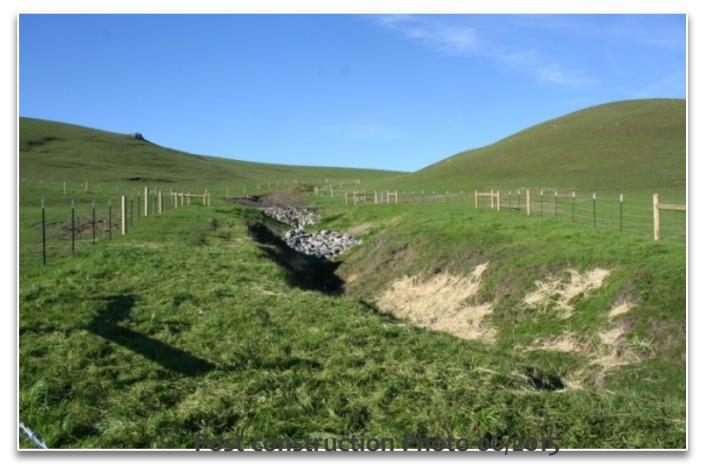
Project site after construction showing the riparian fence encompassing the gully headcut and bordering a livestock culvert crossing repair.

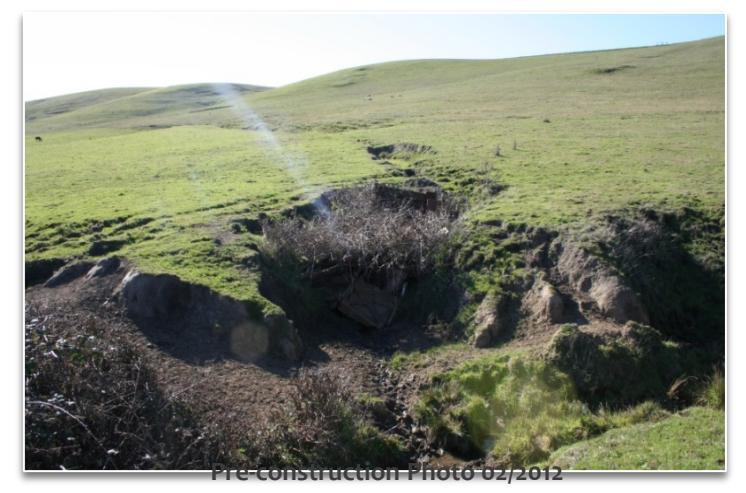
Project site before construction displaying downstream view of degraded stream channel riparian before fencing and vegetation.

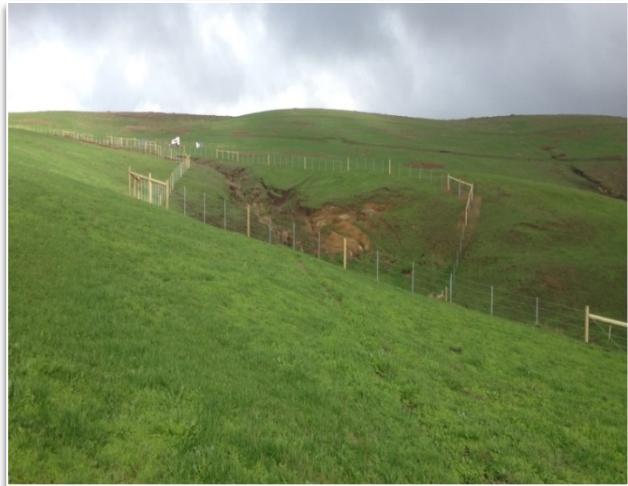
Pre-construction photo of site two taken from top of headcut looking down towards the culvert along Dillon Beach Rd. The photo displays the width and depth of the active headcut. Post-construction photo of site two taken from top of headcut repairs. The photo displays the reshaped rock lined waterway with a wide channel and shallow channel bottom surrounded by riparin fencing.

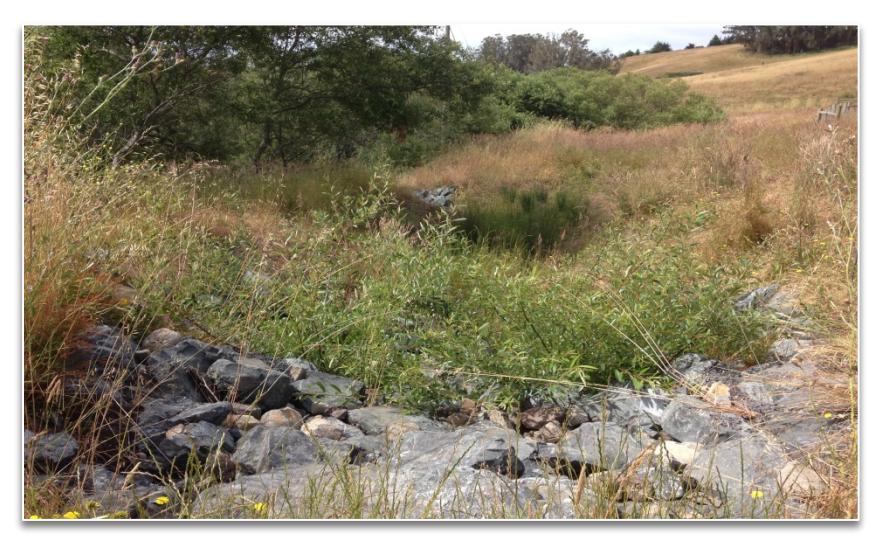
**Vegetation Survival Monitoring Photo 06/2017** Close up view of the willow spring planted within headcut repair.
