# **Geomorphology of the Walker Creek Watershed: Prospects for Habitat Enhancement and Sediment Management**

Prepared for  
**Marin Resource Conservation District**

Prepared by  
**Lauren Hammack**  
**Prunuske Chatham, Inc.**

**August 10, 2005**

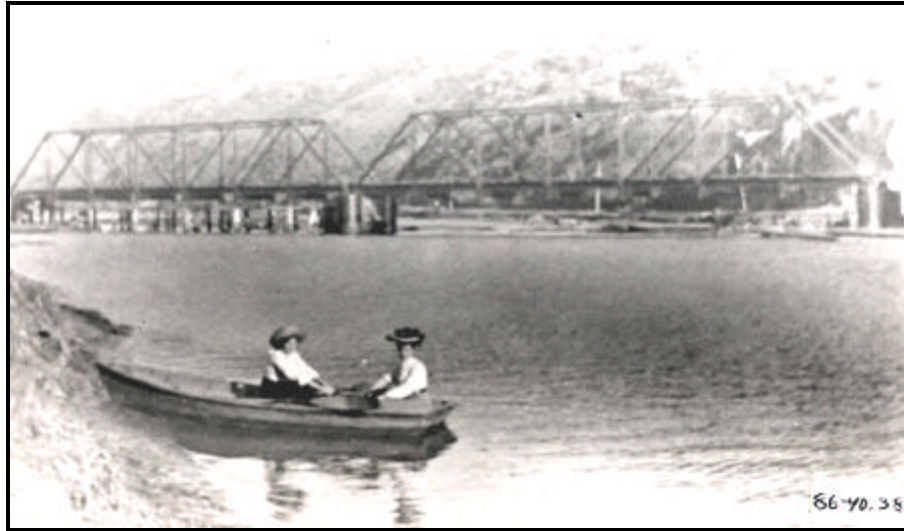
**Figure 5.** Photo circa 1900-1919 of boating in Walker Creek near the train trestle and Ocean Roar. Channel is now approximately half the width seen in this photo. (From [www.krisweb.com](http://www.krisweb.com) courtesy of the Tomales Regional History Center)

Dramatic changes in channel form and behavior continued to occur throughout the watershed as a result of landuse impacts. Haible (1980) documented that during the 60 years between 1915 and 1975 the channels in the upper watershed incised 5 to 8 feet while the lower reaches of Walker Creek, above the Highway 1 Bridge, aggraded approximately 4 feet. Infilling and narrowing of the estuary has continued over the past 100 years (Figure 5 and 6). Extensive tidal flats have developed and have been slowly extending seaward to cover several kilometers at the mouth (Figure 7). Conversations with long-term residents in the watershed indicate that the primary incision documented by Haible (1980) occurred prior to 1950.

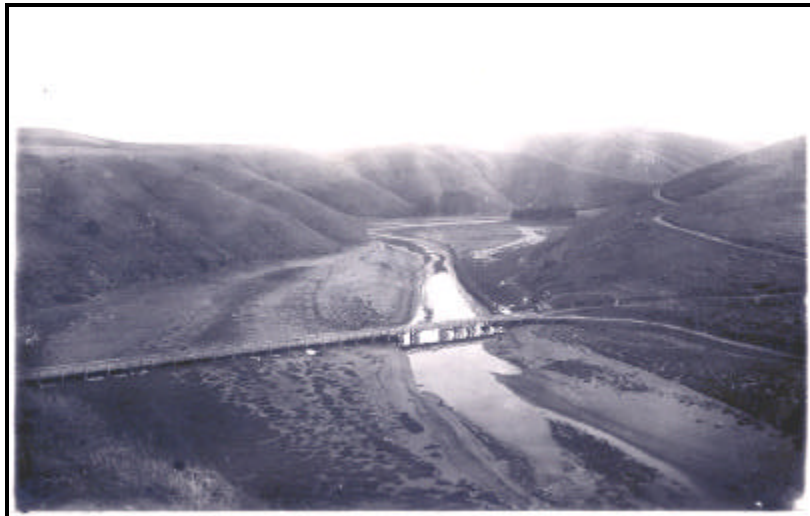
**Figure 6.** Highway 1 crossing at lower Walker Creek circa 1920. View is looking upstream. Note extensive fine-grained sediment deposits on both banks and in the channel at lower right. (From [www.krisweb.com](http://www.krisweb.com) courtesy of Tomales Regional History Center)

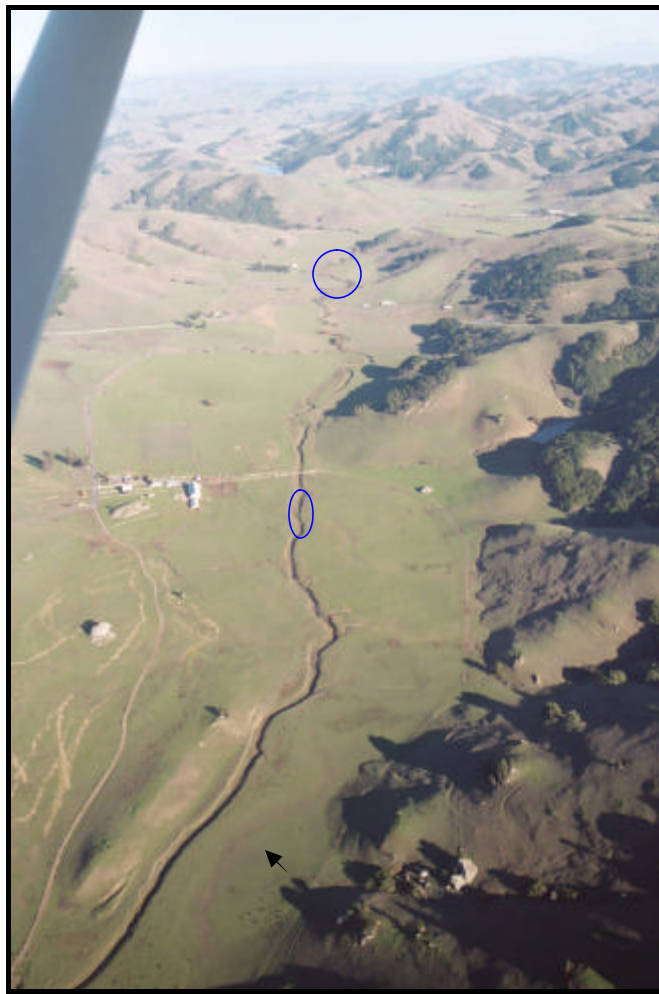
**Figure 9.** An example of the Alluvial Valley Transfer/Deposition Zone shown with Chileno Valley looking upstream. Straightened reach in lower left of photograph with black arrow pointing to possible original channel course. Blue circles indicate reference site locations.

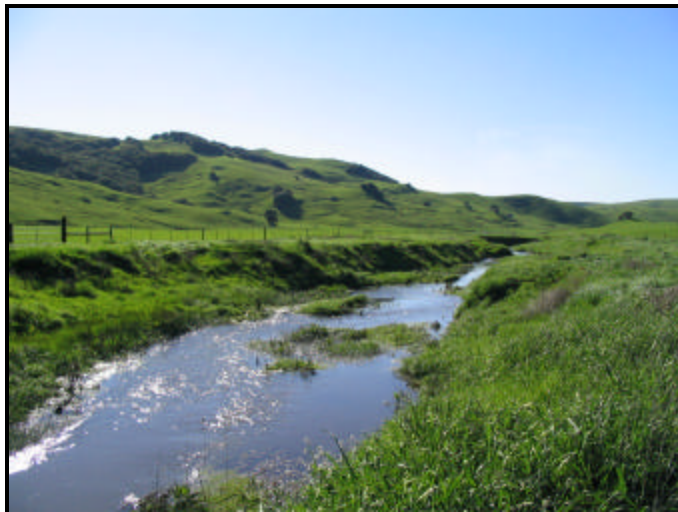
**Figure 11.** An example of the straight channel form in the Alluvial Valley Transfer/Deposition Zone. View is looking downstream at site 1B during winter base flow.

- Narrow, incised channel.
- Alternating, low gravel bars.
- Few, widely spaced pools that become disconnected in summer.
- Small, intermittent floodplain strip (formed by bank slumping).
- Little to no riparian vegetation.
- Erosion on selective alternate banks.

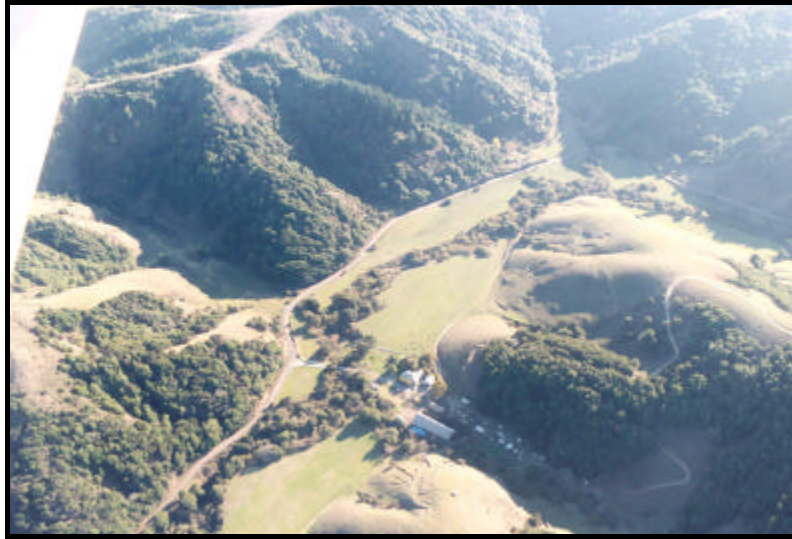
**Figure 13.** *An example of Reach Type 2 – Incised Transfer Zone. Middle Salmon Creek shown in photo with flow from lower left to upper right.*

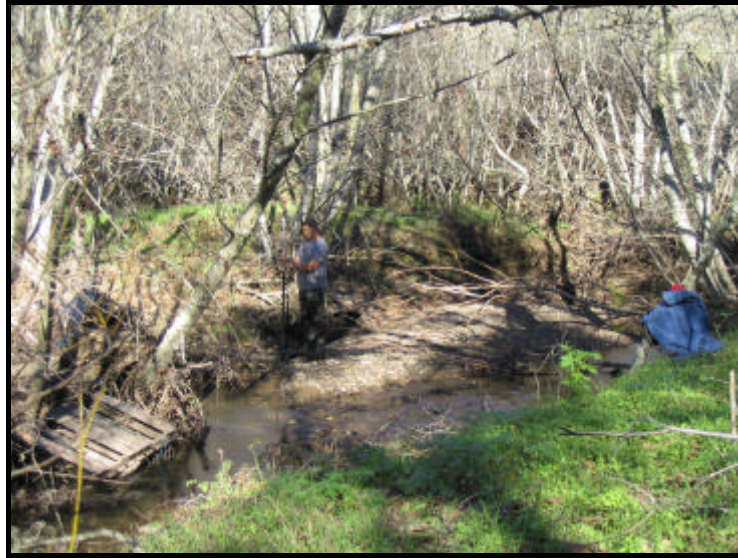
**Figure 15.** Example of channel and floodplain in the 2A reference site. Flow is from right to left with constructed willow wall in the far background across grassy floodplain.

- Moderately sinuous channel pattern.
- Inset floodplains and point bars.
- Well developed pool-riffle sequences.
- Deep pools associated with root wads and debris jams.

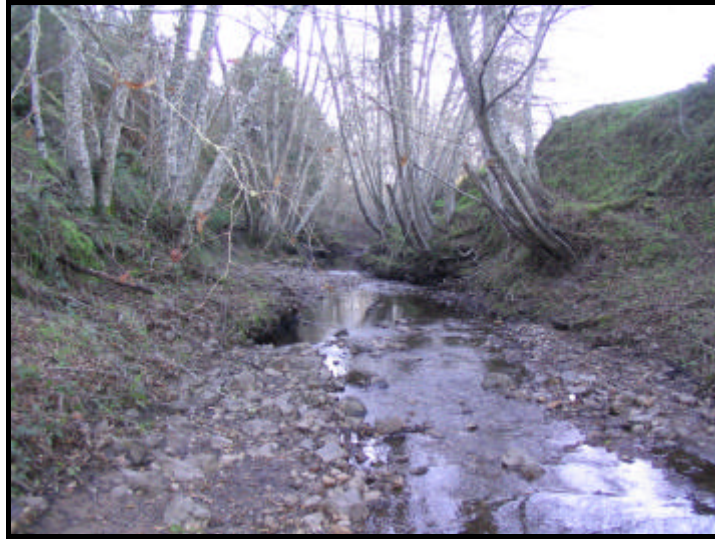
**Figure 16.** Example of entrenched, straight channel type. Flow is away from the camera.

- Incised channel.
- Riffle/run dominated.
- Alternating coarse gravel bars.
- Few, small inset terrace remnants.
- Shallow, widely-spaced pools.

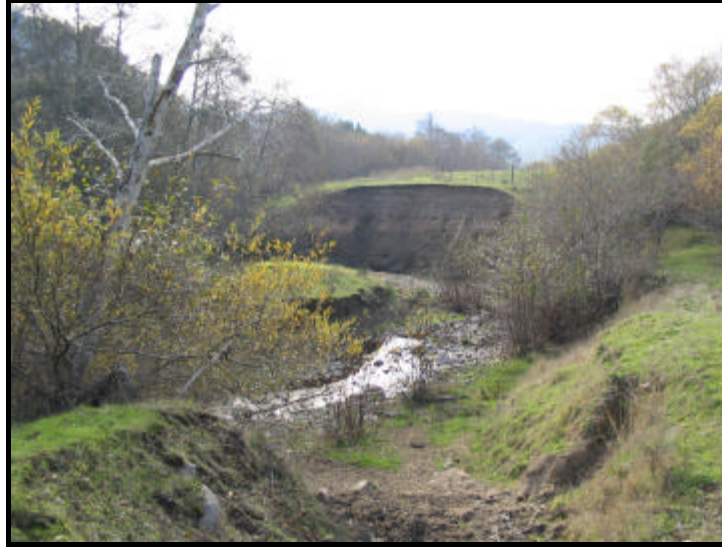
**Figure 18.** Characteristic terrace/bank erosion in Channel Reach Type 2 – Incised Transfer Zone. Flow is away from the camera.

Channels in Reach Type 2 typically function as sediment transfer zones with little net aggradation or degradation occurring. Discrete bank erosion sites like that shown in Figure 18 are chronic sediment sources. Channel widening through bank erosion is the natural process associated with the channel evolutionary stage seen in the Incised Transfer Zone Reach. Rapid incision leads to destabilization of channel banks, especially in areas with minimal woody riparian vegetation to stabilize the banks. This process combined with reduced sediment loads from improvements in land use practices and gully erosion-control naturally initiates channel widening through meander bend migration. Channel widening, if combined with grazing control and riparian vegetation establishment, will lead to complex channel feature development and sediment storage.

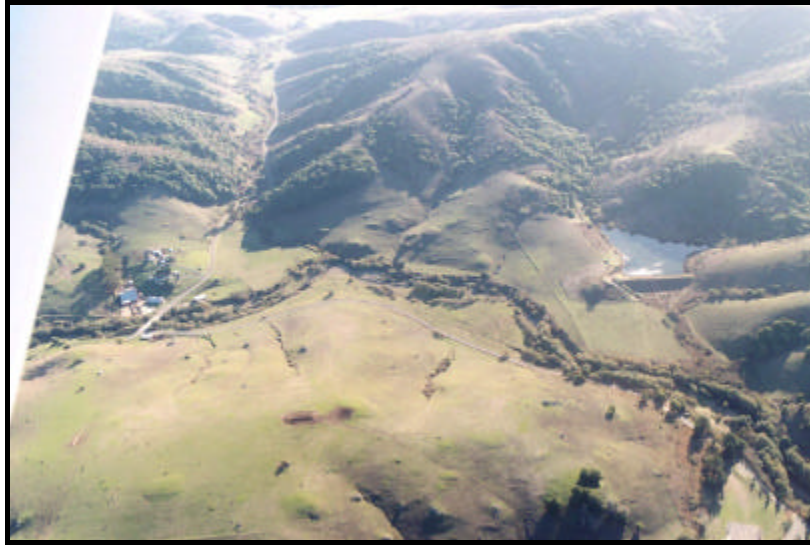
**Figure 19.** Upper Walker Creek mainstem as an example of the Inset Floodplain Exchange Zone channel reach type. Flow is from left to right.

The majority of the Walker Creek mainstem is typed as the Inset Floodplain Exchange Zone – channel reach type #3 (Figure 8). A broad, active floodplain is inset into high, Holocene terraces (Figure 19). Dense riparian woodland has established itself throughout most of this Reach since the mid 1980s. Knick zones appear to be moving up the system. Channel avulsions are common and multiple side channels are present in most sections. High mid-channel gravel bars are remnant from the 1982 flood.

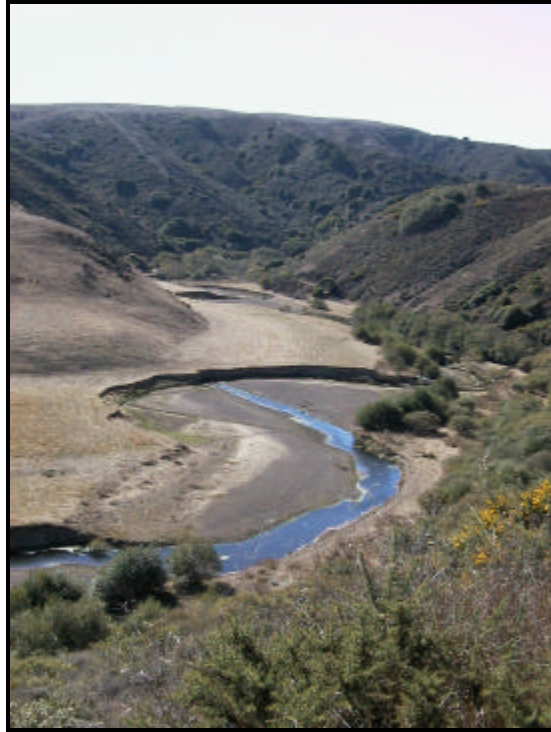
**Figure 22.** Overview of the Valley Transfer Reach. Development of a sinuous channel and meander bend migration has occurred since 1984, eroding terrace pasture land. Flow is from left to right.

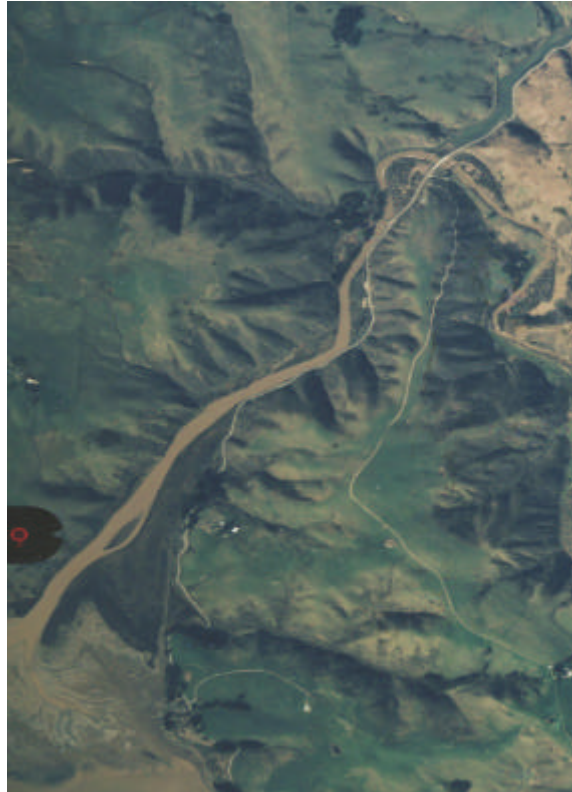
**Figure 24.** *The Tidal Deposition Zone extends from the mouth upstream to the town of Tomales on Keys Creek and approximately 2 miles upstream of the Highway 1 bridge on Walker Creek. Extensive aggradation of this reach occurred in the late 1800s. Fine sediment continues to accumulate and enlarge the delta at the mouth.*

typed the Tidal Deposition Zone. The bulk of the sediment delivered to this Reach is deposited in the channel or floodplain. Coarse sediment that enters this settles out in the upstream sections, with the location dependent upon hydraulic interactions of tide and streamflow. The grain-size distributions of the channel and floodplain deposits tend to decrease with proximity to the mouth. Sediment that makes it through the system is likely to be deposited on the delta at the mouth.

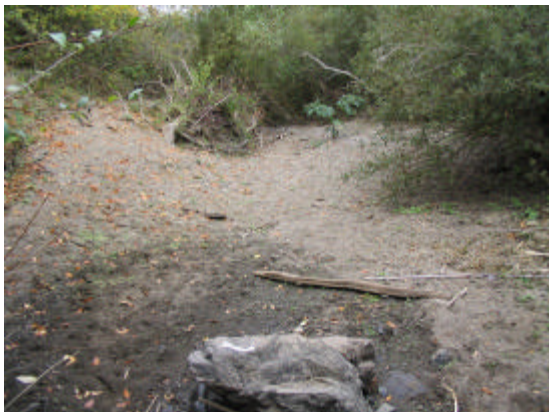
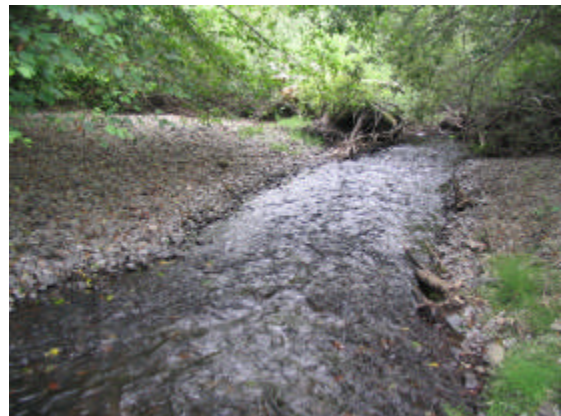
**Figure 27.** Comparison of channel features in transport limited (left) versus equilibrium (right) channels in Walker Creek.

Most of the perennial channel reaches appear to have the competence to transport their available sediment loads. They may be transport-limited at some flows, as is evidenced by fine grained, in-channel deposits and poorly sorted gravel bars. A few reaches are clearly transport-limited with no equilibrium between their sediment and flow regimes; appearing to be inundated with high annual sediment delivery. Lower Chileno Creek is a reach where significant in-channel accumulations of unconsolidated sand and fine gravels are present and available for delivery downstream (Figure 27). Portions of Reach Type #3—Inset Floodplain Exchange Zone—have both the hydraulic competency and complex morphologic structure of channels in dynamic equilibrium (Figure 27). These reaches exhibit defined pool and riffle structure and the bed and bank material is well sorted by morphologic location, providing functional habitat.
