PROJECT HIGHLIGHTS, 2012-003

Project 2012-003*Livestock Pond Fence Exclusion and Water Development*

Livestock Pond Fence Exclusion and Water Development

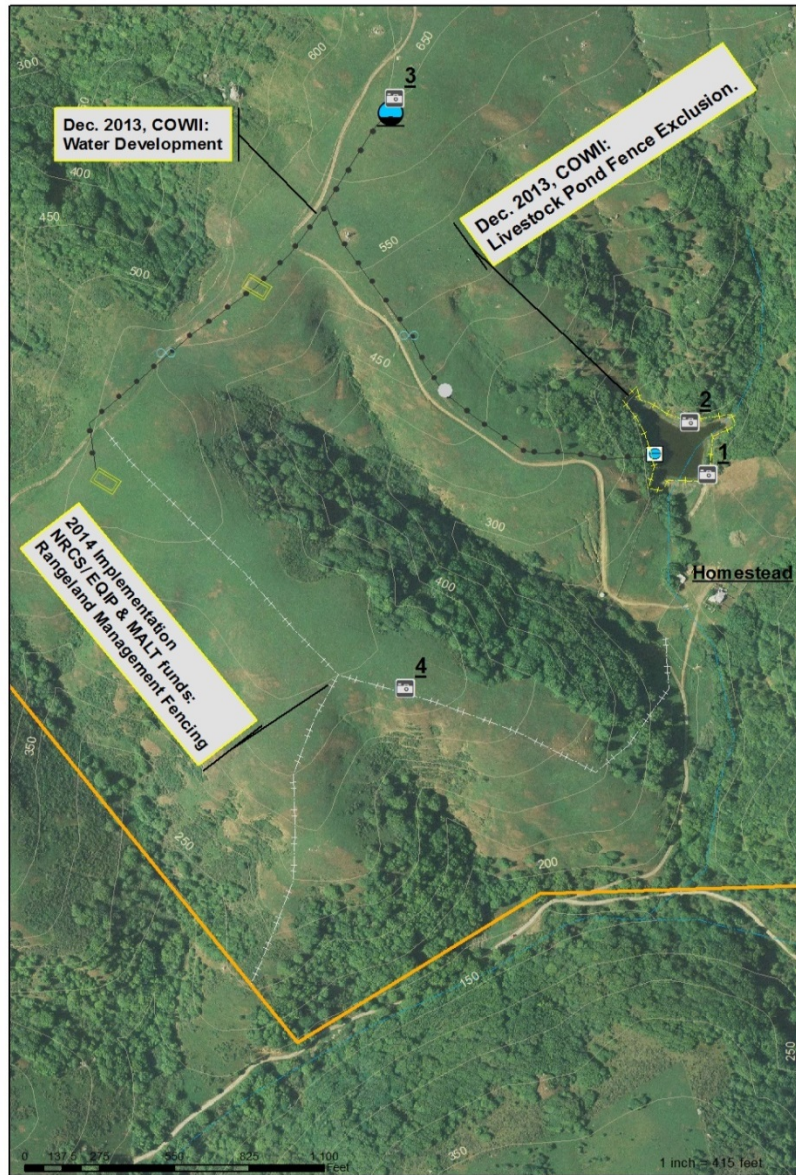
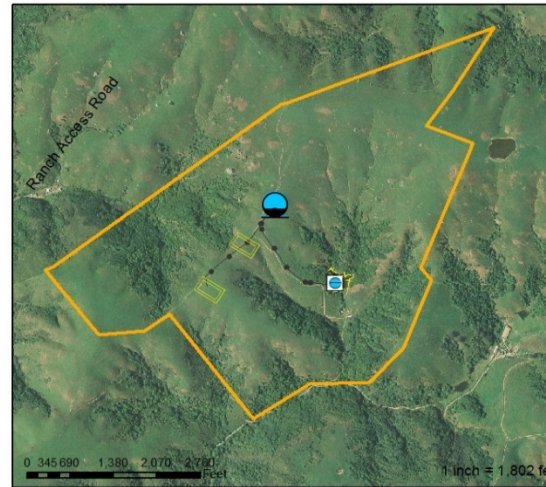
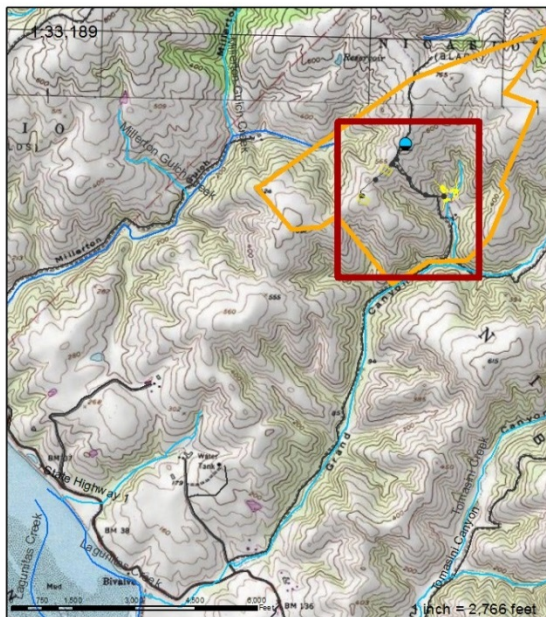
Figure 1. Maps of Project 003, Left: Map labeled with current and past conservation practices implemented. Top right: COW project completed in partnership with MALT, NRCS and Marin RCD. Bottom right: USGS topography map with the property boundary highlighted in orange and a red box identifying the general location of the project.

The ranch is accessible from State Highway 1, approximately five miles north of Point Reyes Station, Marin County, California (Fig. 1).

The project site is located north of the homestead/hunting camp, adjacent to an unnamed stream off of Grand Canyon Creek and a maintained ranch road (Fig. 1).

The constructed fence was measured at 935 linear feet, which was longer than the planned 450 linear feet of 5-strand regular terrain fence (Table 2). The difference in fence constructed vs planned was due to the contractor having to set the fence back further than what was originally planned in addition to a miscalculation of the fence footage. At the time of construction a slow leak was discovered in the dam causing a significant amount of water loss. The leak created difficult site conditions in the construction of the fence due to extremely saturated soils. This modification increased the total amount of fencing constructed (Fig. 1 & Fig. 2).

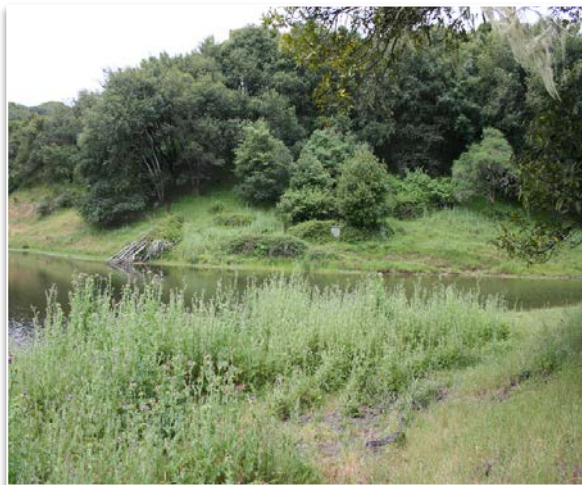
Pre-construction photo taken at Photo Point #2.

Point located adjacent to an old well house at the back of the pond. This photo point displays the encroaching weeds and pre dam leak conditions of the pond.

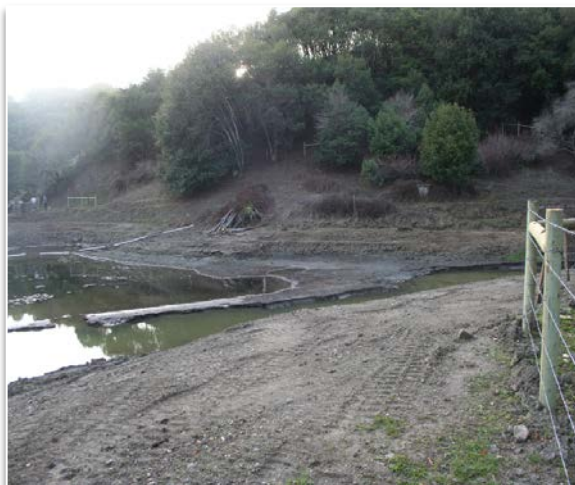
Post construction photo taken at Photo Point #2.

One month post-construction photo taken near the old well house at the back of the pond. The photo displays the livestock fencing surrounding the pond. Due to the leak and weed removal the pond level was low and slowly recovering.

At the time of the interview the pond was still recovering from the construction (pond leak, fence, pump and pipe installation) and an unexpected drought year. The landowner was optimistic and expects the project to aid in water reduction and conservation for the ranch. He also anticipates the improvements to enhance the overall management of the ranch by reducing livestock impact at the pond thus decreasing

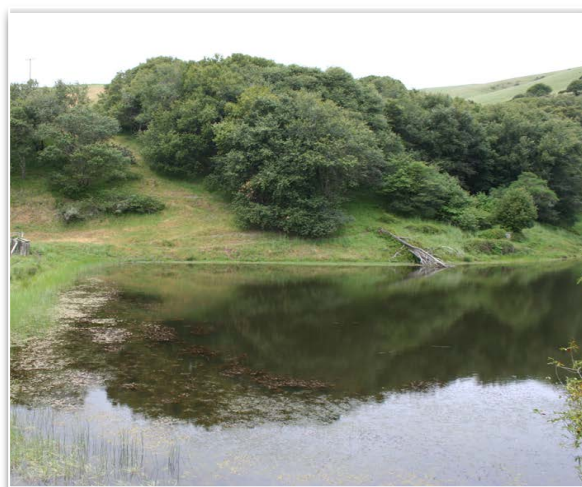
Pre-construction photo taken at Photo Point #1.

Photo taken next to the pond entrance gate to show the existing fence and pre-construction project condition.

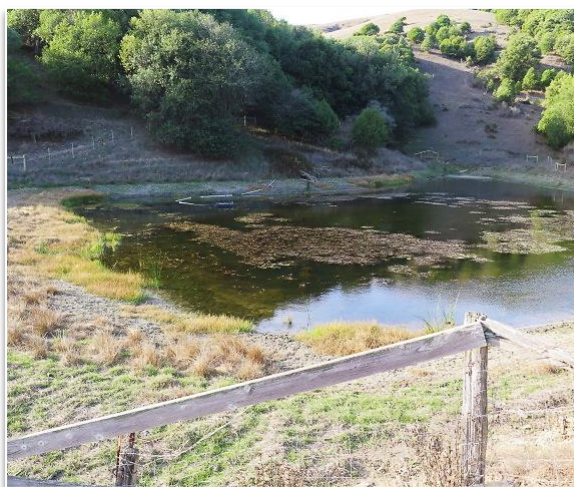
Post construction photo taken at Photo Point #1.

The pond one year post-construction documenting the completed project: exclusionary fence, pump and start of pipeline system and revegetation.

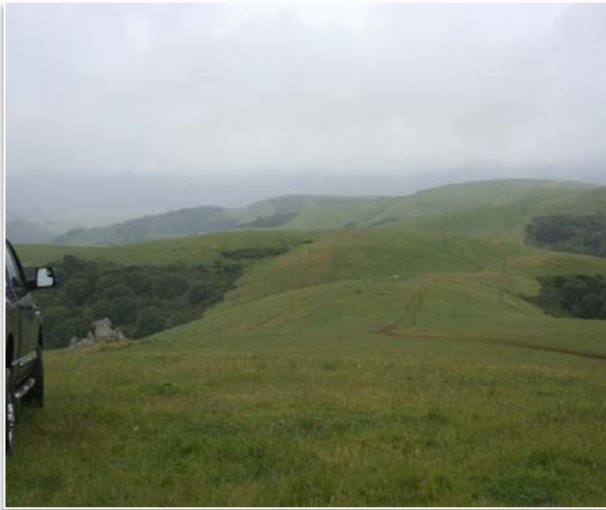
Pre-construction photo (1-year pre-project) taken from Photo Point#3.

Photo displaying the condition of the water development project site along the ridge top.

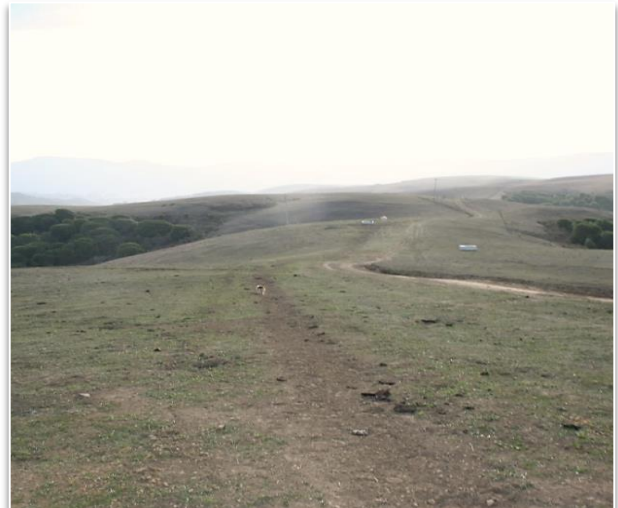
Post-construction photo taken from Photo Point#3.

Displaying the restored pipeline trench and two water troughs in the distance along the ridge top.

a steep hill slope while adjusting for an elevation change of 350 feet. A trench was constructed to bury the livestock pipeline along the side of the ranch road which travels uphill and along the ridge in both directions. To regulate the volume, quality and rate of delivery, a bladder tank with a pressure-relief valve was installed halfway up the hillslope along with two air vents to prevent air locking which would protect the pipeline since the water was traveling a long distance from the source to concrete troughs. At the top of the ridge the pipeline split, traveling in two directions, to disburse water east to a water storage tank (5000 gallon) and west to two concrete troughs. The two concrete troughs were designed to meet the water supply requirements of the livestock operation and wildlife. The troughs were placed on durable firm foundations to protect the surrounding areas from resource concerns related to animal concentration and unexpected water overflow. Adequate access for wildlife was also incorporated by adding an escape ramp per NRCS standards and specifications (Table 2, Fig. 1 & Fig. 3).

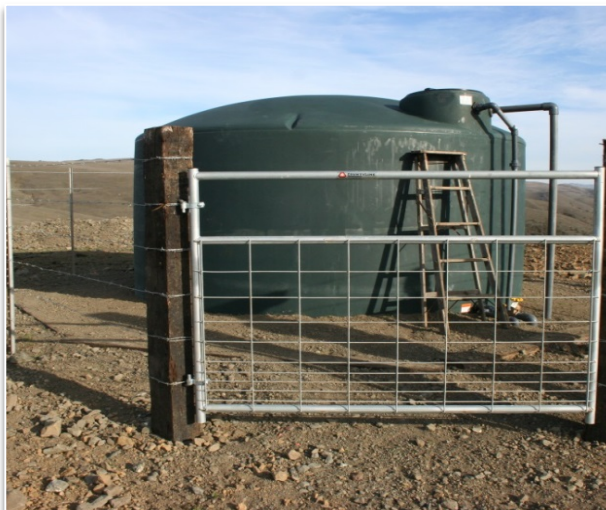
Post Project Photo 12/2013

Photo of installed 5,000-gallon water tank.

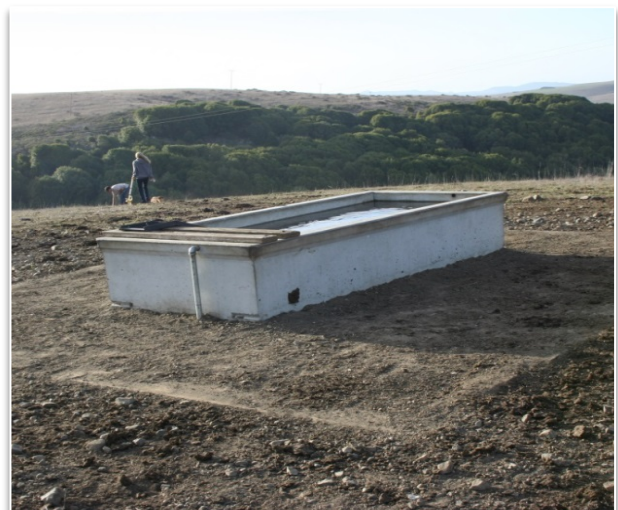
Post Project Photo 12/2013

One of two concrete 400-gallon water troughs installed with a concrete pad and wildlife ramp.
