MARIN COASTAL WATERSHEDS PERMIT COORDINATION PROGRAM 2015 REPORT

June 2016

PROJECT PROFILE: #2013-001

PROJECT PROFILE: #2013-004

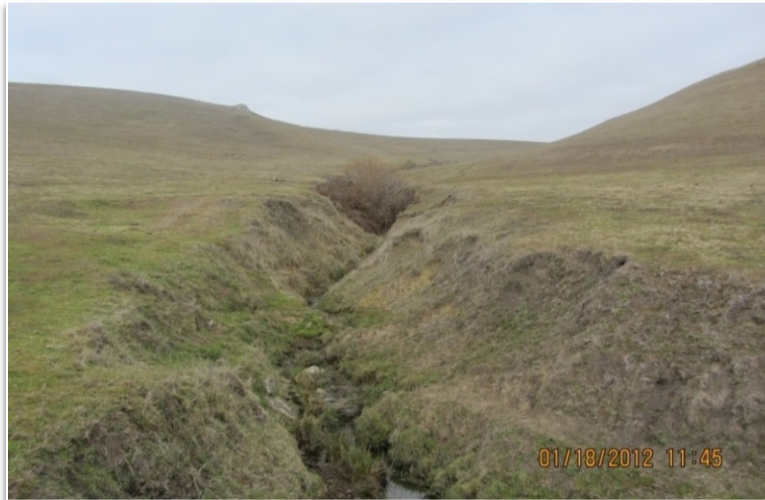
Upstream view before riparian fence and grade stabilization repairs were installed.

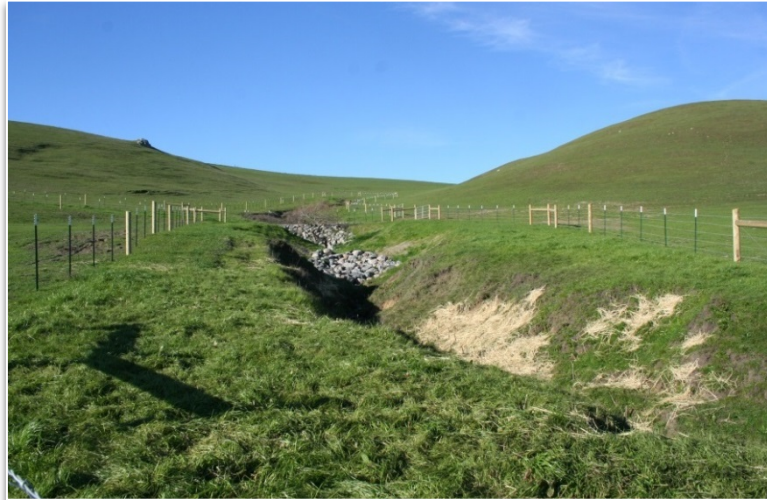
Post-construction Photo 01/2015

Upstream view after construction of the following practices: riparian, fence, grade stabilization repairs and revegetation.

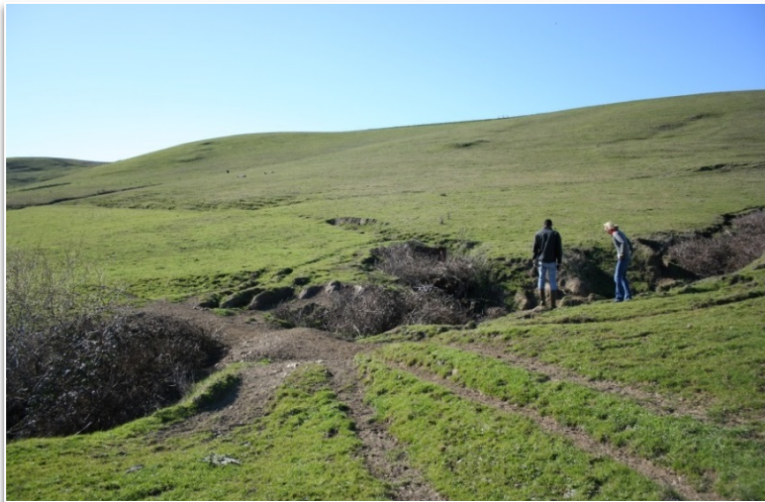
Pre-construction Photo 02/2013

View of livestock culvert crossing and active side gully headcutting before construction.

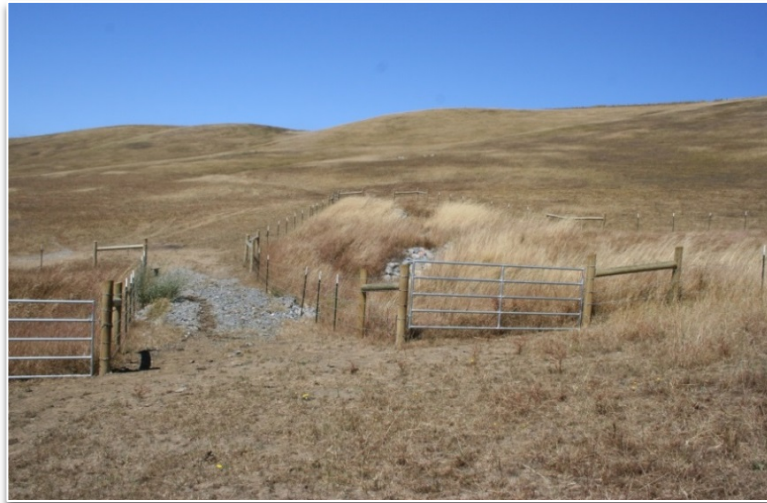
Post-construction Photo 06/2015

Project site after construction showing the riparian fence encompassing the gully headcut and bordering a livestock culvert crossing repair.

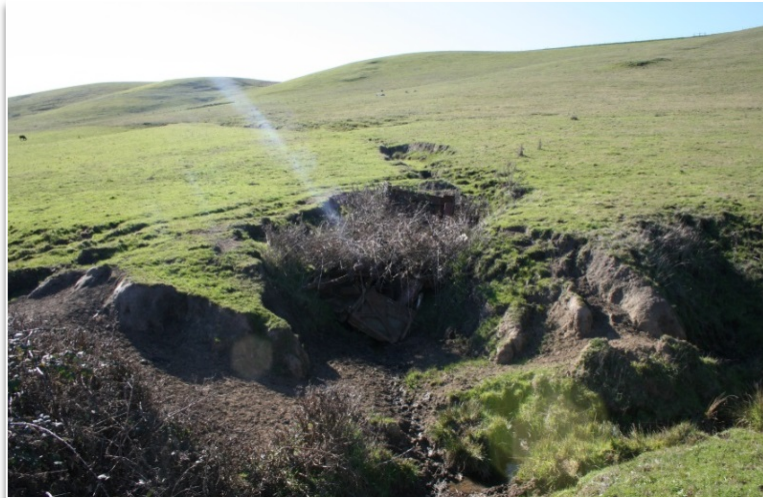
Pre-construction photo of project viewing active headcut side gully before construction.

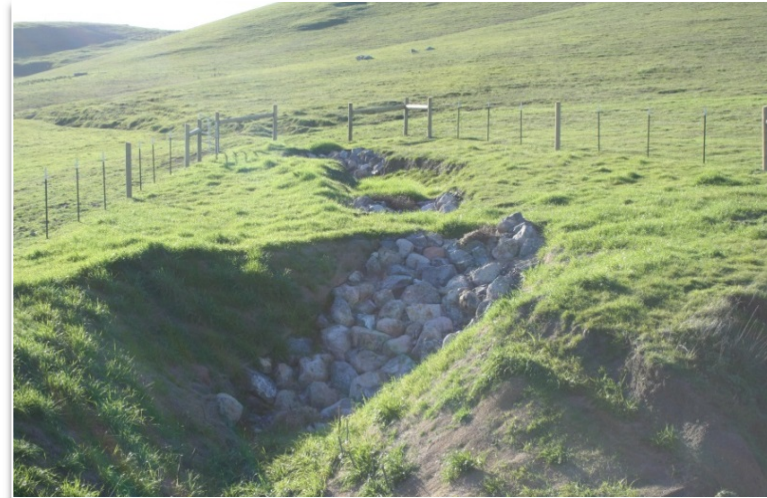
Post-construction Photo 01/2015

In early 2015, the Project Assessment Checklist was completed. At the time of inspection the side gully headcut and grade stabilization repairs showed no evidence of erosion or rock movement at the top or toe of the structures. All rock appeared to be secure and holding in place. There was no evidence of erosion scour around the rock structure, soil piping through or under the rock structures. The only flaw observed was evidence of visible fabric remaining from the repairs. The contractor was asked to trim back the remaining fabric surrounding the repairs before completion of the project. The effectiveness and stability rating for post-project was ‘good’ for post-project construction.

Post-construction project photo displaying side headcut gully repairs and fencing.

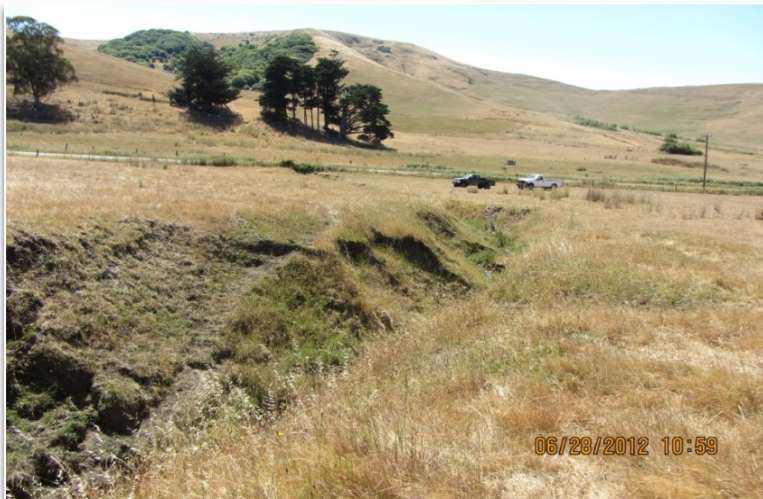
Pre-construction Photo 02/2012

Project site before construction displaying downstream view of degraded stream channel riparian before fencing and vegetation.

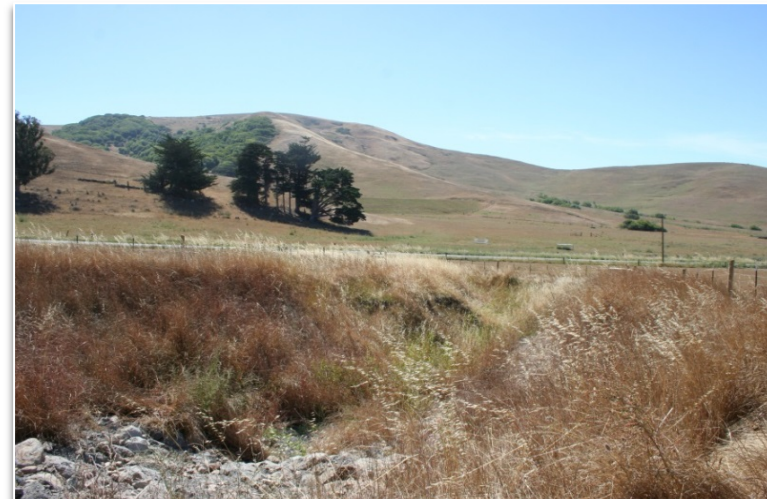
Post-construction Photo 06/2015

The stream grade stabilization headcut repairs however both rated ‘fair’ in effectiveness and stability and needed attention post-construction. The larger headcut repair below the culvert crossing and the side headcut upstream showed evidence of rock movement. The smaller rock washed out, exposing the erosion control fabric and leaving large voids between the larger placed rocks. The side headcut experienced rock movement, exposing the erosion control fabric and channeling the flow of water and cause additional erosion. Both of these issues were brought to the attention of both the PCI design engineer and

Downstream view after construction of the riparian fence, grade stabilization repairs and STRAW plantings of willow sprigs and *Juncus*.

contractor. Repairs were made immediately following the post construction assessment and the project rating improved from 'fair' to 'good' in effectiveness and stability.

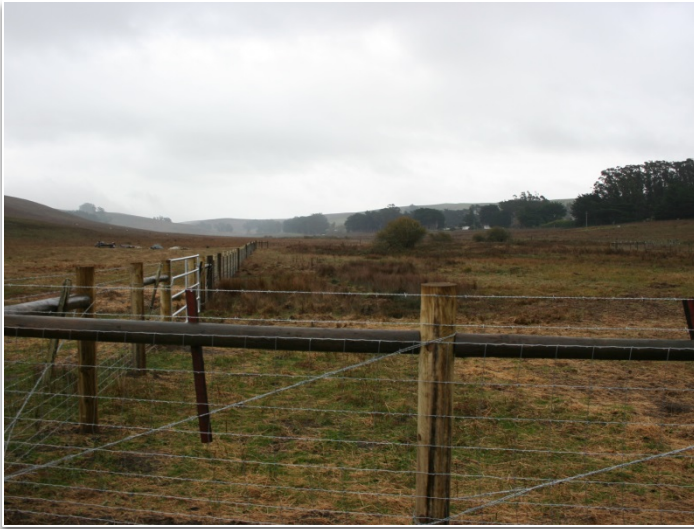
Post-construction Photo 11/2014

Post-construction photo of exclusionary fencing at eastern parcel, Site 1.

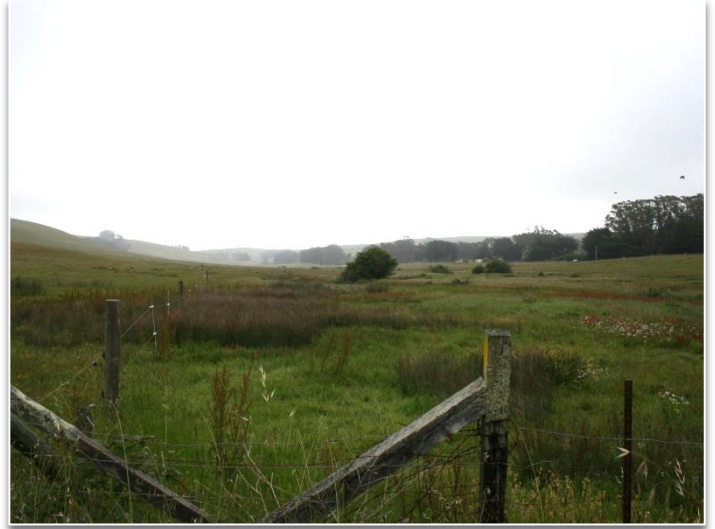
Pre-construction Photo 05/2014

Pre-construction photo of eastern parcel, Site 1 pre exclusionary fencing and planting. View taken from Photo Point 1.

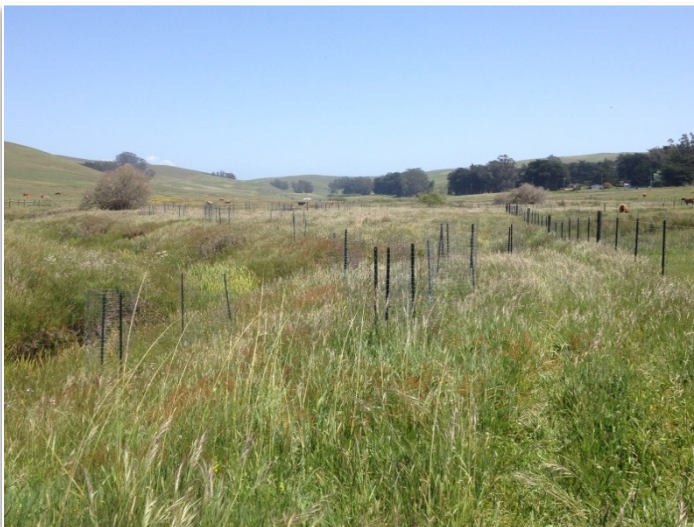
Post-construction Photo 05/2015

Post-construction photo riparian fencing encompassing the critical area planting.

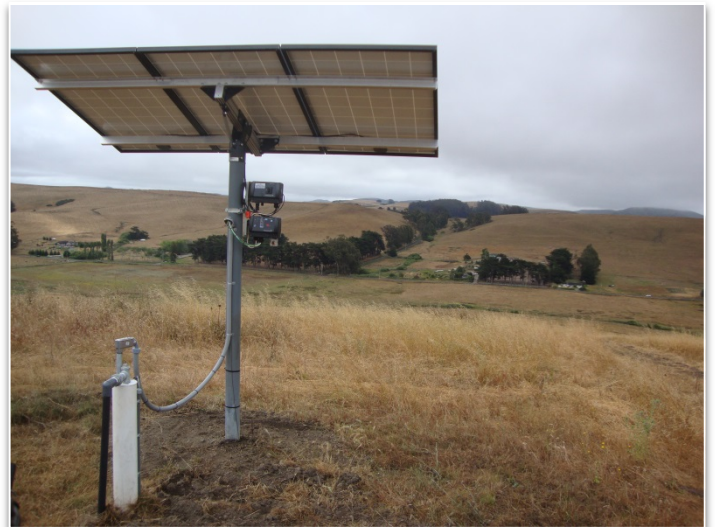
Post-construction Photo 07/2015

Post-construction photo of solar pump at well on eastern parcel, Site 1.

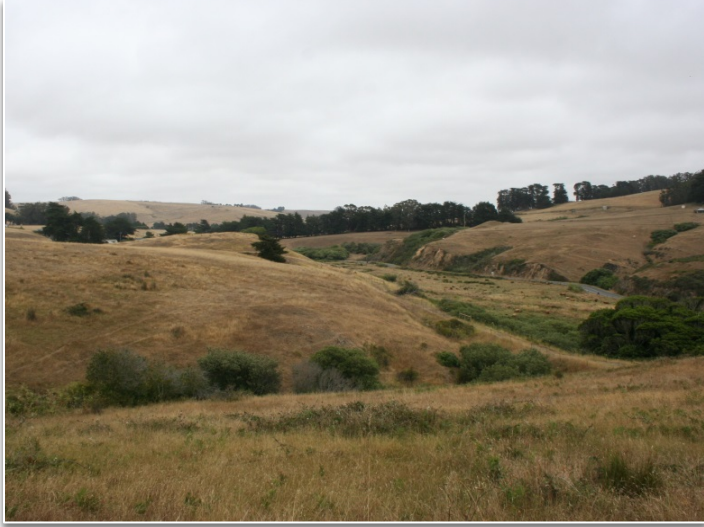
Pre-construction photo of Site 1 (a landscape view).

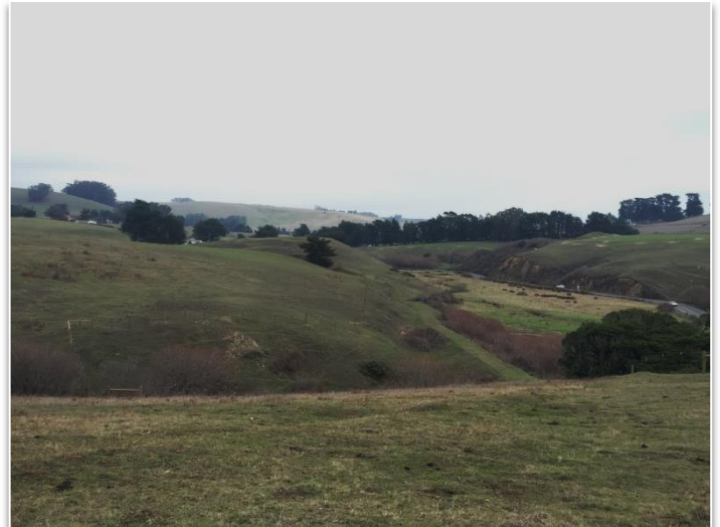
Post-construction Photo 01/2015

Post-construction photo of the landscape view displaying the riparian fencing.

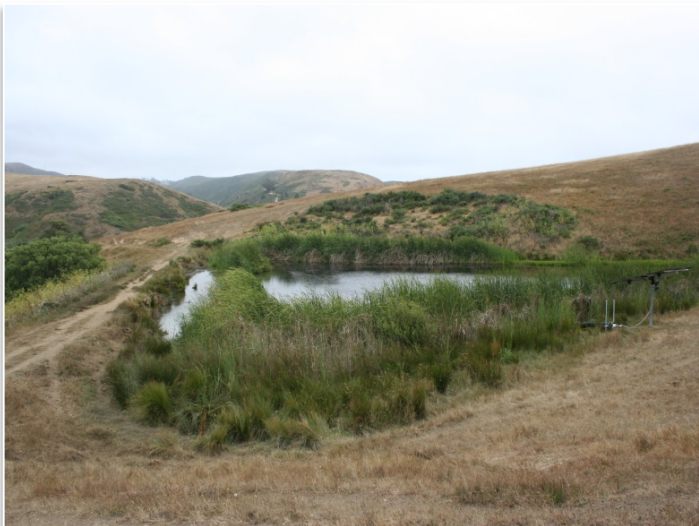
Pre-construction Photo 07/2015

Pre-construction photo of Site 2 taken from the pond embankment.

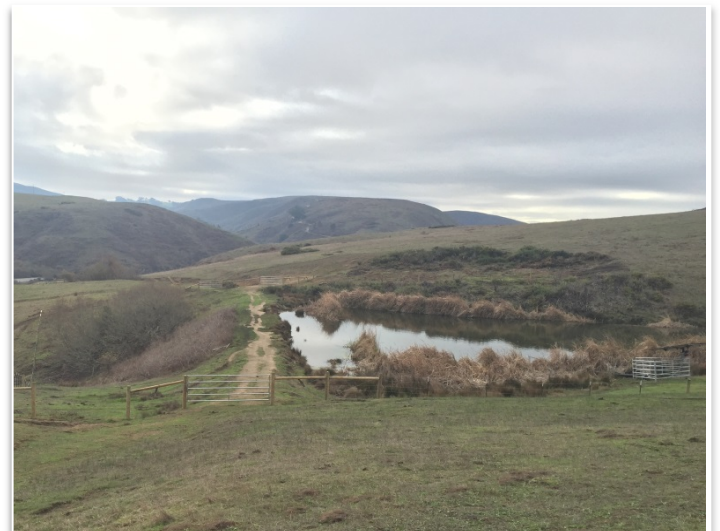
Post-construction Photo 12/2015

Post-construction photo at Site 2. Photo displays exclusionary livestock fencing encompassing the face of the dam and solar pump.

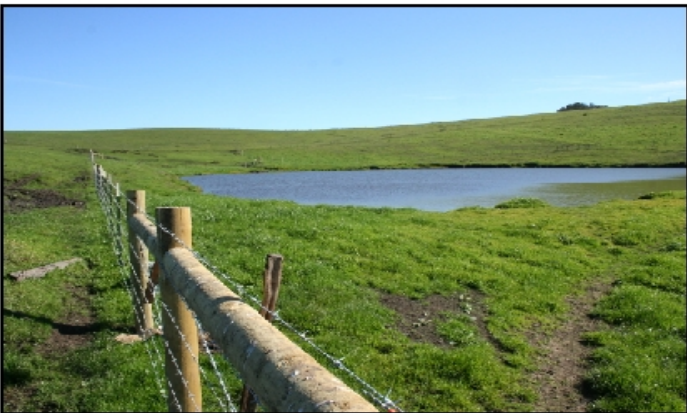
Figure 1. Map of Project 2013-005 showing the location of completed conservation practices implemented January 2014-2015.

Project #2013-005 Livestock Exclusion Fencing and Water Developments Project

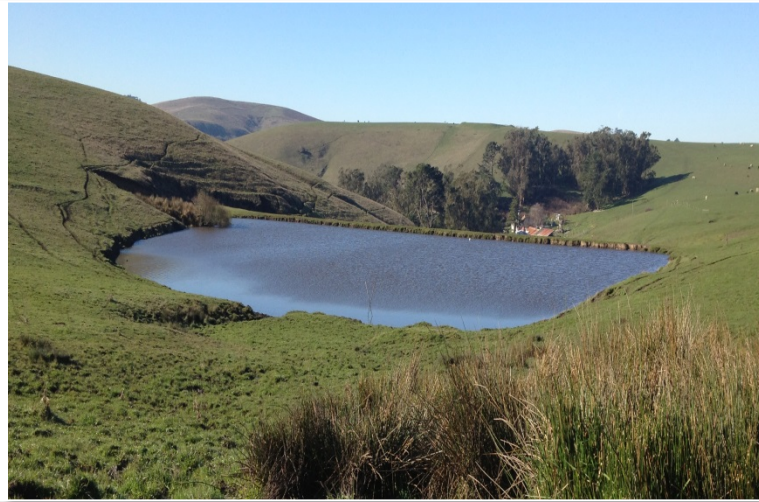
View of pond before the livestock exclusion fencing was installed.

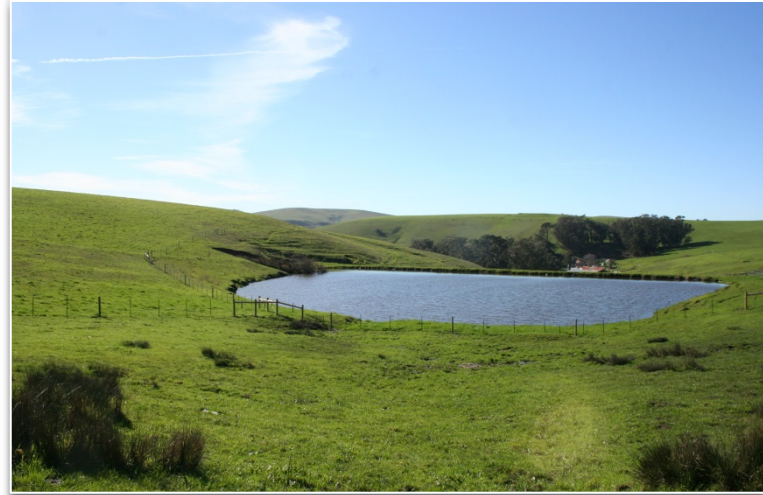
Post-construction Photo 01/2015

After construction of the livestock exclusion fencing encompassing the pond.

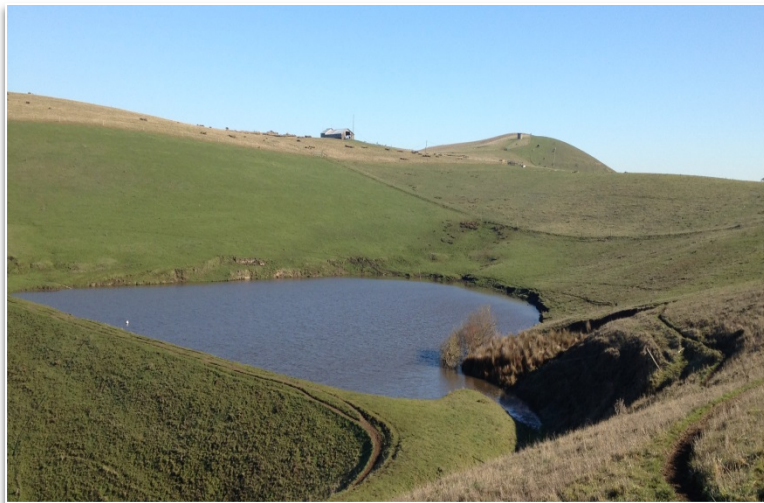
Pre-construction Photo 02/2013

View of livestock pond pre fence exclusion. Photo displaying side banks of pond and spillway.

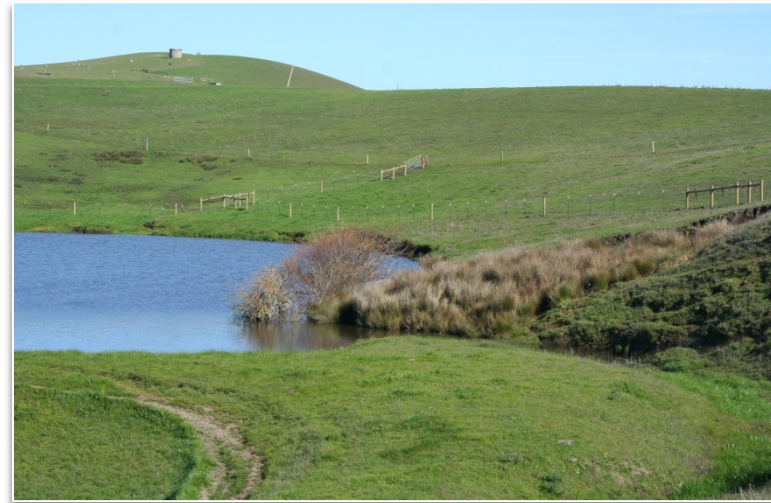
Post-construction Photo 01/2015

Project site after construction showing the riparian fence encompassing the pond and spillway as well as increase in ground cover.

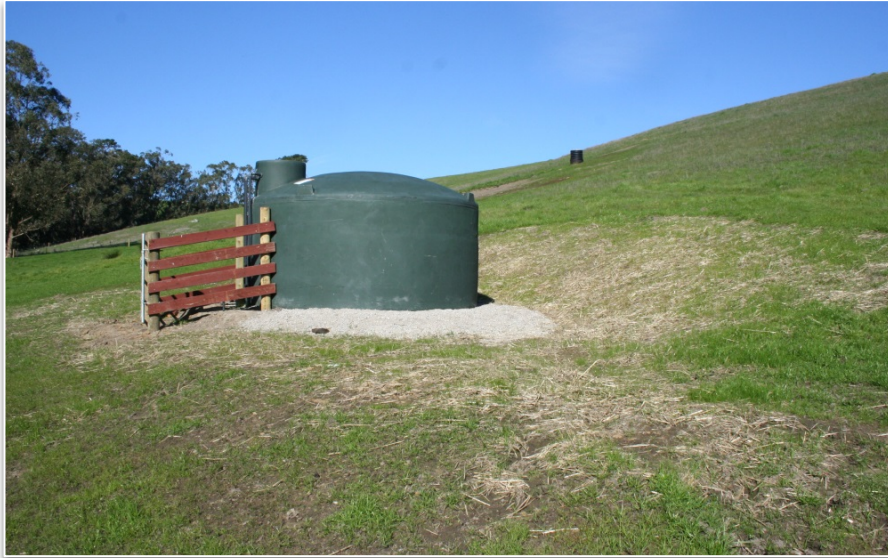
Post-construction photo of project viewing east field water development; 5,000 gallon water tank and spring development in the background.

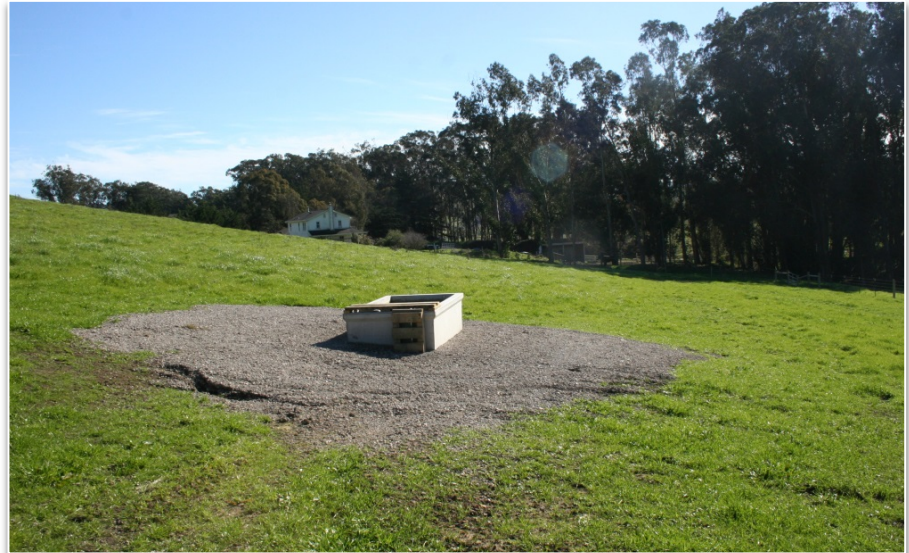
Post-construction Photo 01/2015

All concrete troughs were designed to meet the water supply requirements of the livestock operation and wildlife specification. Adequate access for wildlife was also incorporated by adding an escape ramp per NRCS standards and specifications. Both the tank and troughs were placed on durable firm foundations, $\frac{3}{4}$ " road base with greater than 6" depth, to protect the surrounding areas from resource concerns, animal concentrations and unexpected overflow. After construction was completed, the area was seeded and mulched to reduce impacts from soil disturbance.

After construction of one of the three 342 gallon water. The photo displays the protection pad and wildlife escape ramp.

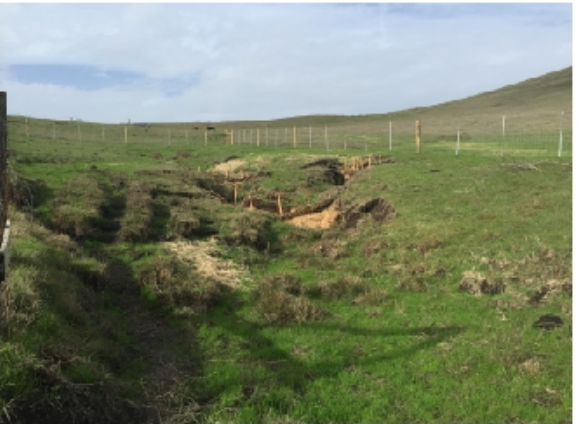
Figure 1. Map of Project 2013-006 showing the location of completed conservation practices implemented November 2015.

Livestock Exclusion and Gully Repairs: Project #2013-006

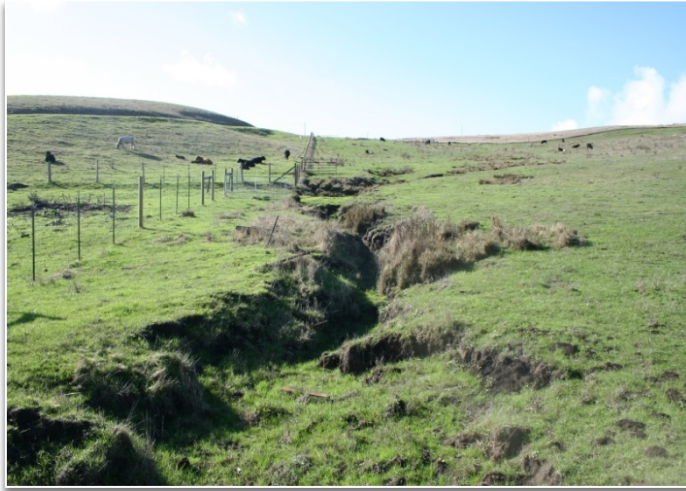
Upstream view of western tributary before riparian fence, livestock crossing repairs were installed.

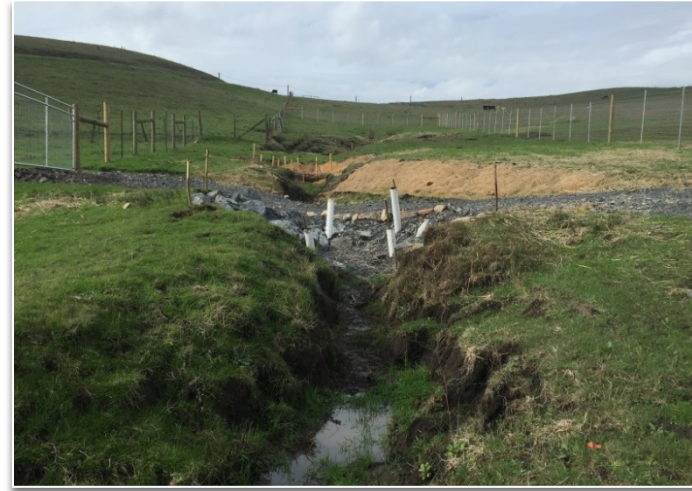
Post-construction Photo 11/2015

Upstream view of western tributary after construction of the following practices: riparian, fence and livestock crossing repairs.

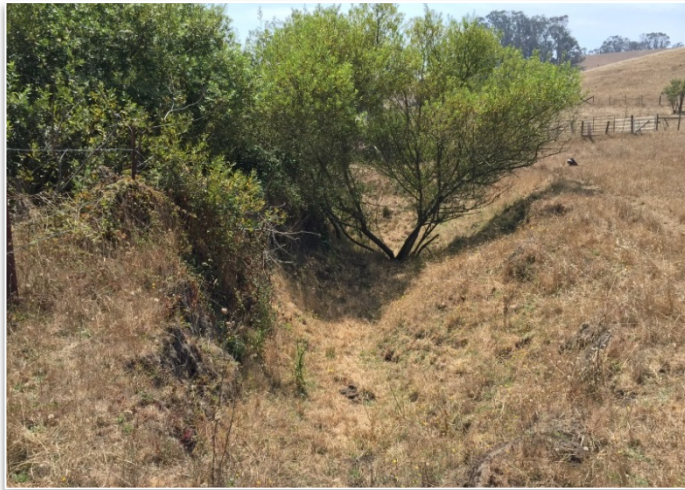
Pre-construction Photo 08/2015

View of Tomales Creek before photo of streambank stabilization critical area planting .

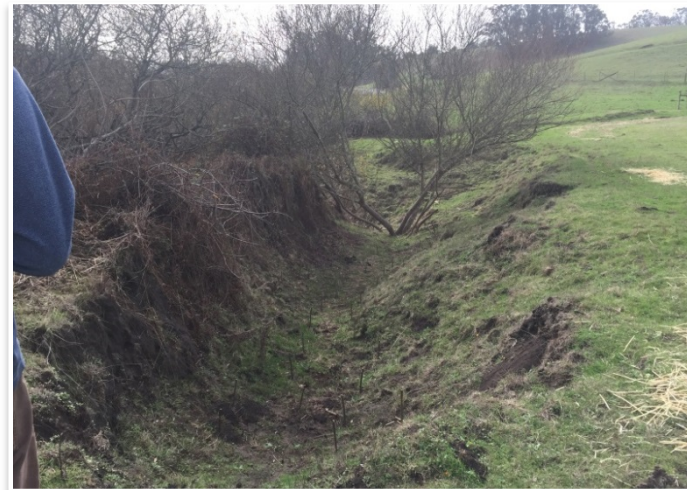
Post-construction Photo 12/2015

Project site after revegetation of streambank stabilization critical area plating above Tomalas, 3350 sq feet.

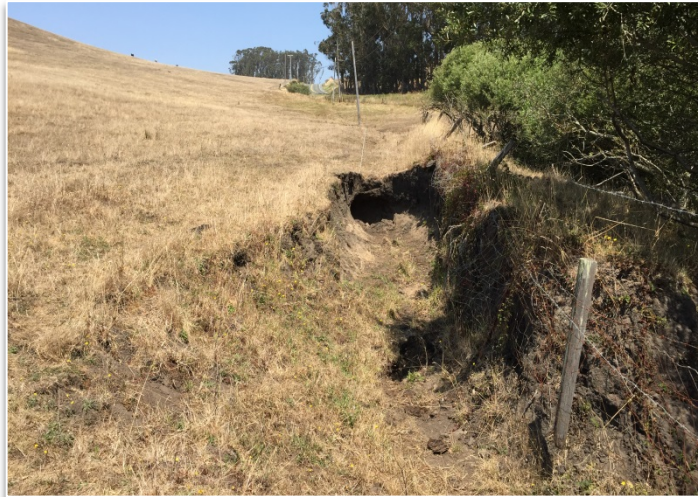
Pre-construction photo of the active headcut adjacent to the berm before construction above Tomales Creek.

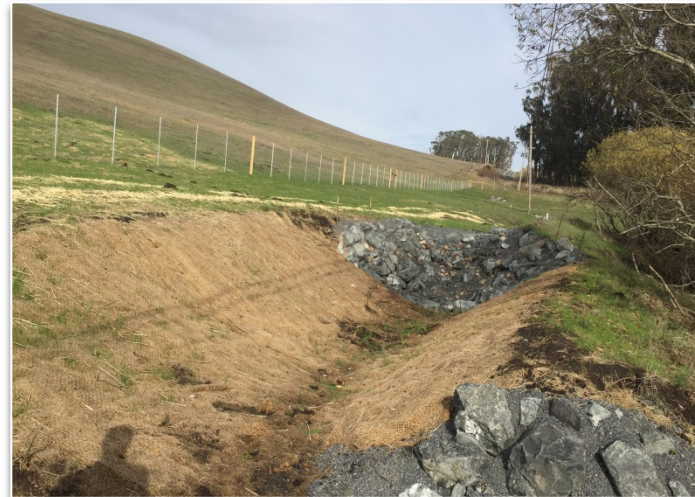
Post-construction Photo 12/2015

Post-construction project photo displaying headcut repair tying into the drainage swale and fencing.

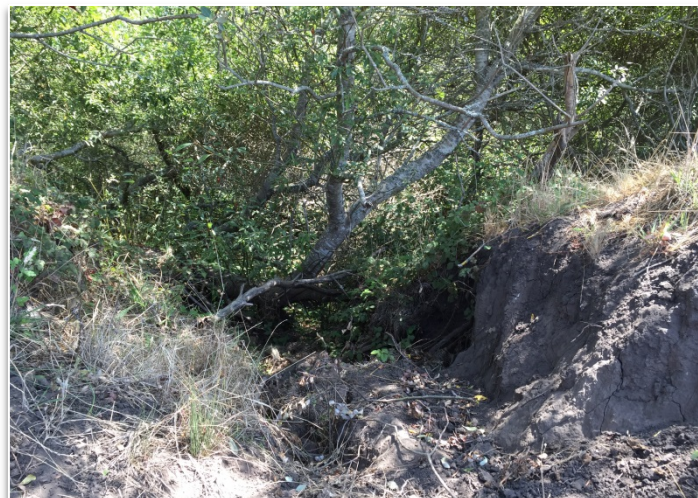
Pre-construction Photo 08/2015

Project site before construction displaying view from the berm sinkhole looking down into Tomales Creek.

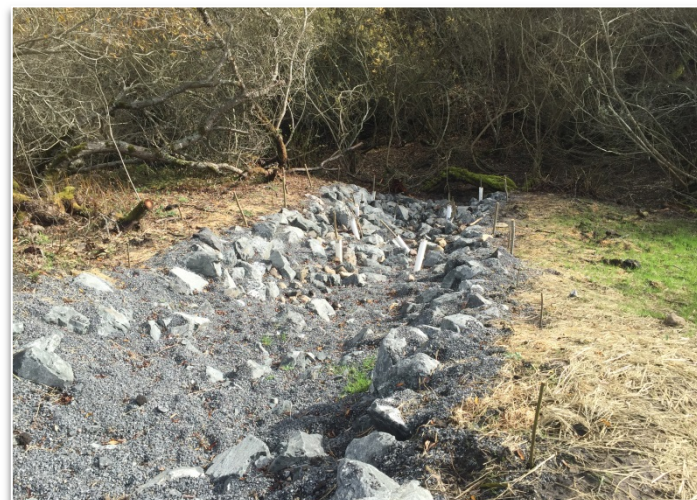
Post-construction Photo 12/2015

View after construction of the rock channel headcut repair and STRAW plantings of willow sprigs.

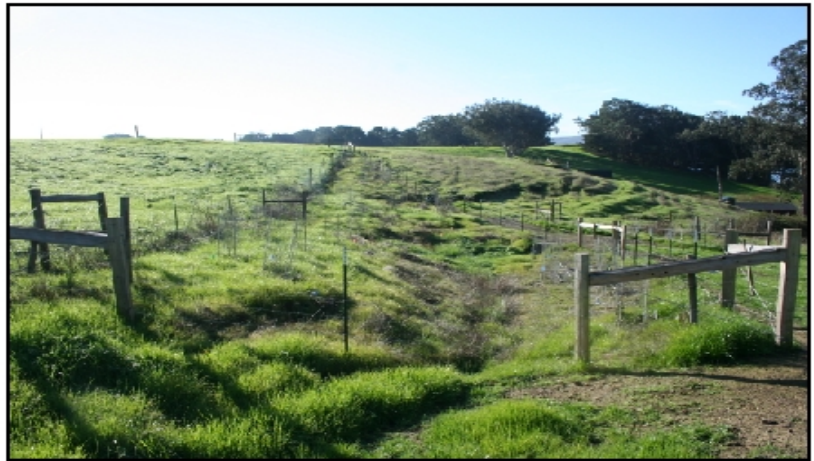
Figure 1. Maps of Project 2013.007. Left: Past and current conservation practices implemented at the ranch. Top right: Close-up of current project. Bottom right: A USGS topography map with the ranch boundary highlighted in orange and a red box identifying the general location of the project.

Vegetated Field Buffer, Hedgerow and Fencing: Project #2013-007

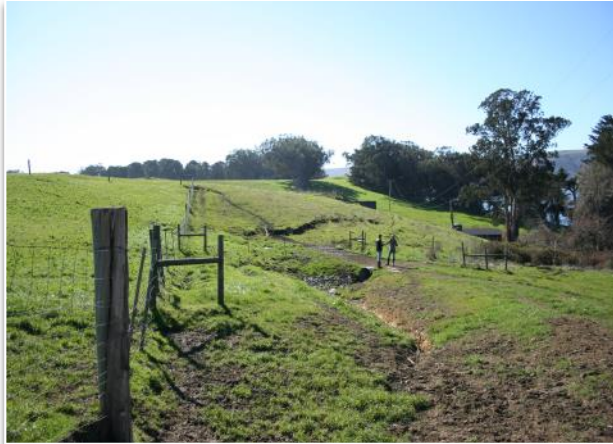
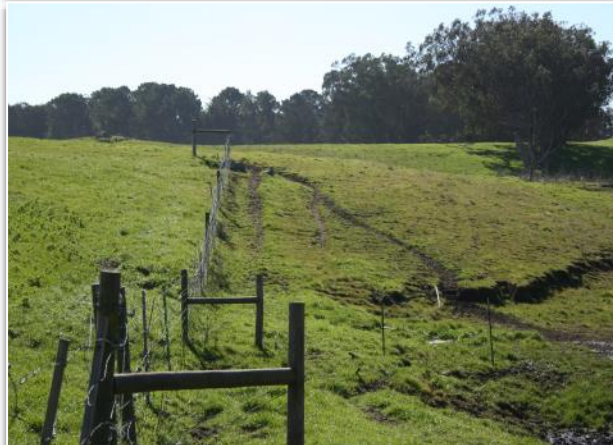
- Pre-Construction 02/11/2012

Figure 2. Left photos: Pre-construction photos taken from photo monitoring point bearing 184°. The photos display the overall condition of the project site 1-year pre-project. Right photos: Post-construction photos document the completed project. Top right: Photo shows an entire view of the fence exclusion, buffer strip and hedgerow planting. Bottom right: Photo displays the detail and placement of the plantings.

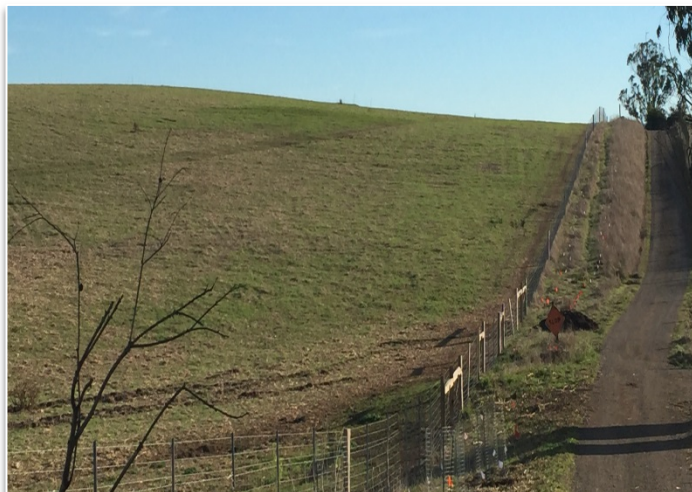
Project Site displaying flagged locations for individual plant installation.

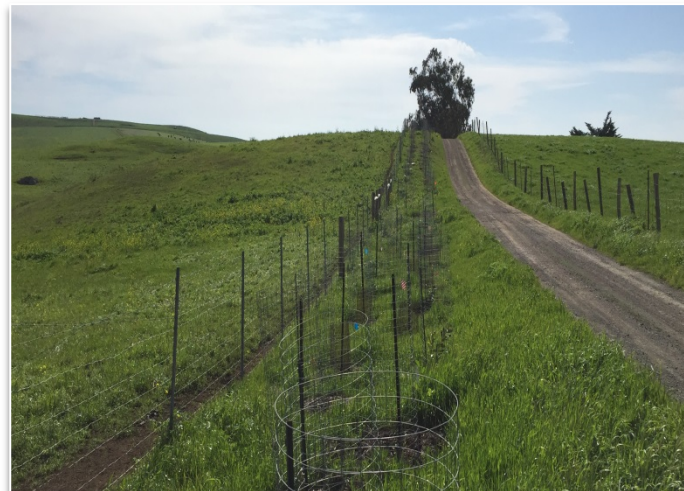
Post-construction Photo 01/2016

Project site, looking south displaying the installation 350 trees and shrubs.

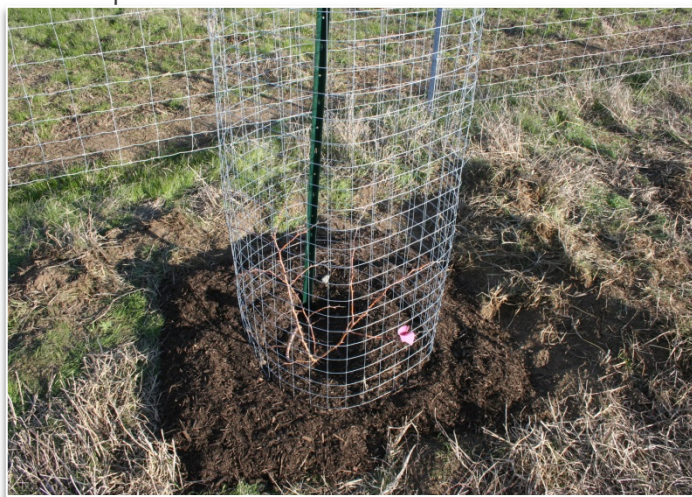
Close up view of individual planting displaying tree staking and wire protection.

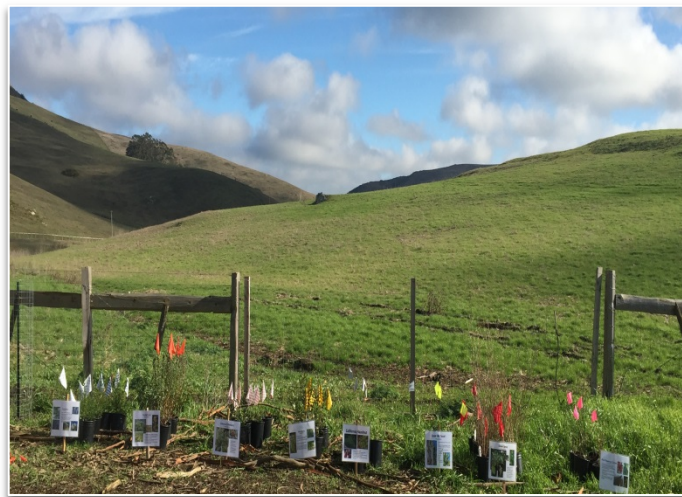
Post-construction Photo 11/2015

Photo displaying the variety of trees and shrubs for planting.

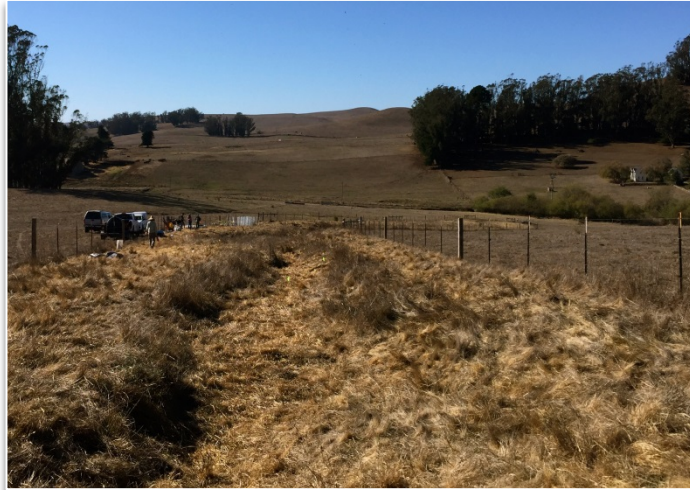
Pre-construction Photo 10/2015

Project Site displaying intermittent stream before individual plant installation.

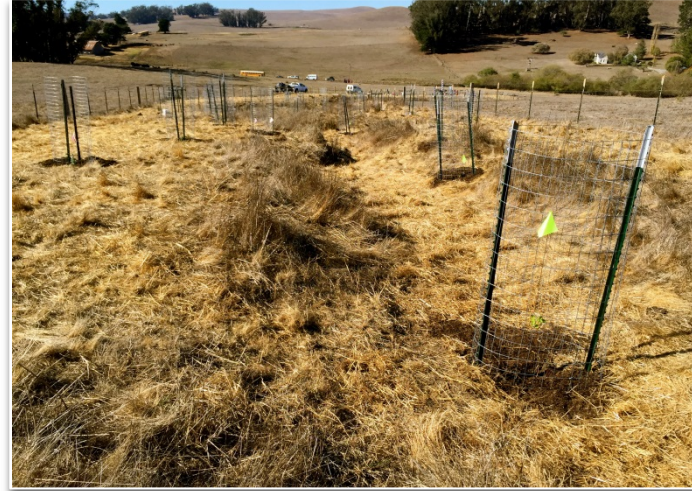
Post-construction Photo 01/2016

Project site, looking west displaying the installation 179 trees and shrubs.

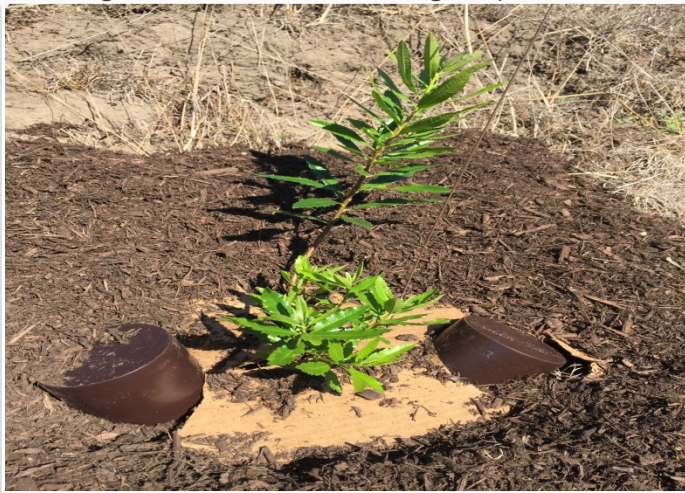
Post-construction Photo 11/2015

Close up view of individual planting displaying dri water and mulching before installation of staking and protection.

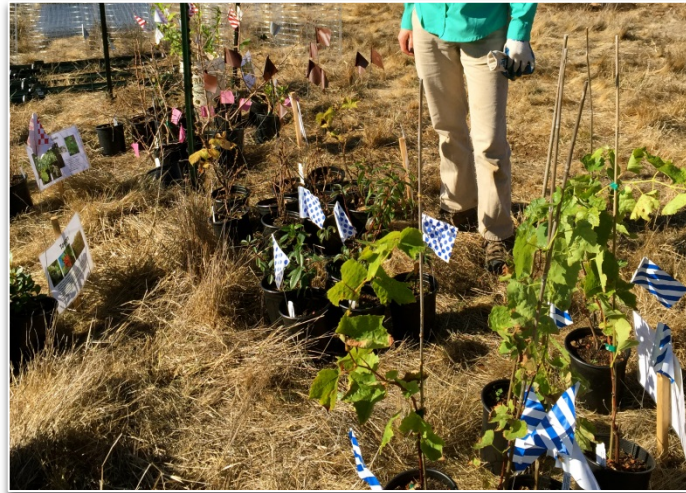
Post-construction Photo 11/2015

Photo displaying the variety of trees and shrubs for planting.

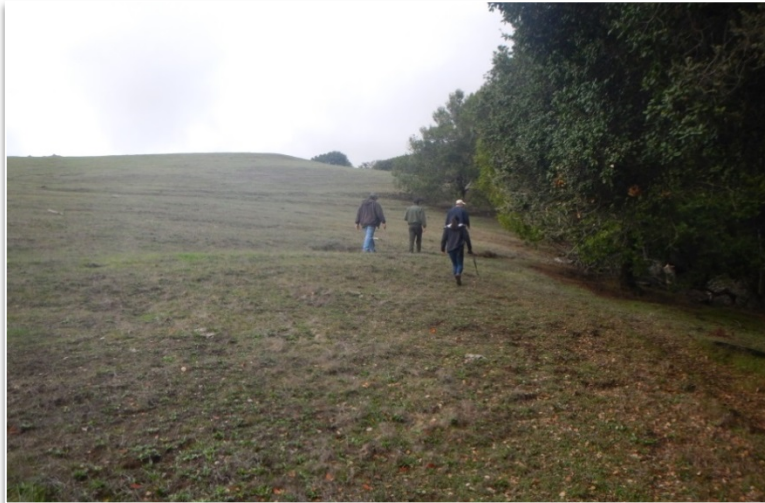
View of riparian cooridor before fencing installation.

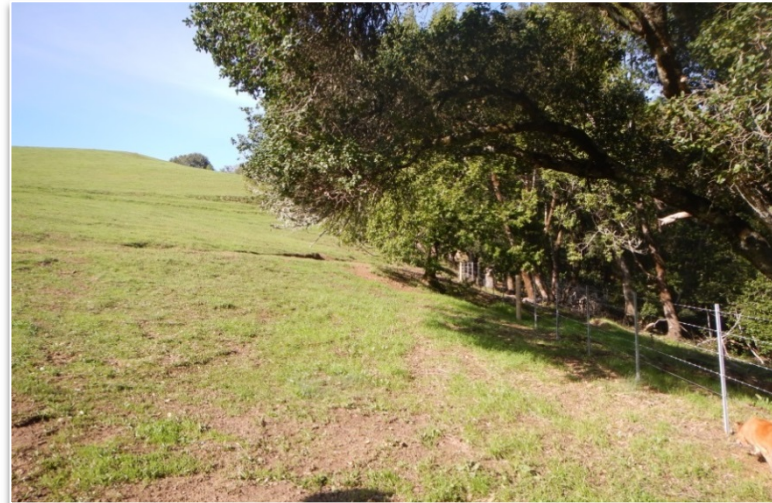
Post-construction Photo 03/2016

Riparian fencing after construction excluding riparian cooridor of Zanardi Gulch.

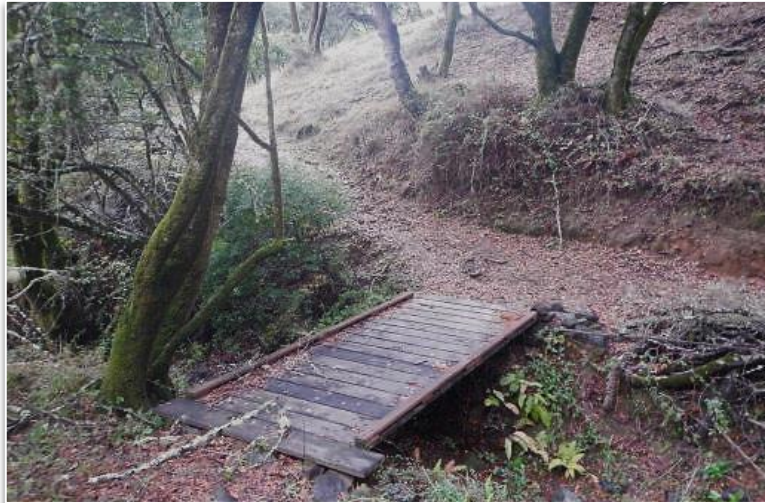
Pre-construction Photo 12/2015

Before photo of ATV trail above Zanardi Gulch and wooden crossing a side tributary.

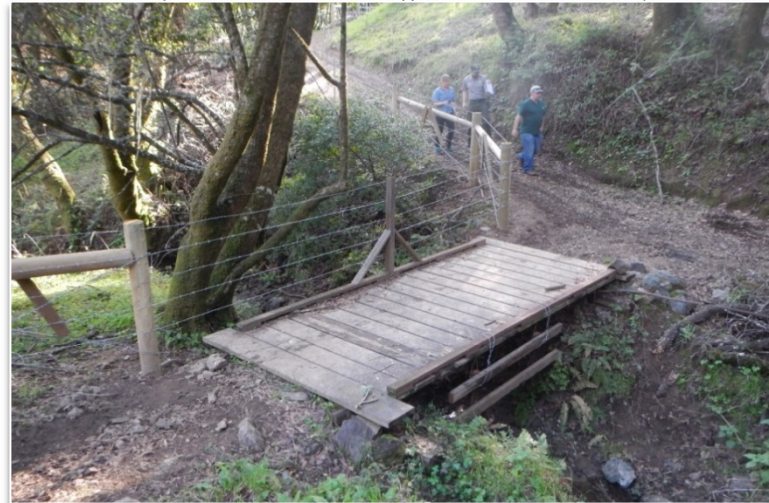
Post-construction Photo 03/2016

View of riparian fencing constructed along the ATV trail above Zanardi Gulch, and wooden crossing over a side tributary .

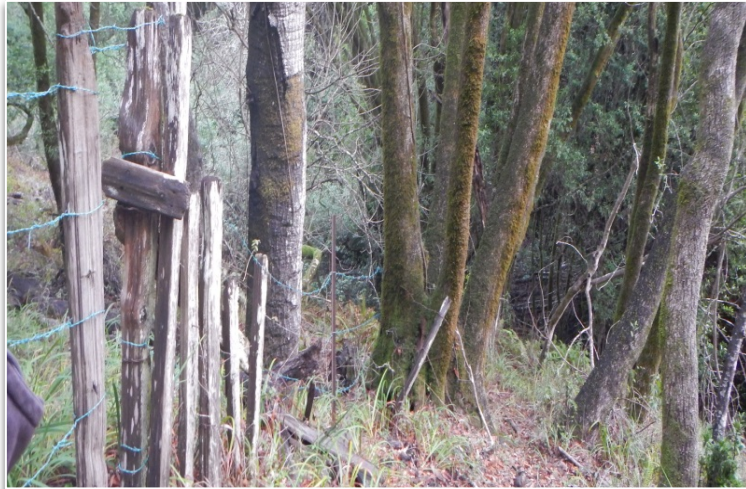
Pre-construction photo of old degraded fence above Zanardi Gulch.

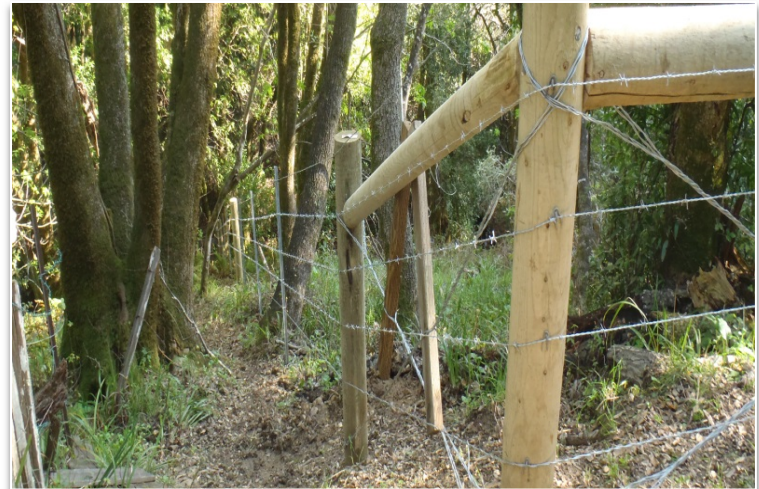
Post-construction Photo 12/2015

Post-construction project photo displaying constructed fence adjacent to old degraded fence above Zanardi Gulch.

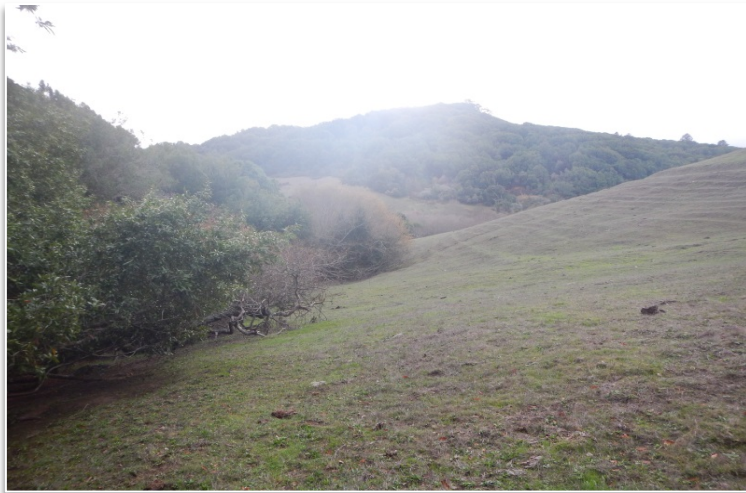
Pre-construction Photo 08/2015

Pre-construction displaying riparian corridor of side tributary before fence installation.

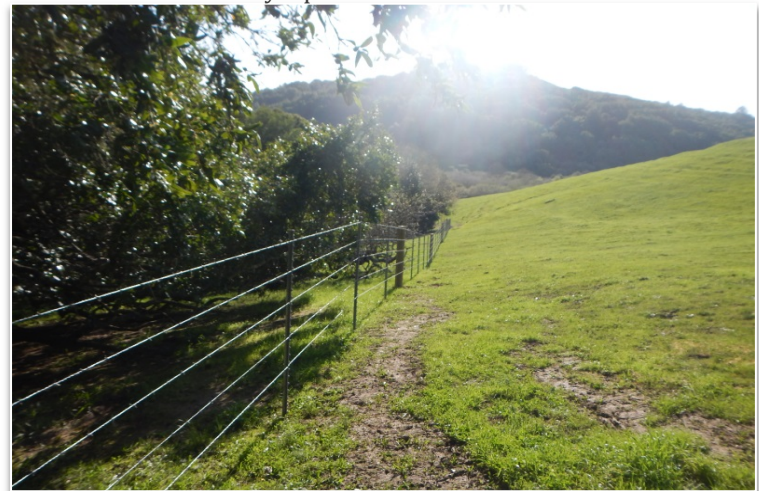
Post-construction Photo 12/2015

Post-construction photo of constructed fence along the tree line of the side tributary riparian corridor.
