Final Report: PINE GULCH CREEK INSTREAM FLOW ENHANCEMENT PROJECT

Grant Agreement # P1130410

Pine Gulch Creek Instream Flow Enhancement Project

Accomplishments: Constructed four irrigation ponds for three organic farms

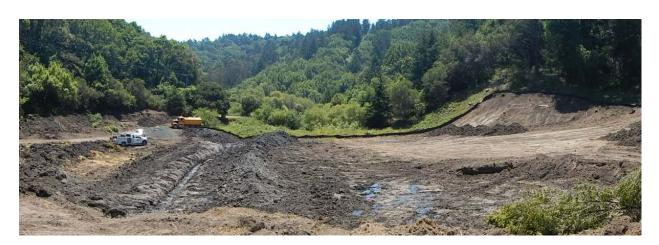
strength. The drains developed were somewhat effective: a meadow center drain 12 feet deep flowed at about 3 gallons per minute (gpm); and a 740-foot perimeter drain around the east and north of the meadow flowed at a steady 4 gpm. The sub-drains functioned as intended but were unable to significantly affect the bulk of the saturated material. Additional water percolated up maintaining the profile in a saturated condition (see photo below of the Pond 1B site with Green Pond to the right of the yellow water truck).

The unexpected saturated conditions prevented effective operation with standard earthmoving equipment. The deep profile of saturated soil prevented the development an adequate foundation to support the levee embankment. It was the consensus of Project Geotechnical Engineer and Project Civil Engineer that timely and cost-effective construction was not possible at this site. MRCD notified all permitting agencies of the issue and proposed a project modification that would achieve the desired environmental goals consistent with the permit provisions and would provide the Fresh Run Farm with its irrigation water needs. MRCD proposed and ultimately received agency approval for the following solution: abandon Pond 1B, capture water from the existing drains at the Pond 1B site to supplement the farm's water supply, and expand Pond 1A to partially mitigate for storage loss due to not constructing Pond 1B. The drains at 1B were estimated to collect about 1 AF of water a month (if flows stay constant over time) from the impacted area. By capturing this water over the irrigation season, the farm can potentially secure about 7AF of water to irrigate. The combination of seasonal drainage flows collected from 1B along with expansion of 1A to 11.7 AF would help the farm meet its irrigation demands.

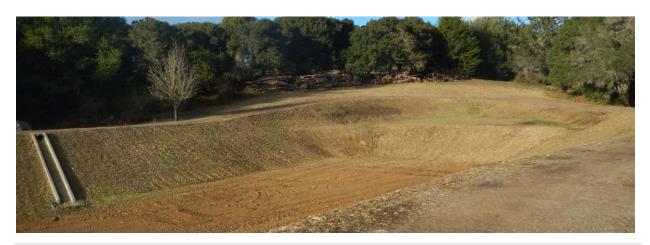
Construction at Pond 1A began June 22, 2015. Soil conditions were good and the small pond, 3.5 AF, was practically finished by July 2, 2015 when construction at Pond 1A was halted due to the issues at Pond 1B. Once the project modification was accepted, the storage capacity of Pond 1A was increased from 3.5 AF to 11.7 AF starting on August 28, 2015. The altered configuration expanded the pond footprint into highly used farmland and avoided a man-made duck pond. The expanded pond version of Pond 1A, Pond 1A.2, would collect about 11.7 AF/year of rainfall and non-jurisdictional upland sheet flow based on its location in the watershed. The new pond design would eliminate the need to withdrawal from Pine Gulch Creek. The modified Pond 1A also included a shallow section to create California red-legged frog (CRLF), *Rana draytonii*, breeding habitat (see photo below of shallow shelf in Pond 1A).

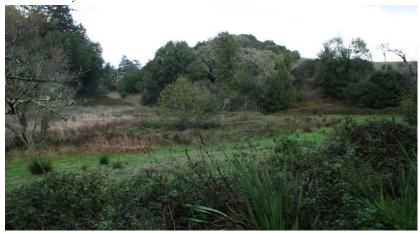
Pond 1B Before Construction

Fresh Run Farm Site 1B Spring Development: Pond 1B was planned to provide Fresh Run Farm with 17AF of water storage, but wet soil conditions rendered the pond unbuildable. The perimeter drains installed to dry out the construction site ended up tapping into a spring that provides a reliable source of water for the farm providing the farm with about 1AF each month.

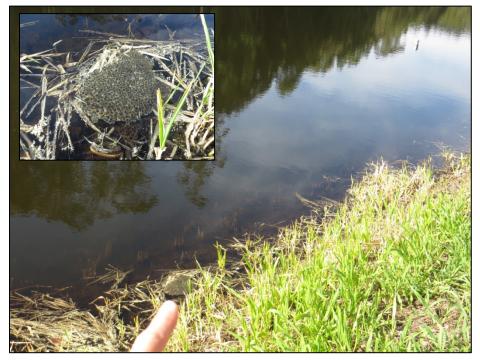
Several frogs were also detected at the Pond 3B site. Positive identification could not be determined, but they appeared to be juvenile California red-legged frogs (at least 2 individuals). They did not exhibit the characteristic "squawk" made by American bullfrog and were too large to be Sierran treefrog. Sierran treefrog were also detected at the Pond 3B site in the ditch around the perimeter of the pond and access road.

California red-legged frog egg mass observed on February 10, 2016; see inset for close-up.
