# Public Report: PINE GULCH CREEK INSTREAM FLOW ENHANCEMENT PROJECT

*Grant Agreement # P1130410*

*Prepared by  
Marin Resource Conservation District  
Point Reyes Station, California*

*December 20, 2015*

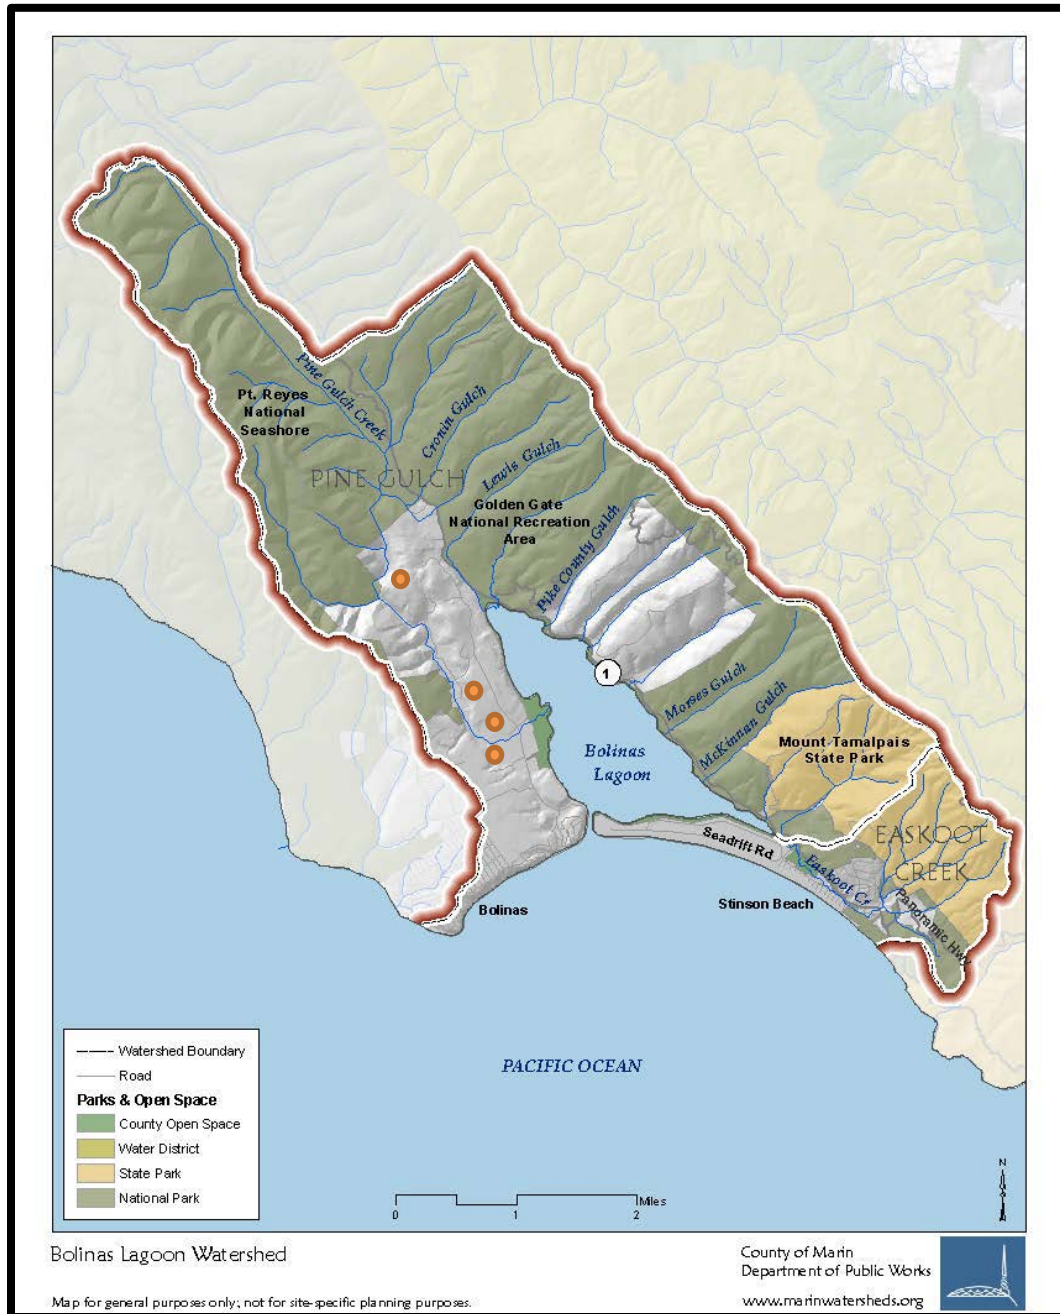
**Figure 1. Map of the Bolinas watershed, in Marin County, California (courtesy of Marin County) showing the Pine Gulch Creek watershed. A portion of it flows within the Point Reyes National Seashore and the remainder run through private property. The orange dots show the locations of the irrigation ponds constructed in the Pine Gulch Creek Instream Flow Enhancement Project.**

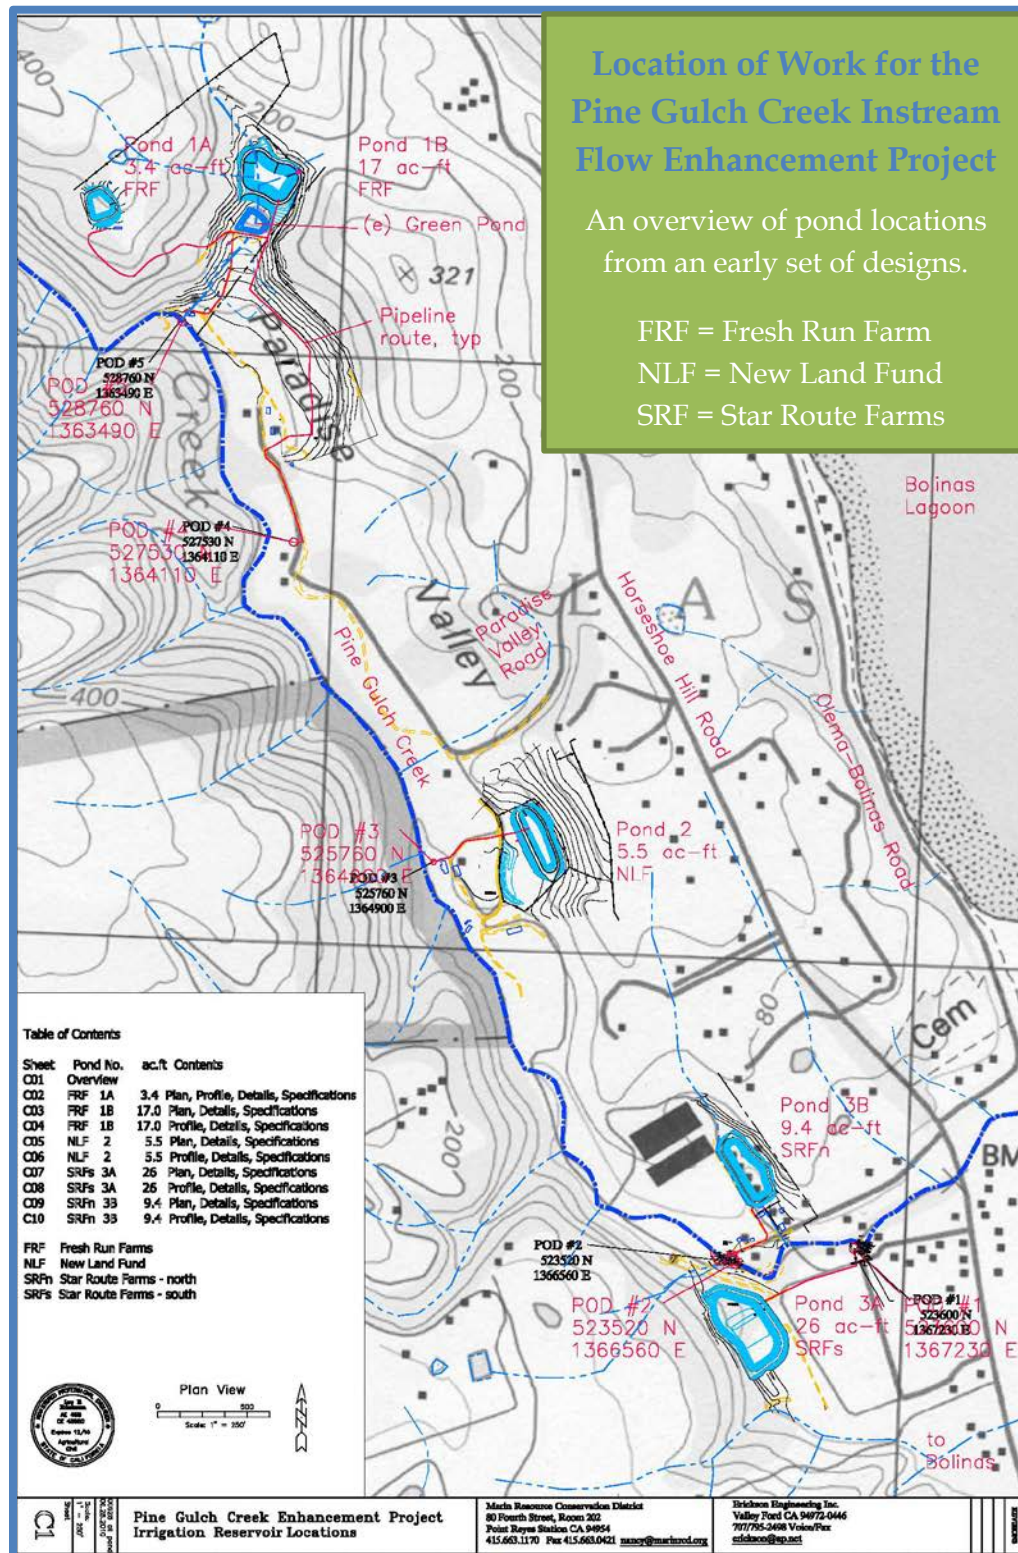
Figure 2. Map of pond locations for the Pine Gulch Creek Instream Enhancement Project from an early set of plans. This map also shows the relation of the ponds to roads within Bolinas, California.

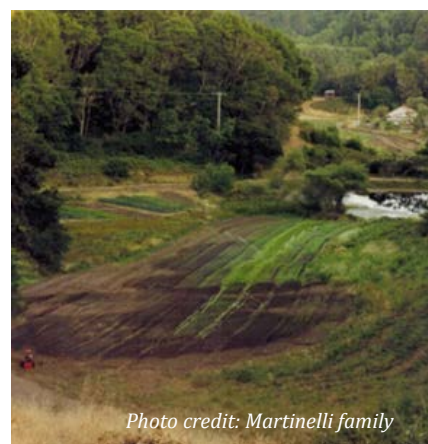
Construction of the ponds at Fresh Run Farm began with Pond 1B, since the site's Geotechnical Investigation Report (Miller Pacific Engineering Group, 2002) indicated the soils were highly saturated, yet buildable with reasonable soil profiles. The site for Pond 1B was slated to be built over a historically farmed site just above an old livestock pond, called Green Pond (see historical photo to the right. Green Pond is indicated above the farmed area, later to be the site for Pond 1B). On June 15, 2015, construction at Pond 1B was initiated. The contractor removed vegetation and installed drainage trenches, which revealed the underlying soil to be saturated, consolidated sand with substantial water present. Once disturbed, the sand lost all strength. The drains developed were somewhat effective: a meadow center drain 12 feet deep flowed at about 3 gallons per minute (gpm); and a 740-foot perimeter drain around the east and north of the meadow flowed at a steady 4 gpm. The sub-drains functioned as intended but were unable to significantly affect the bulk of the saturated material. Additional water percolated up maintaining the profile in a saturated condition (see photo below of the Pond 1B site with Green Pond to the right of the yellow water truck).

The unexpected saturated conditions prevented effective operation with standard earthmoving equipment. The deep profile of saturated soil prevented the development an adequate foundation to support the levee embankment. It was the consensus of Project Geotechnical Engineer and Project Civil Engineer that timely and cost-effective construction was not possible at this site. MRCD notified all permitting agencies of the issue and proposed a project modification that would achieve the desired environmental goals consistent with the permit provisions and would provide the Fresh Run Farm with its irrigation water needs. MRCD proposed and ultimately received agency approval for the following solution: abandon Pond 1B, capture water from the existing drains at the Pond 1B site to supplement the farm's water supply, and expand Pond 1A to partially mitigate for storage loss due to not constructing Pond 1B. The drains at 1B were estimated to collect about 1 AF of water a month (if flows stay constant over time) from the impacted area. By capturing this water over the irrigation season, the farm can potentially secure about 7AF of water to irrigate. The combination of seasonal drainage flows collected from 1B along with expansion of 1A to 11.7 AF would help the farm meet its irrigation demands.

In late August 2015, the soils at Pond 1B were regraded back into place. A portion of the disturbed area at Pond 1B was return to its' historical farmland use and another portion at the bottom of the work area was left to return to wetland. Plumbing and a sump pump were installed to route sub-drain discharge to tank storage.

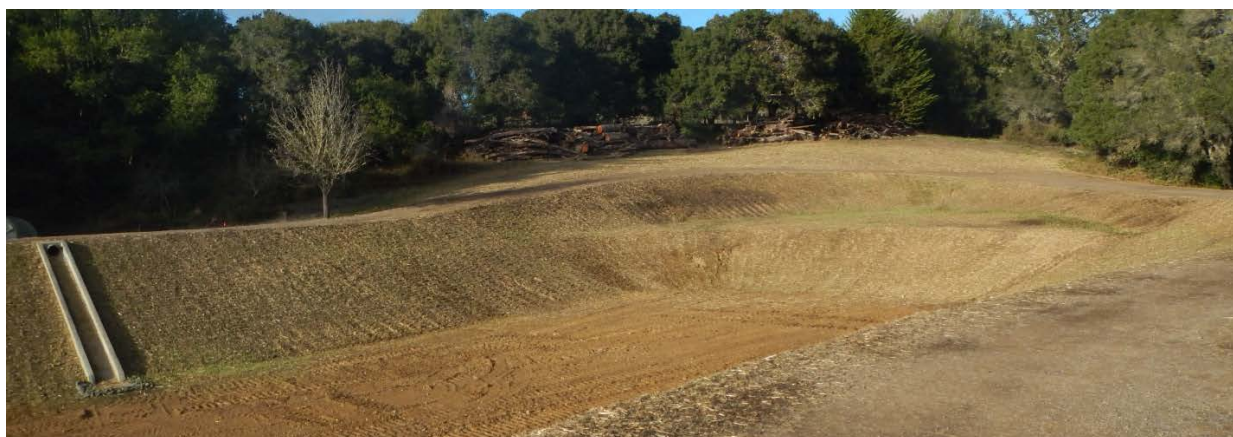
Construction at Pond 1A began June 22, 2015. Soil conditions were good and the small pond, 3.5 AF, was practically finished by July 2, 2015 when construction at Pond 1A was halted due to the issues at Pond 1B. Once the project modification was accepted, the storage capacity of Pond 1A was increased from 3.5 AF to 11.7 AF starting on August 28, 2015. The altered configuration expanded the pond footprint into highly used farmland and avoided a man-made duck pond. The expanded pond version of Pond 1A, Pond 1A.2, would collect about 11.7 AF/year of rainfall and non-jurisdictional upland sheet flow based on its location in the watershed. The new pond design would eliminate the need to withdrawal from Pine Gulch Creek. The modified Pond 1A also included a shallow section to create California red-legged frog (CRLF), *Rana draytonii*, breeding habitat (see photo below of shallow shelf in Pond 1A).

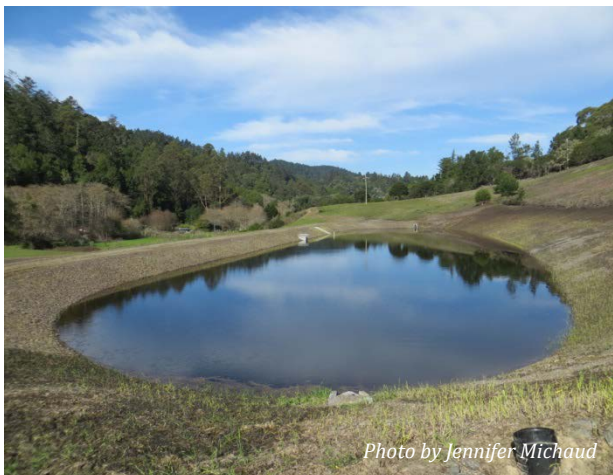
Construction of Pond 2 began on July 27, 2015 and wet soil conditions slowed construction. Wet soils lead to unexpected soil shrinkage problems that resulted in the elimination of the pond's backside pathway in order to secure enough material to finish the pond (see photo to the right of Pond 2 and no pathway on the right side of the pond). The increased level of excavation created a larger reservoir from 5.5 AF to 8.2 AF. Without a complete pathway, New Land Fund may have difficulties managing the vegetation on the backside of the pond. The MRCD will continue to work with the landowner to resolve the issue.

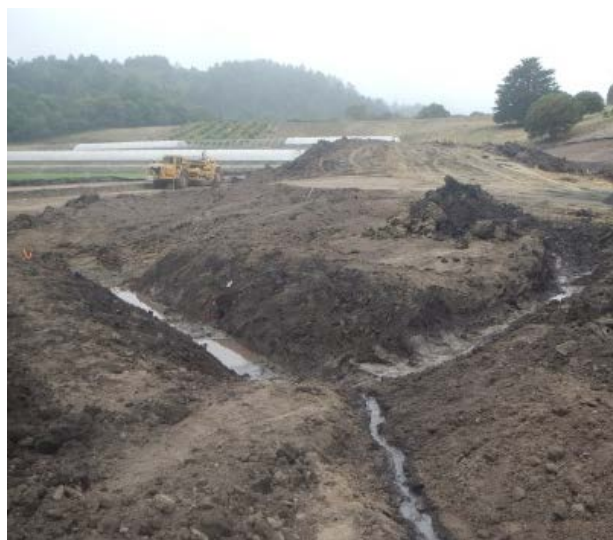
Pond 3B was the first site of the Pine Gulch Creek Instream Flow Enhancement Project opened for construction. Work immediately slowed due to water draining into the construction site. A curtain drain was installed to capture the water in order to dry the site (see photo to the right of the draining process of the Pond 3B site). The contractor also continually worked the dirt, mixing soils to keep soil moisture content levels low and to expedite the drying process. Due to wet soil conditions, the contractor had to wait a couple of weeks to let the bottom of the pond dry out before the final compaction. The completed pond holds 10.6 AF.

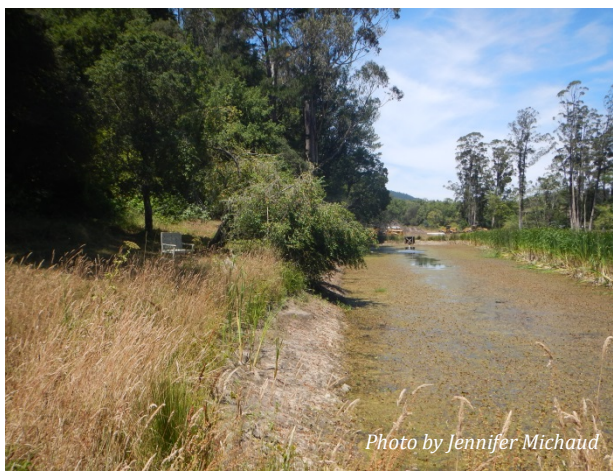
On July 20, 2015, construction began at Pond 3A. Constructing Pond 3A included the demolition of an existing irrigation pond (see bottom right photo of existing pond). The Project Biologist conducted several surveys of the existing pond before construction began and relocated many species from the pond into Pine Gulch Creek including but not limited to: four

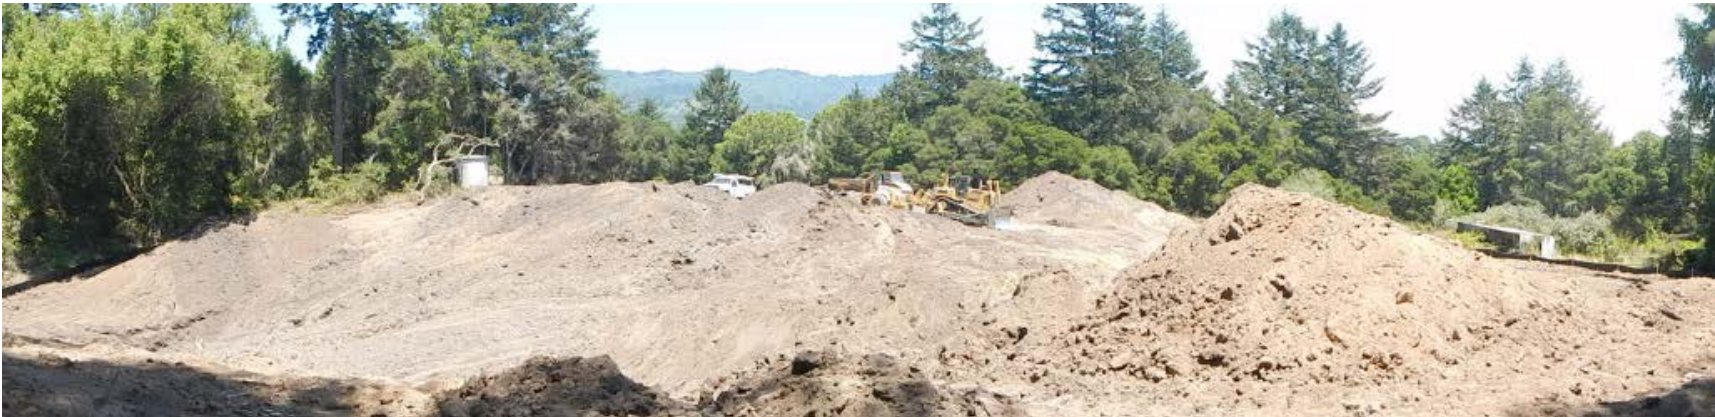
*Fresh Run Farm Pond 1A: Pond 1A is 11. Exhibit C 7 AF and will irrigate 22.5 acres of organic produce. The pond coupled with a spring development will eliminate the diversion of 29.1 AF from Pine Gulch Creek every year.*

*Pond 1A – Start of Construction*

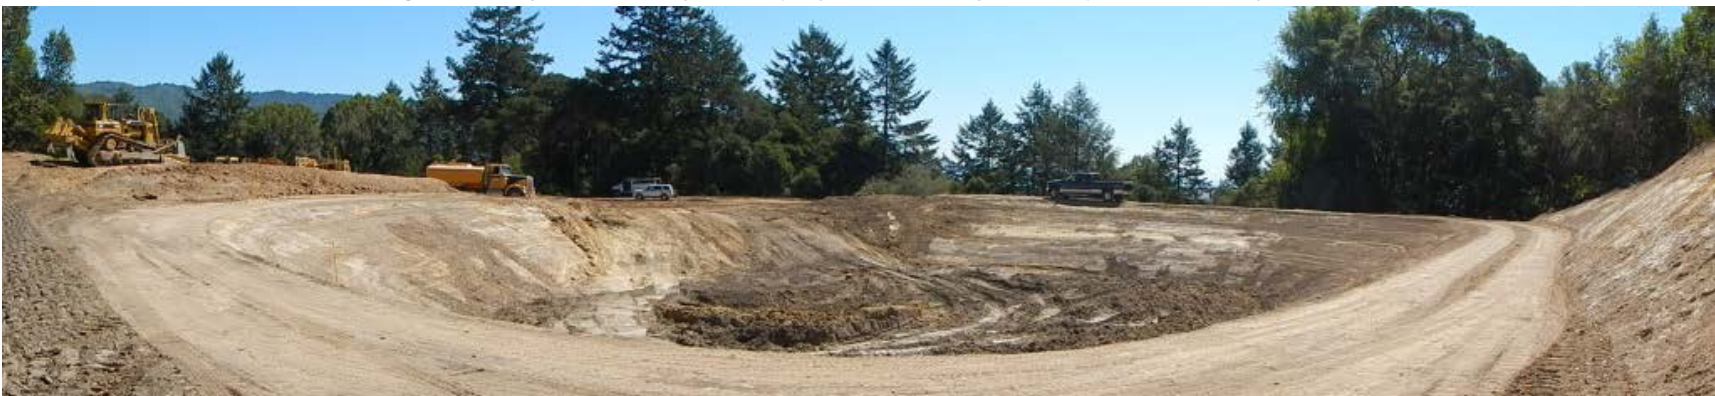
*Pond 1A – Mid-Construction (original size of Pond 1A before the project was modified to expand the size of Pond 1A)*

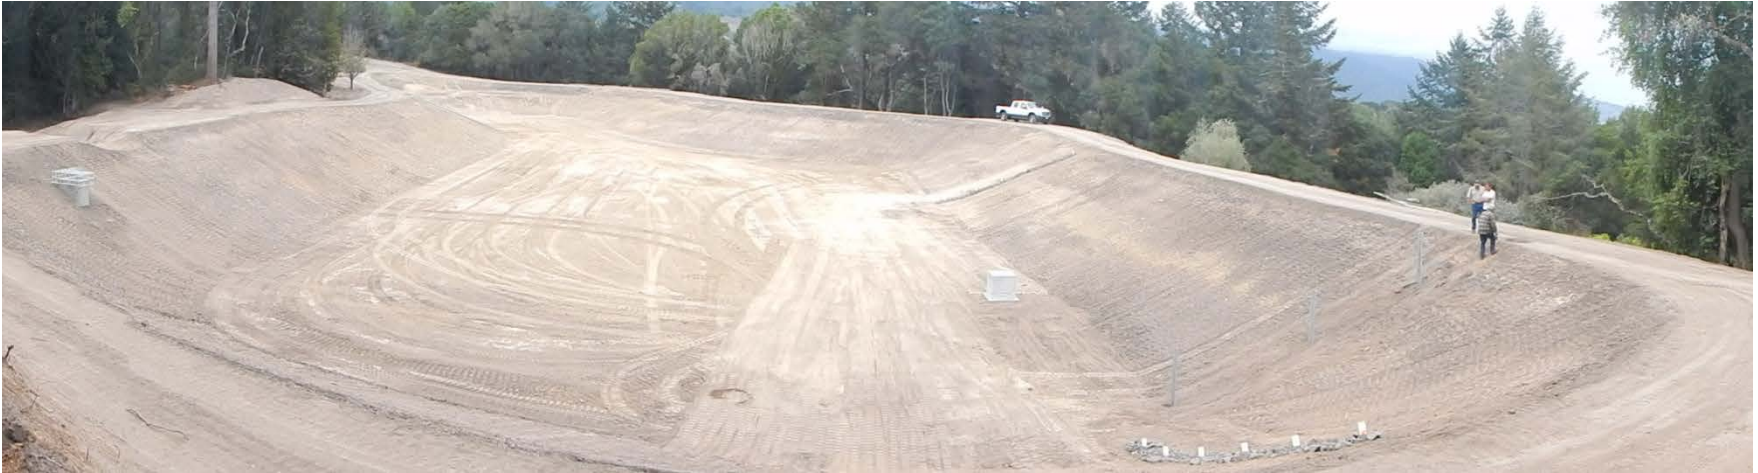
*Pond 1A – After Construction*

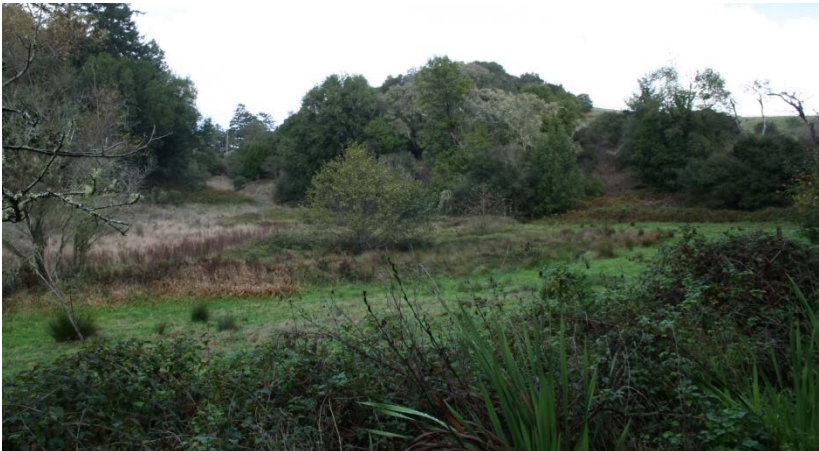
***Fresh Run Farm Site 1B Spring Development:*** Pond 1B was planned to provide Fresh Run Farm with 17AF of water storage, but wet soil conditions rendered the pond unbuildable. The perimeter drains installed to dry out the construction site ended up tapping into a spring that provides a reliable source of water for the farm providing the farm with about 1AF each month.

*Pond 1B Before Construction*

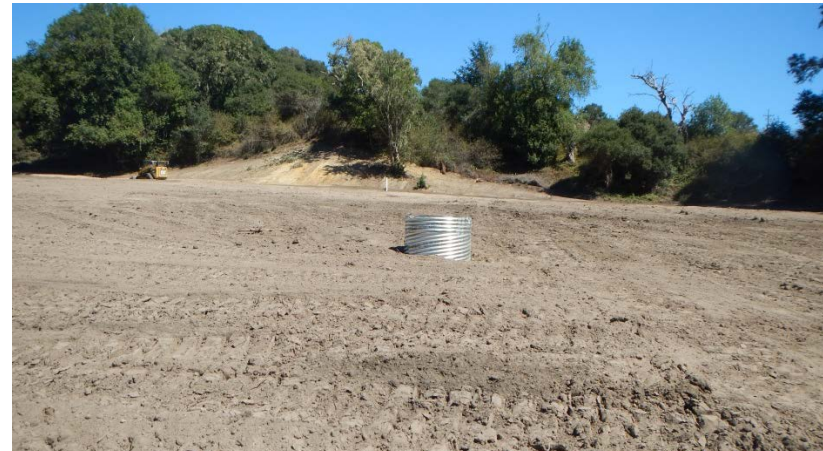
*Pond 1B After Construction (pond abandoned & sump pump)*

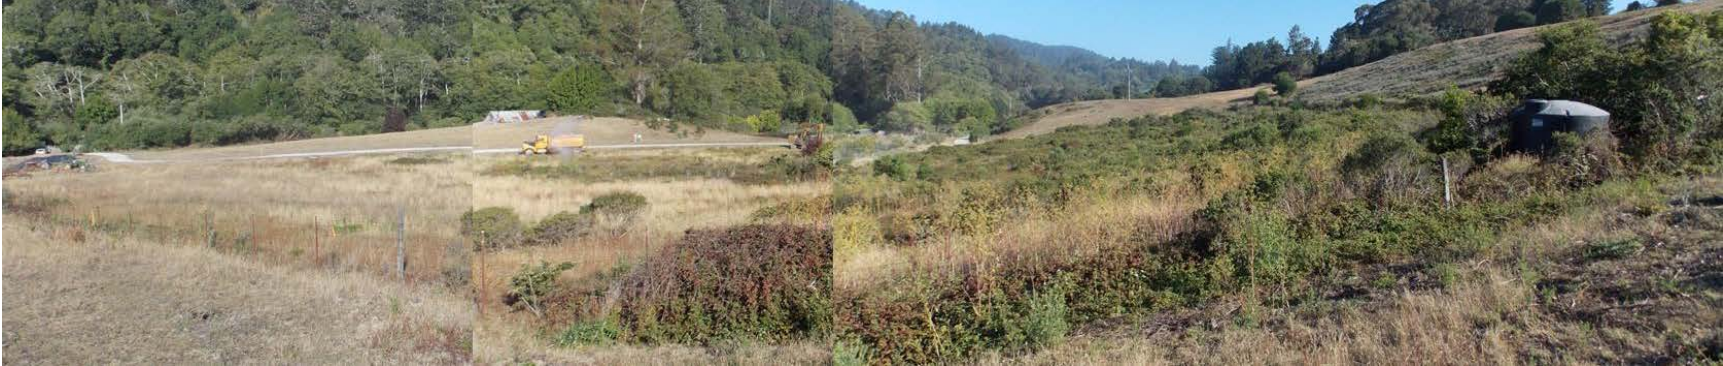
***New Land Fund Pond 2:*** Pond 2 is 8.2 AF and will irrigate up to 10 acres of organic farmland. This pond will eliminate the annual diversion of 7.54 AF from Pine Gulch Creek.

*Pond 2- Before Construction*

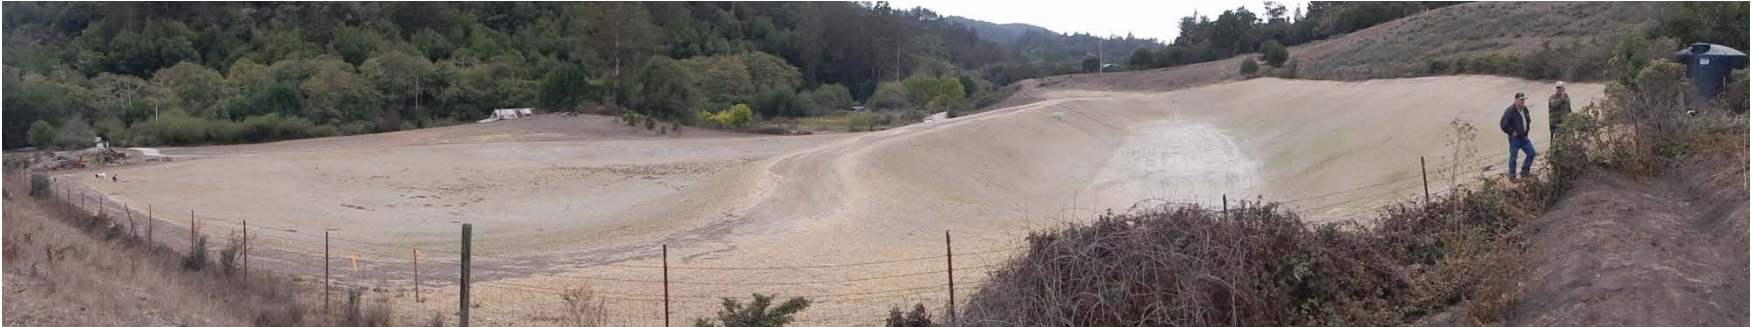
*Pond 2- After Construction*

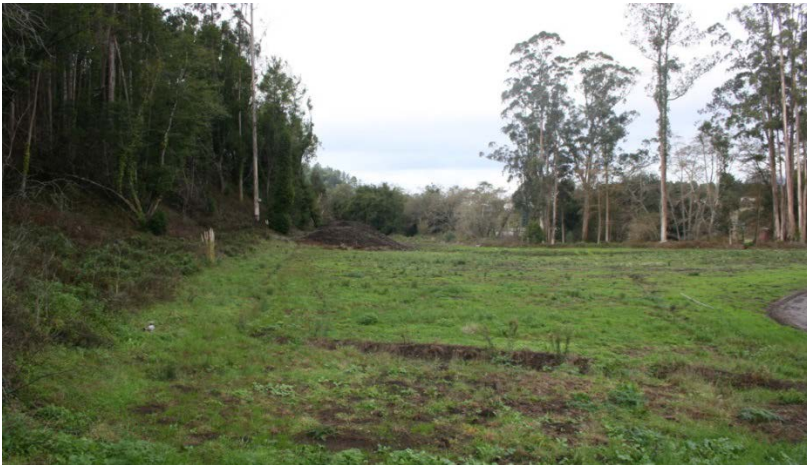
***Star Route Farm Pond 3A and 3B:*** Pond 3A is 31 AF and Pond 3B is 10.6 AF. These two irrigation ponds will support 29 acres of organic row crops. These ponds will eliminate the annual diversion of 53.5 AF from Pine Gulch Creek.

*Pond 3A Before Construction*

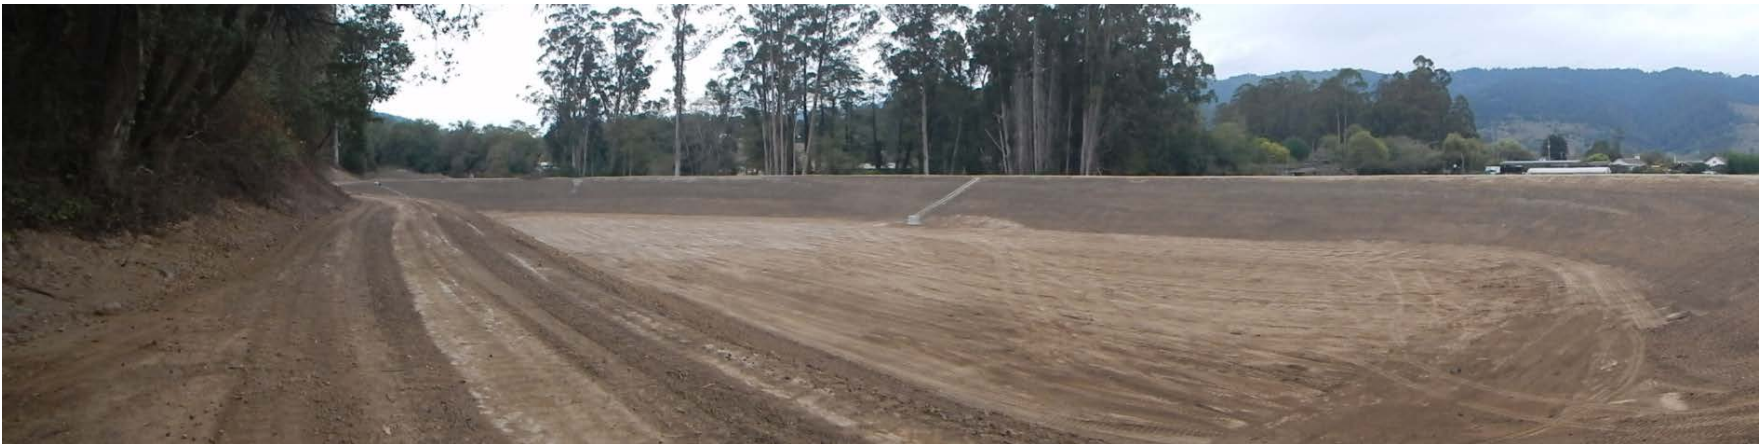
*Pond 3A - After Construction*

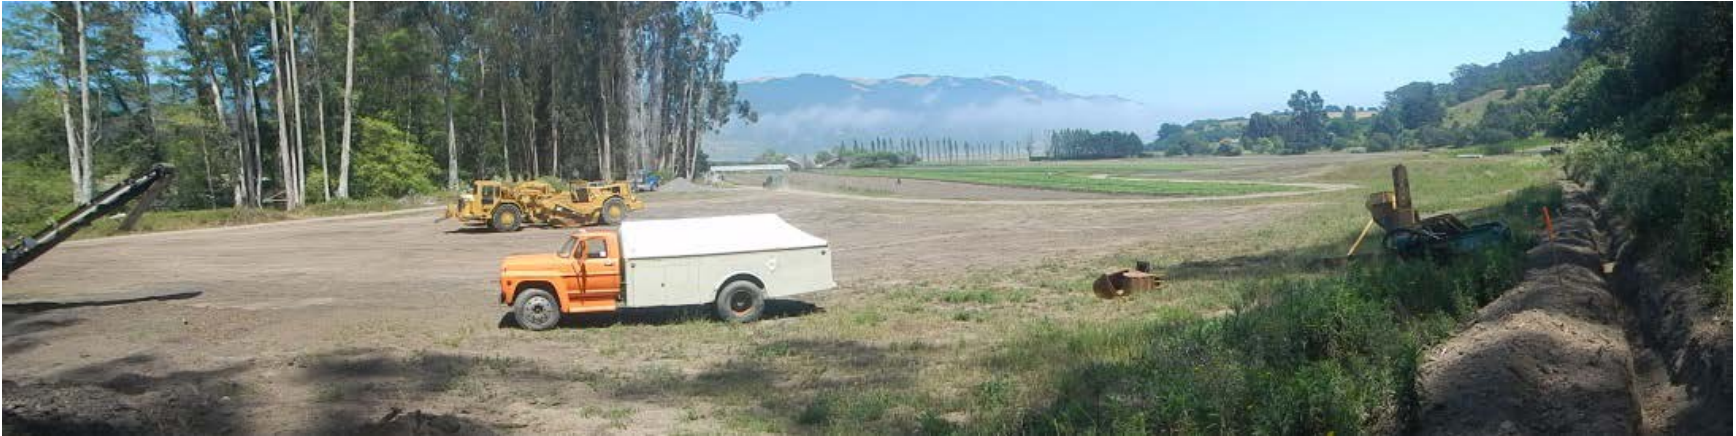
*Pond 3A – Before Construction (from the north looking southeast)*

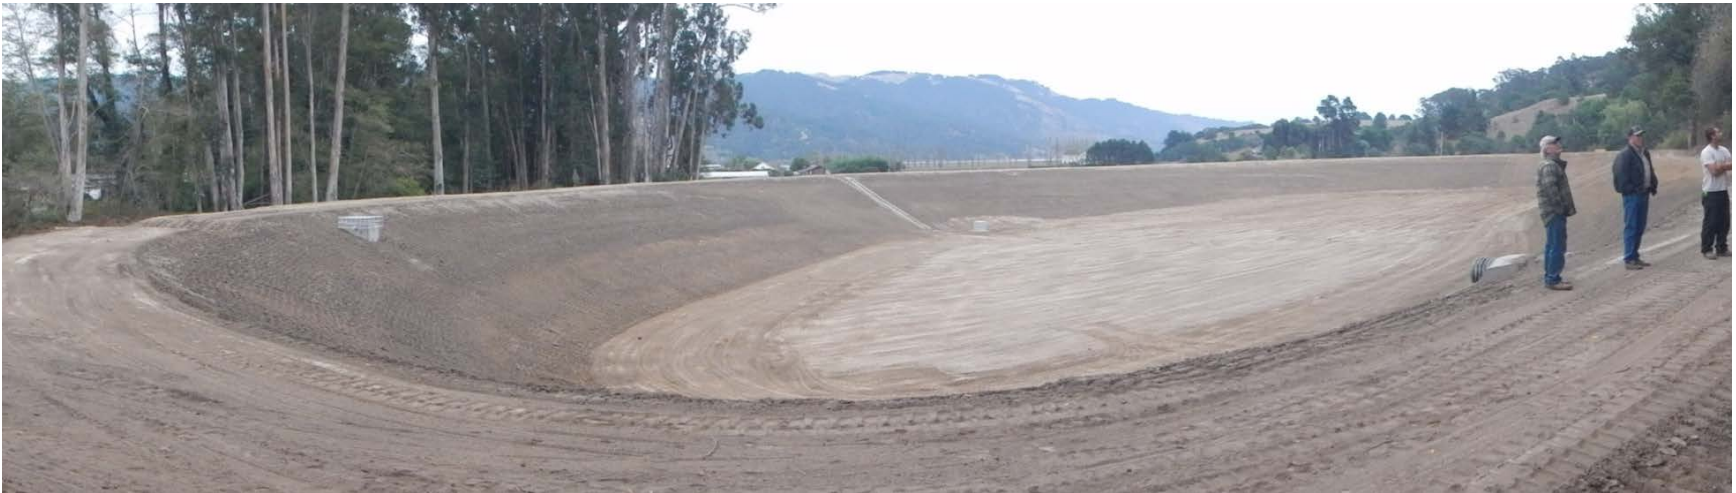
*Pond 3A – After Construction (from the north looking southeast)*

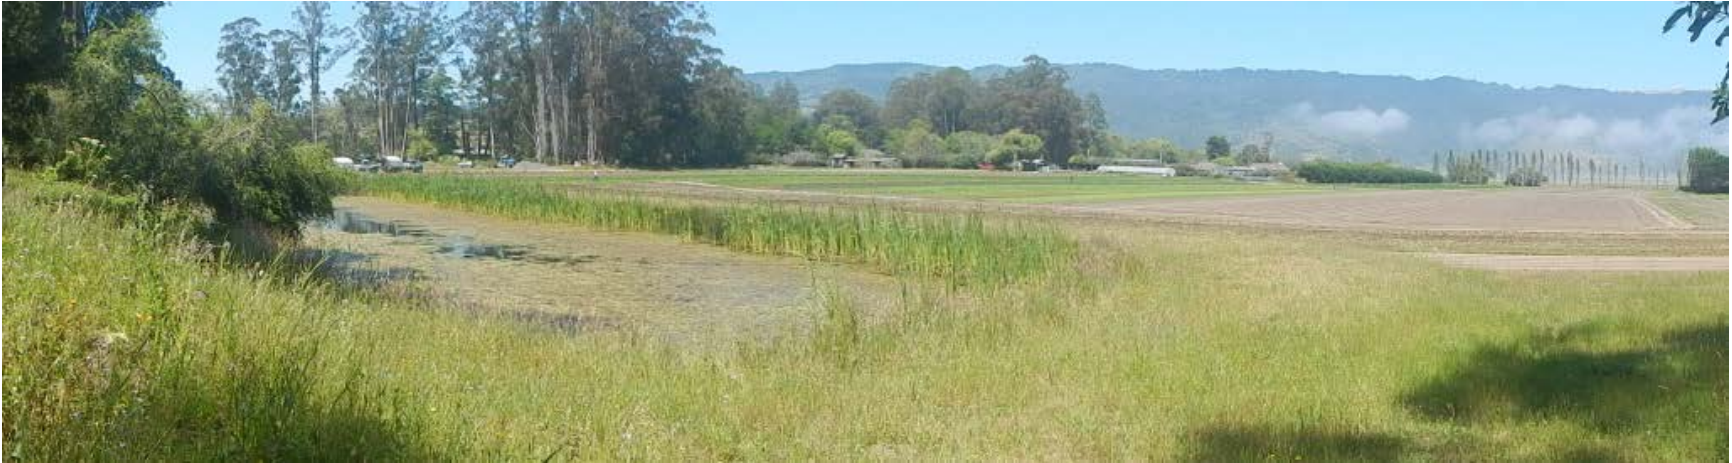
*Pond 3A – Before Construction (photo from the south looking northeast)*

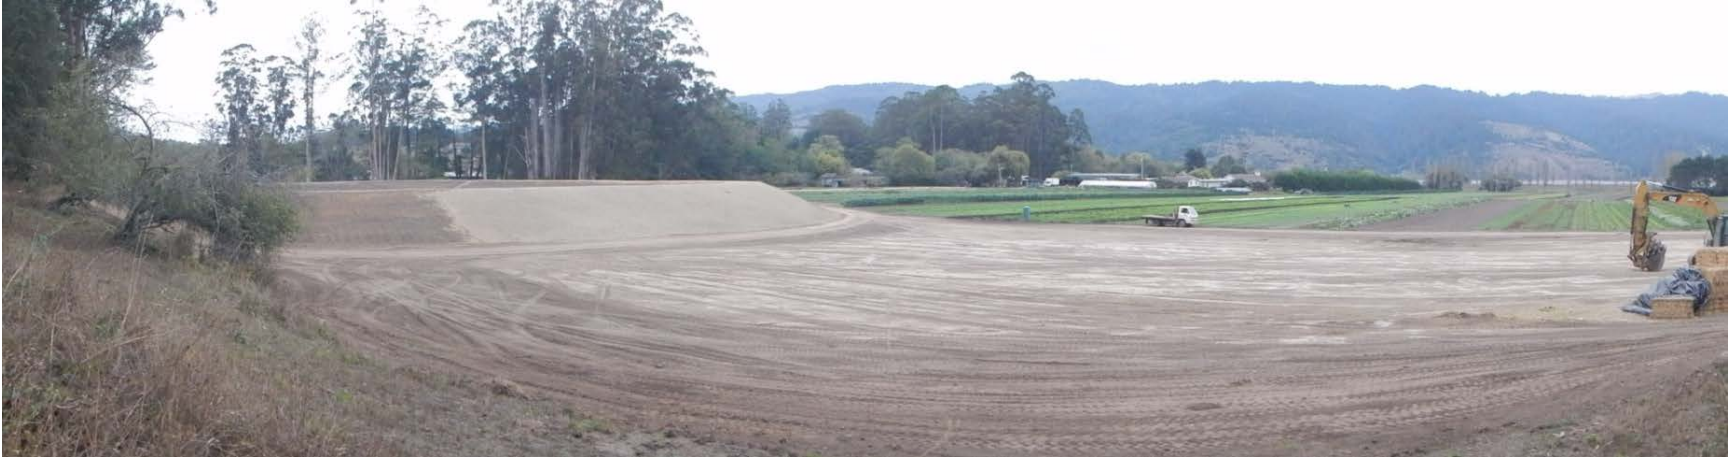
*Pond 3A – After Construction (photo from the south looking northeast)*

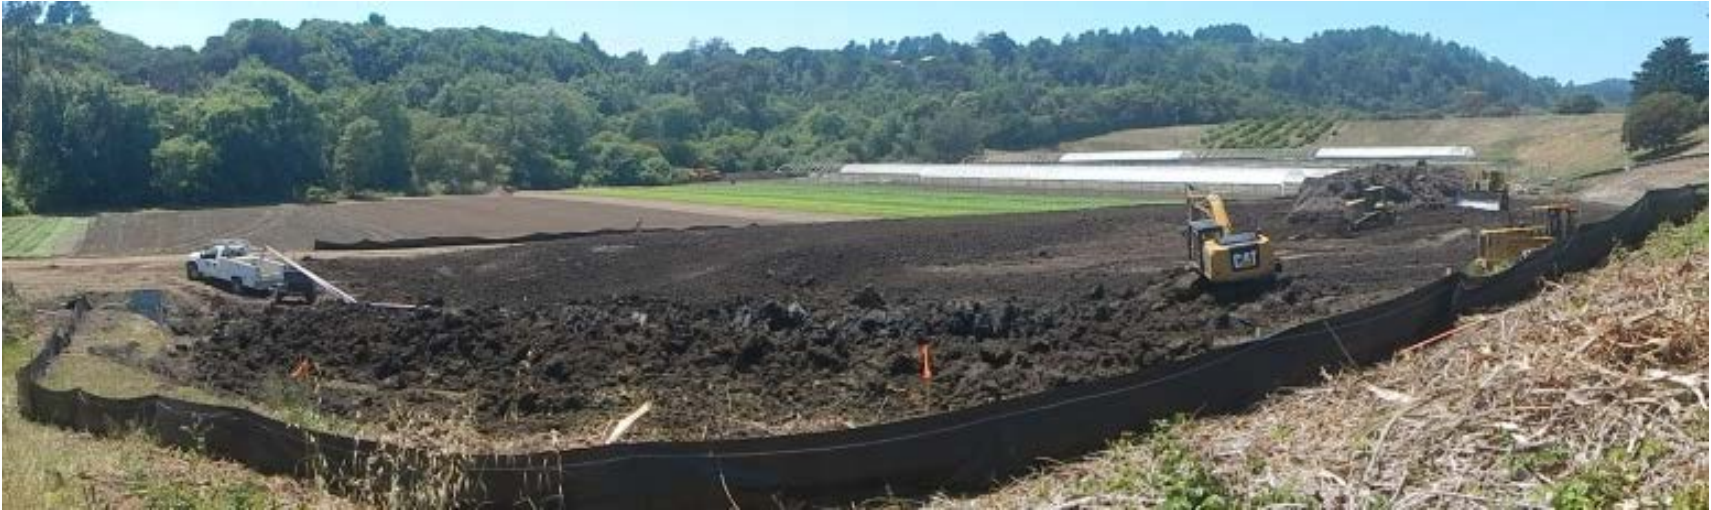
*Pond 3B – Construction Start (photo from the southeast looking northwest)*

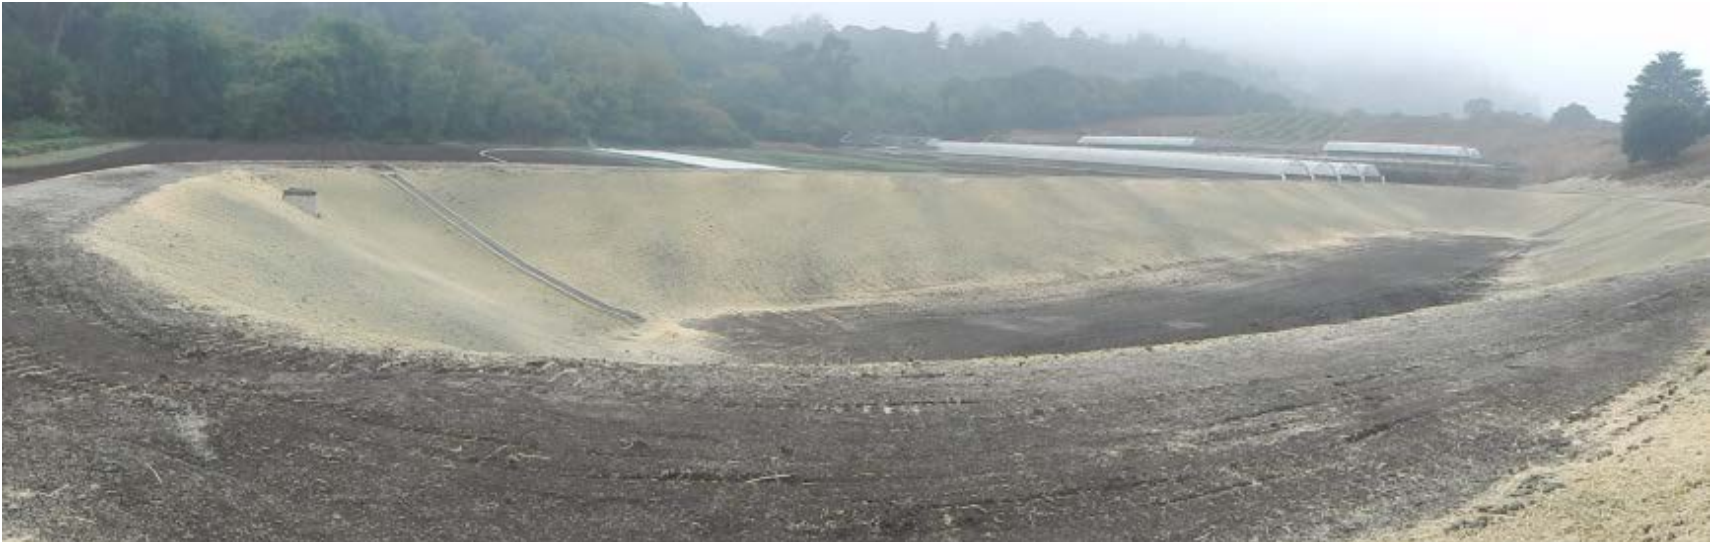
*Pond 3B – After Construction (photo from the southeast looking northwest)*

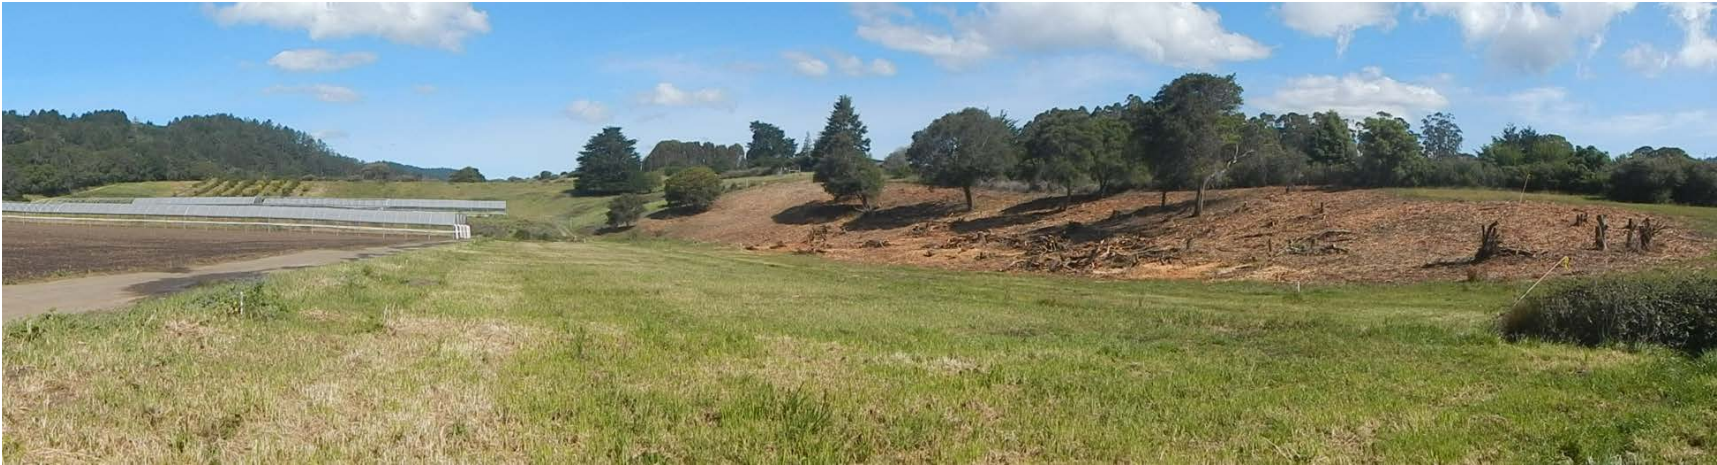
*Pond 3B – Before Construction (photo from the southwest looking north)*

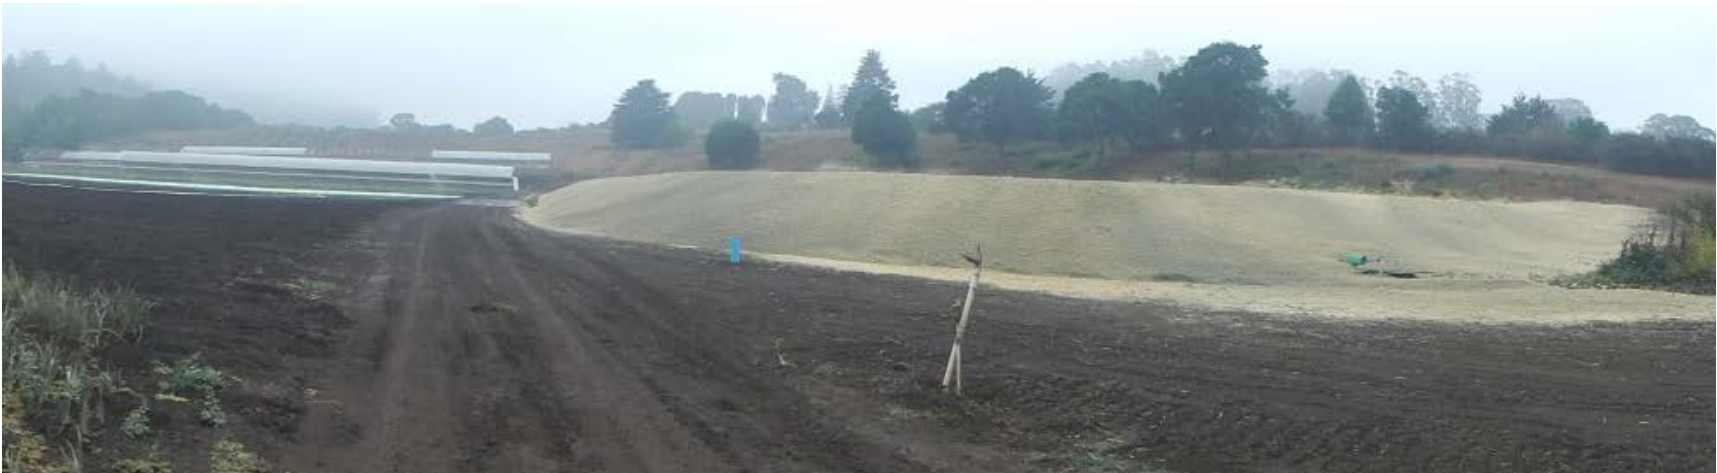
*Pond 3B – After Construction (photo from the southwest looking north)*

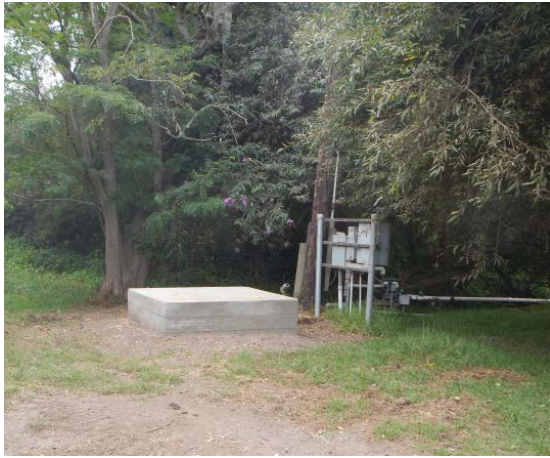
*POD 1 for Pond 3A at SRF before Installation*

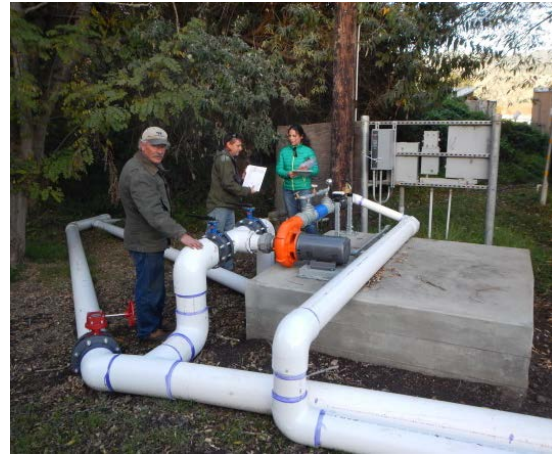
*POD 1 for Pond 3A at SRF after Installation*

At the other farms, POD 3 for Pond 2, POD 2 for Pond 3B and POD 1 for Pond 3A began installation on September 29, 2015 and were completed on December 15, 2015. The PODs include fish screens at the intake valves, in-take flow meters to quantify diversion rate and meters to quantify amount of water diverted. Downstream of Star Route Farm's POD 2 and New Land Fund's POD 3, stream gauges were installed within Pine Gulch Creek. The meters will enable farmers to read stream flow levels and determine time sequence for appropriate diversion. Consequently, Fresh Run Farm did not receive a stream gauge because the farm does not expect to need to pump from Pine Gulch Creek for commercial irrigation.

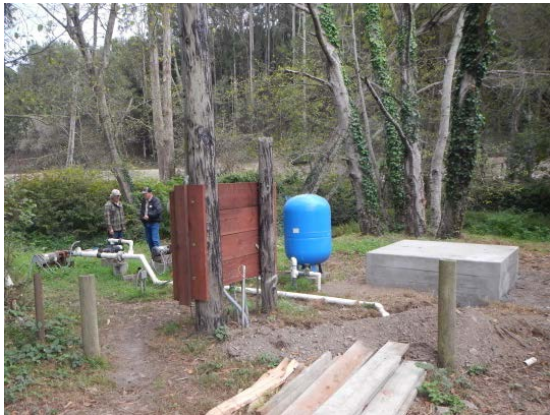
*POD 2 for Pond 3B at SRF before Installation*

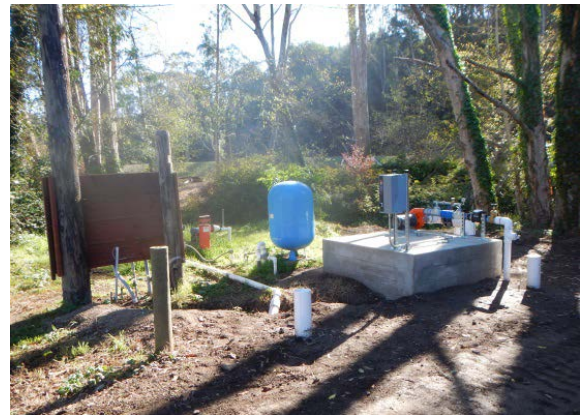
*POD 2 for Pond 3B at SRF after Installation*

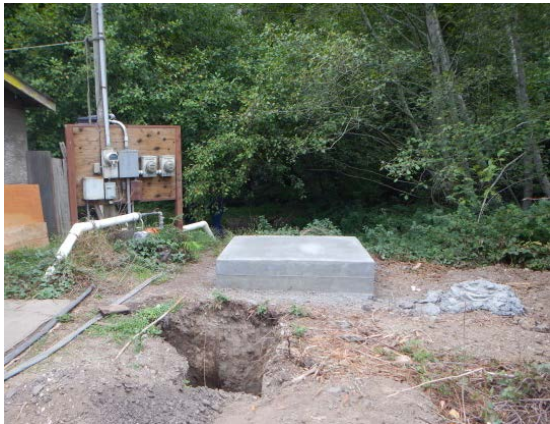
*POD 3 for Pond 2 at NLF before Installation*

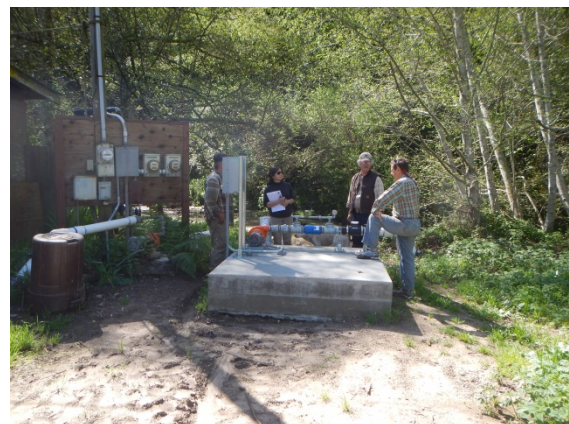
*POD 3 for Pond 2 at NLF after Installation*

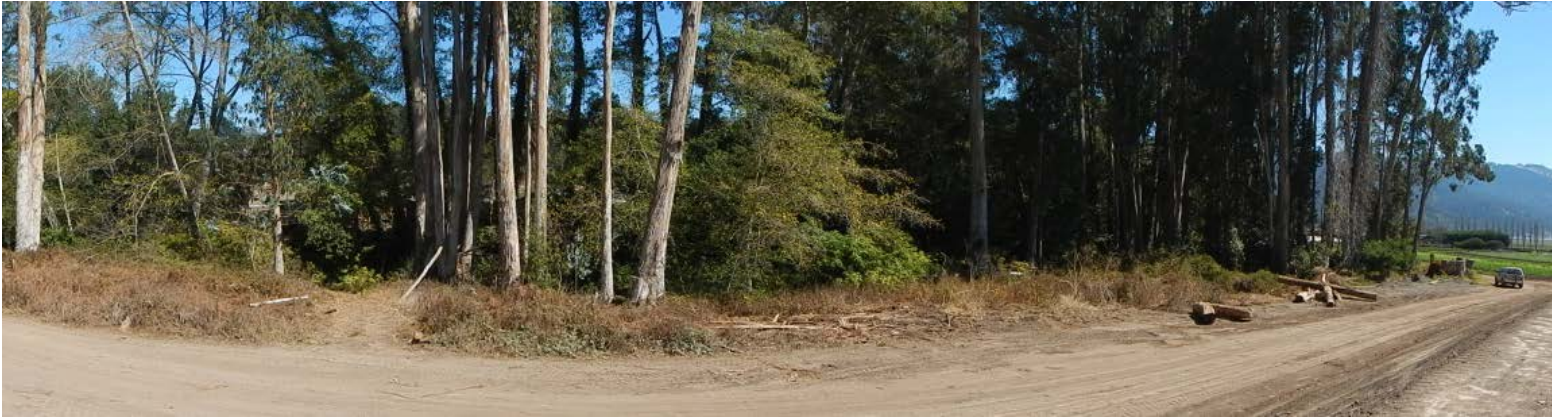
***Riparian Enhancement Area at Star Route Farm** – A 0.67-acre stretch of Pine Gulch Creek, the Riparian Enhancement Area, was improved by removing invasive species and installing 80 native trees. This segment of enhanced riparian corridor is located adjacent to Pond 3A.*

*Before Planting the Riparian Enhancement Area at Star Route Farm*

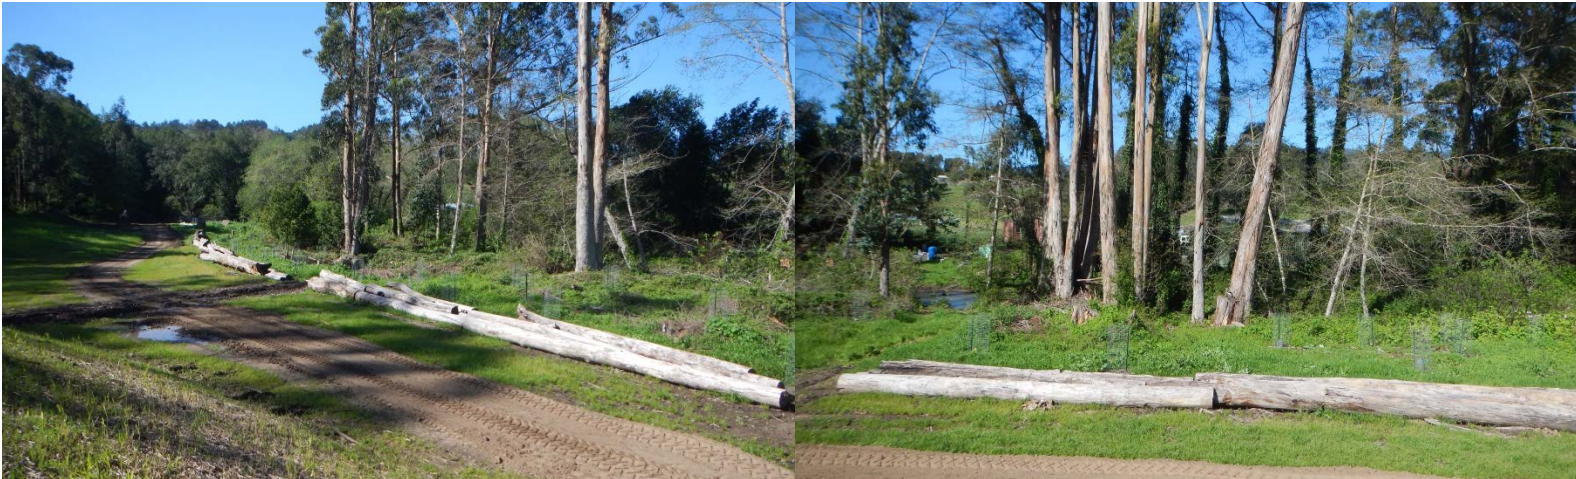
*After Planting the Riparian Enhancement Area at SRF*
