California Department of Fish and Game
Petaluma River Watershed
Stream Habitat Assessment Reports
San Antonio Creek
Surveyed 2007

STREAM INVENTORY REPORT

San Antonio Creek

Surveyed: Summer 2007

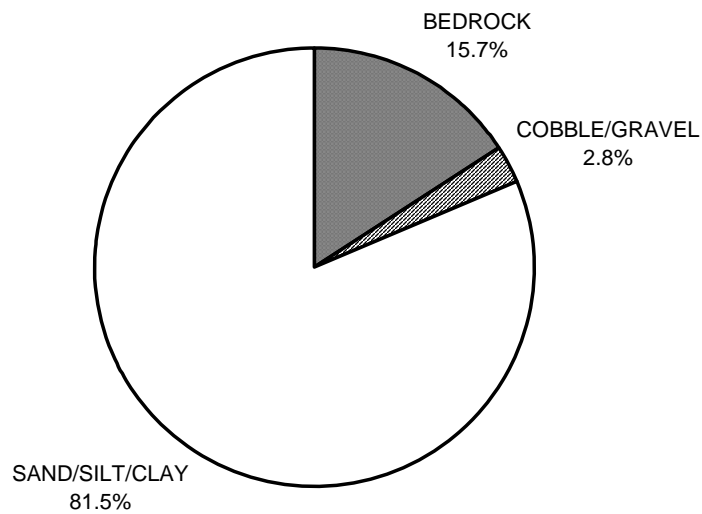
GRAPH 10

For the stream reach surveyed, the mean percent right bank vegetated was 48%. The mean percent left bank vegetated was 54%. The dominant elements composing the structure of the stream banks consisted of 16% bedrock, 3% cobble/gravel and 81% sand/silt/clay (Graph 10). Deciduous trees were the dominant vegetation type observed in 63% of the units surveyed. Additionally, 18% of the units surveyed had grass as the dominant vegetation type, and 15% had brush as the dominant vegetation (Graph 11).

**SAN ANTONIO CREEK 2007
DOMINANT BANK COMPOSITION IN SURVEY REACH**

The percentage of right and left bank covered with vegetation was moderate at 48% and 54%, respectively. In areas of stream bank erosion or where bank vegetation is sparse, planting endemic species of coniferous and hardwood trees, in conjunction with bank stabilization, is recommended.
