MARIN COASTAL WATERSHEDS PERMIT COORDINATION PROGRAM ANNUAL REPORT 2016-2017

JULY 2017

# Marin Coastal Watersheds Permit Coordination Program

# **Annual Report Executive Summary**

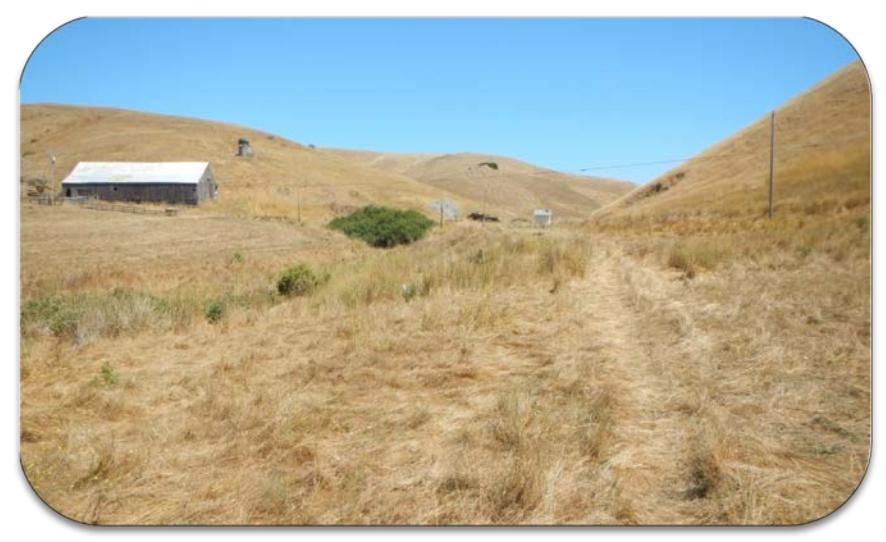
Pre-construction (7/27/16) photo looking upstream of gully.

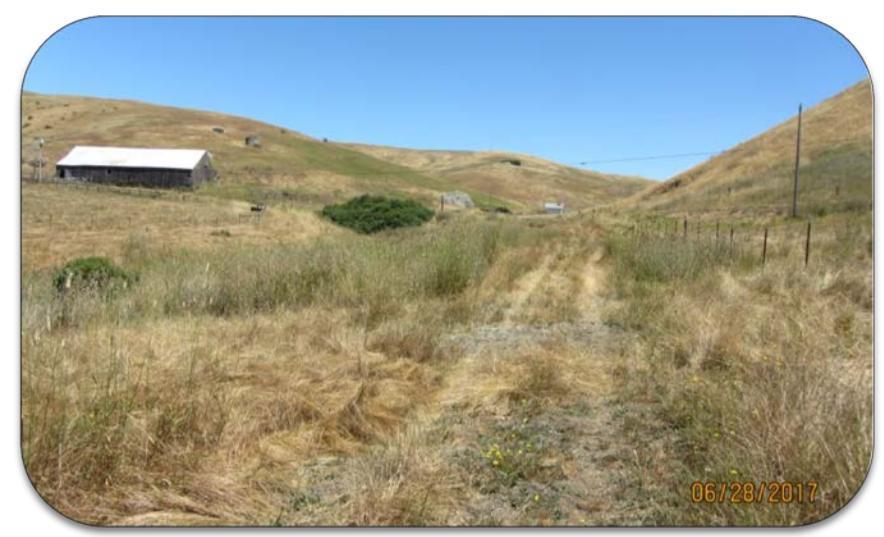
Post-construction (6/28/17) project photo displaying the riparian fence on the right side of the photo.

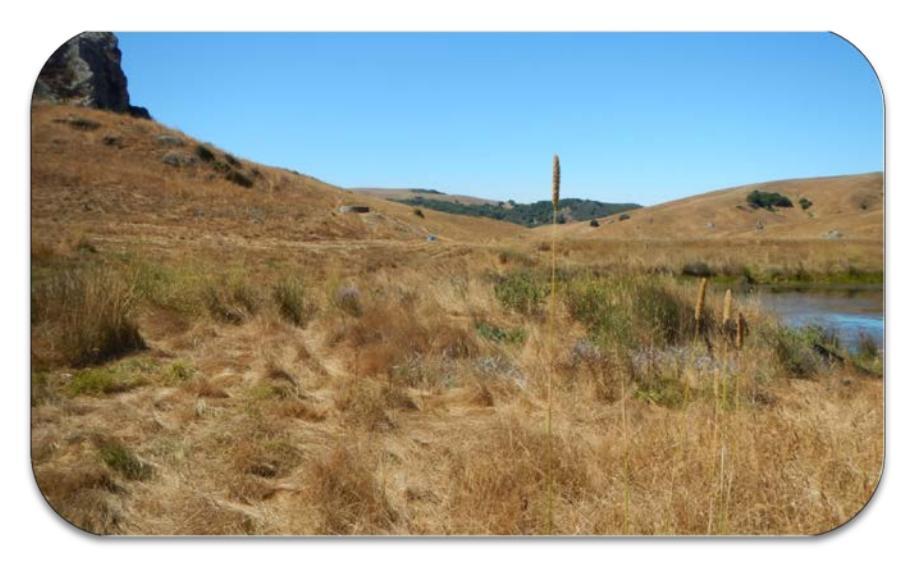
Pre-construction (7/27/16) photo of the solar pump location that will take pond water to tanks to be installed at the top of hill.

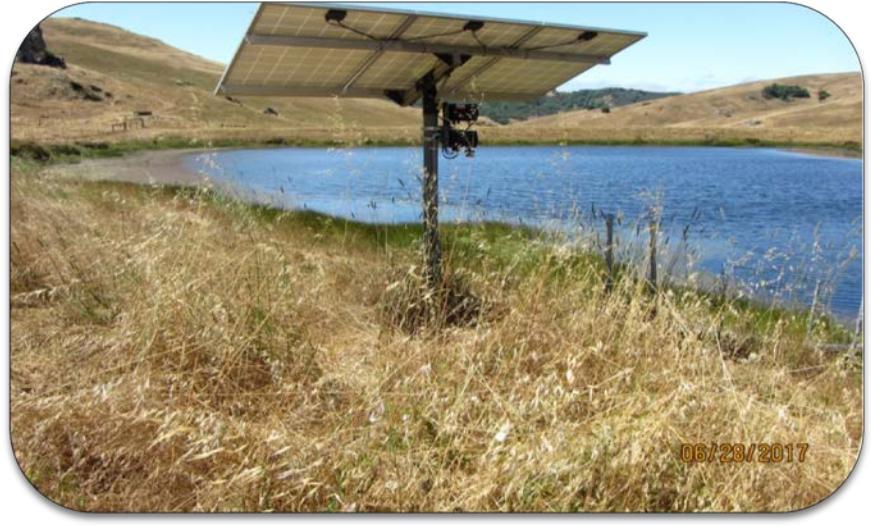
Post-construction (6/28/17) of solar pump solar panel and the above ground pipeline going to the pond can be seen through the dry grass.

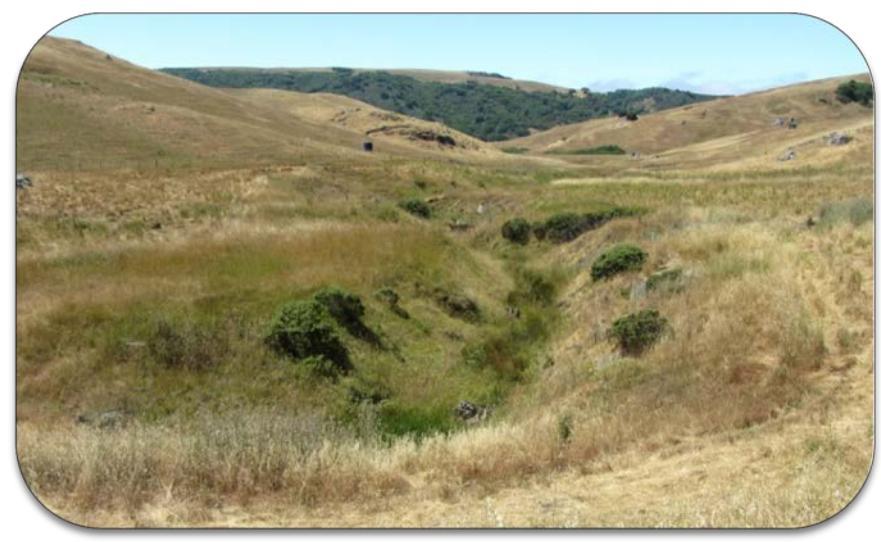
Post-construction (6/28/17) photo of tributary planted by STRAW. Plants installed were less than 3 feet tall, and the cages around the trees are difficult to see in this photo.

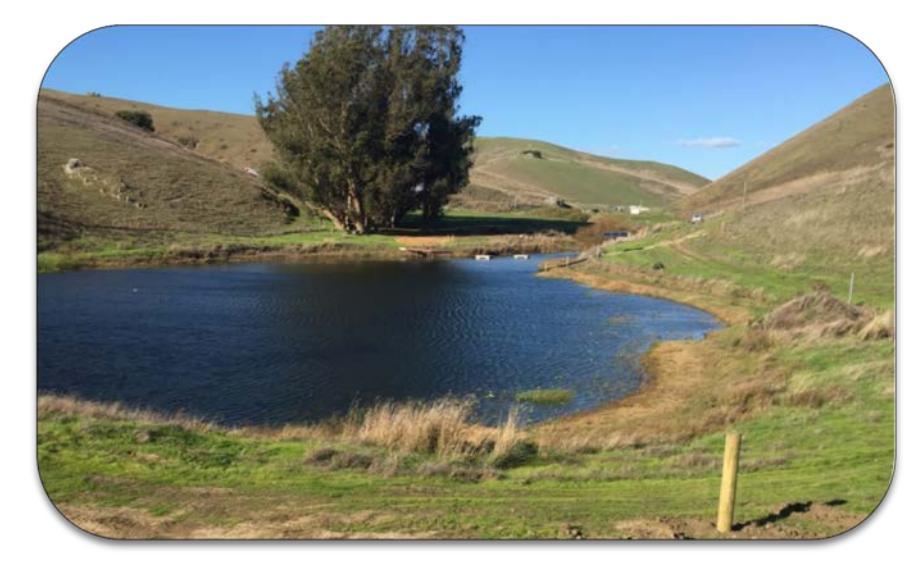
During construction photo of completed solar pumping station and the riparian fence under construction (11/16/16).

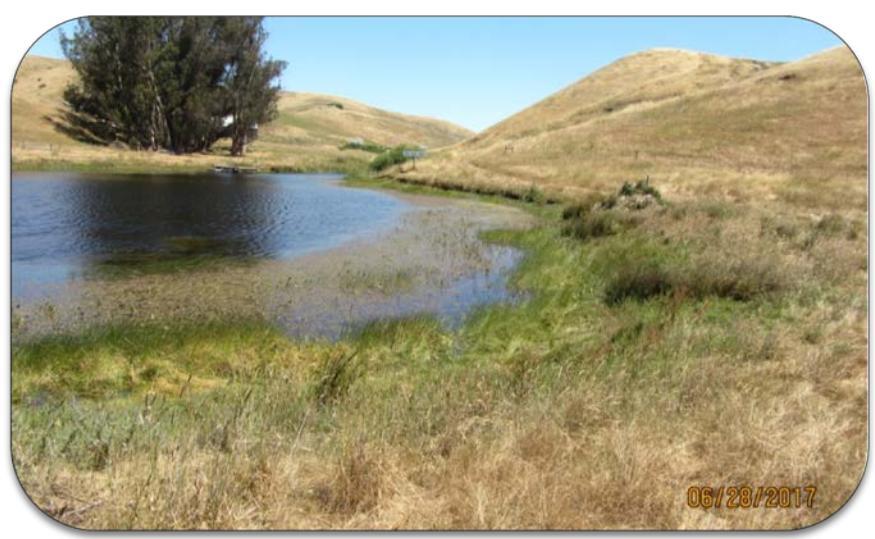
Post-construction (6/28/17) of pond, solar panel and riparian fence.

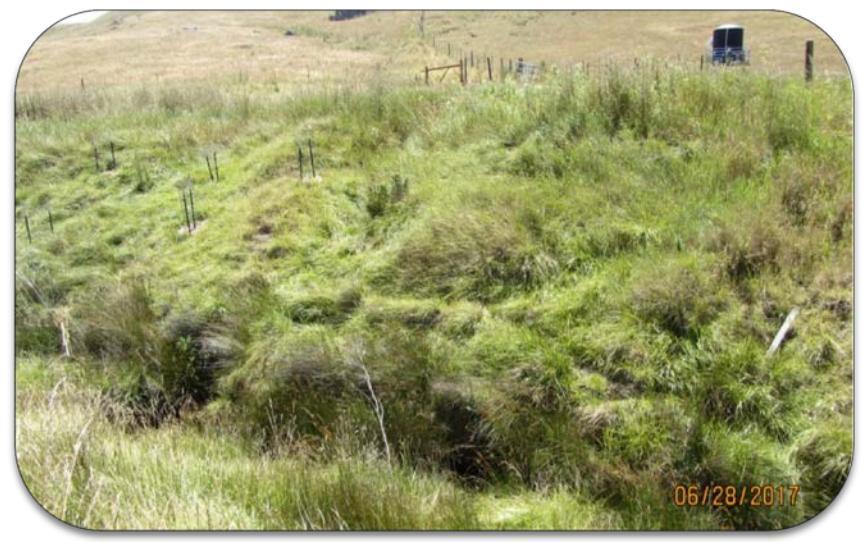
Container plantings located at the end of the Chileno Creek tributary (6/2017). The property boundary fence is visible in the top right of the photo.

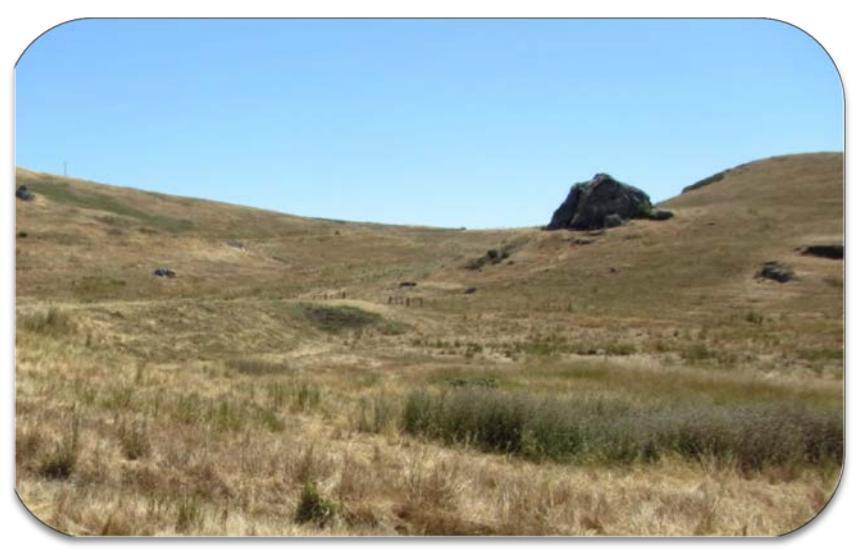
Post-construction photo displaying constructed fence passing below the circular water trough plumped to uphill tanks (6/2017).

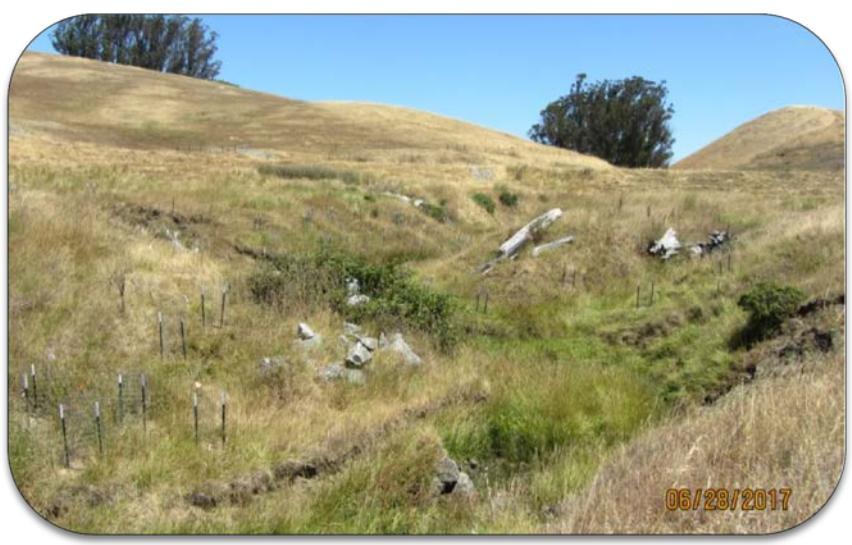
View of container plantings from the middle of the tributary (06/2017). The large logs were placed by the landowner to slow erosion. The pond damn is in the background.

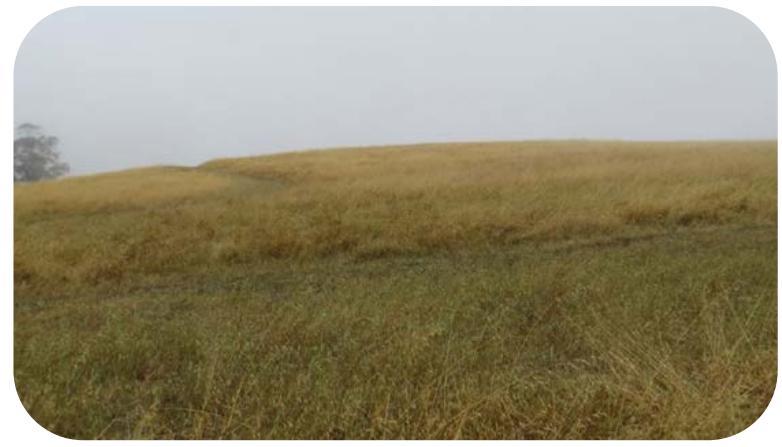
Pre-construction photo of hilltop where the water development will be installed and tapped into a well. Photo taken 07/15/16.

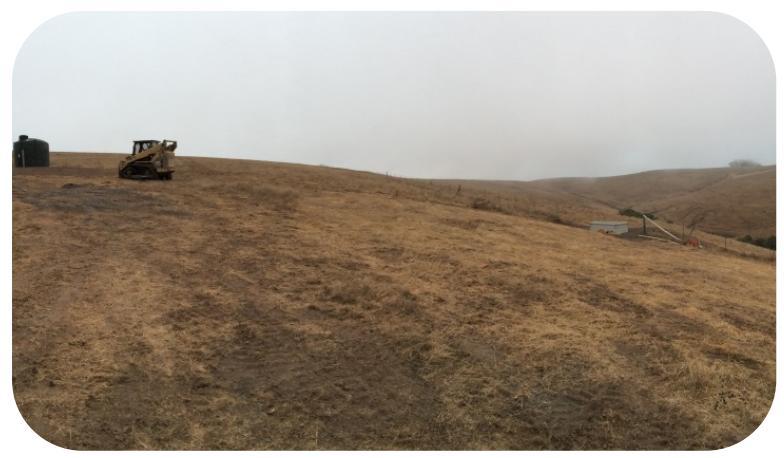
'During' construction photo of the installation of the tank and trough. Taken on 08/23/16.

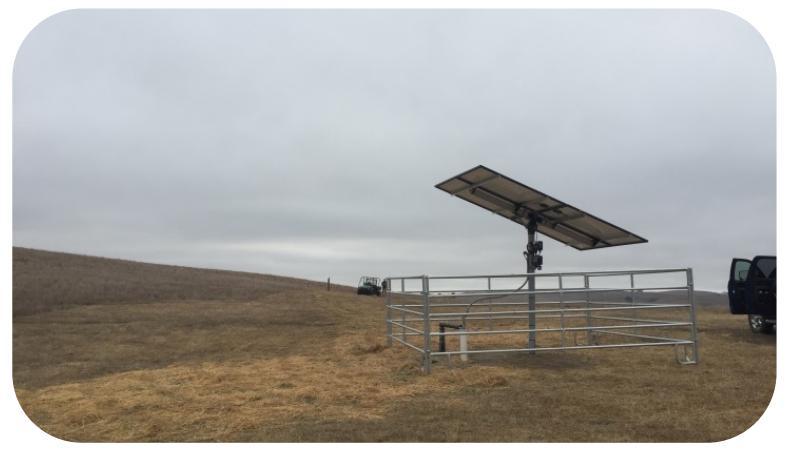
View of solar array and pump which taps into a well that will fill a tank thence a trough. Photo taken 09/08/2016.

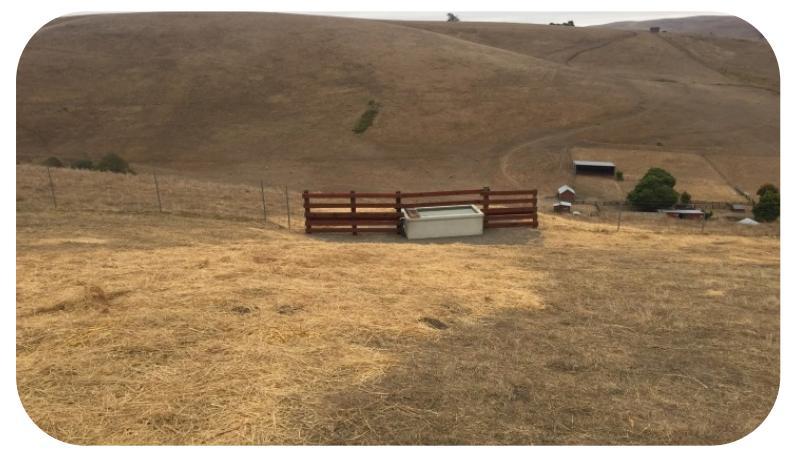
New wildlife friendly trough services two fields and will encourage livestock to spend more time upland. Photo taken 09/08/2016.

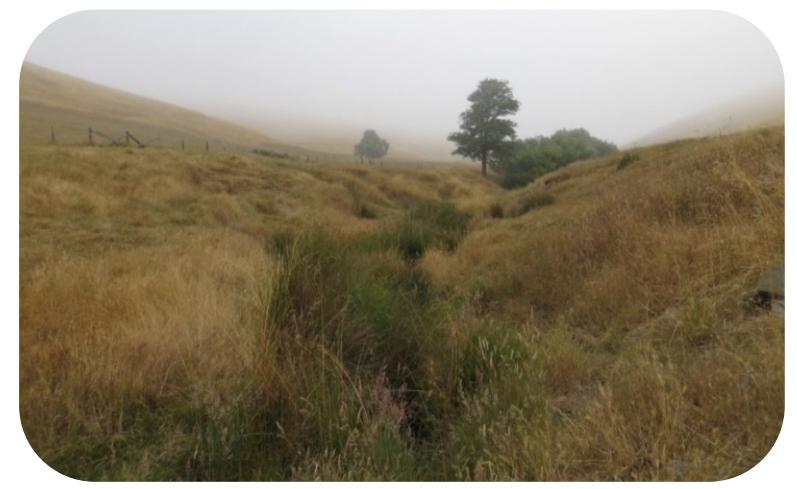
Tributary to Keys Creek on the ranch before completely fenced. Photo taken on 07/15/16.

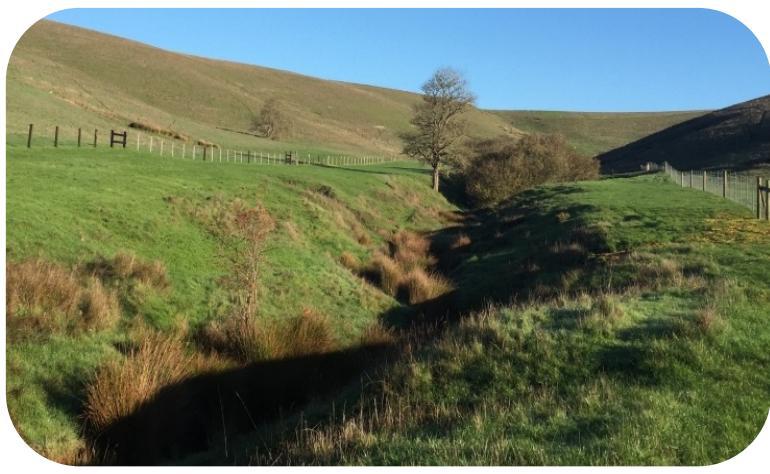
Keys Creek tributary completely fenced on the ranch (new fence on right side). Photo taken on 11/16/16.

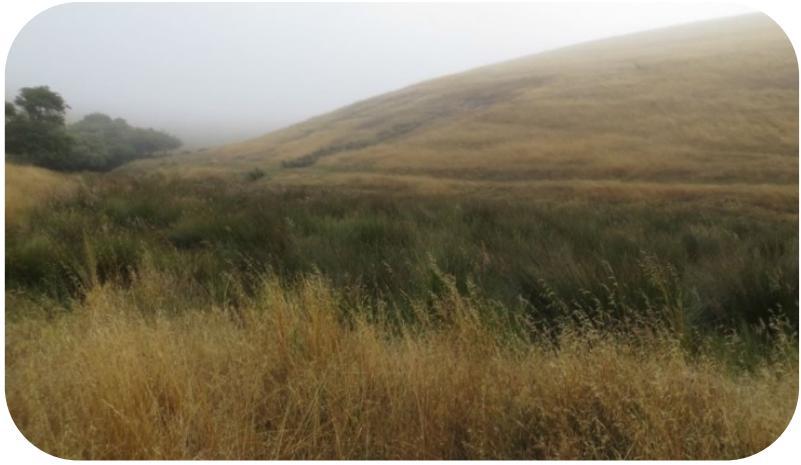
Old pond site in tributary to Keys Creek that is dry and occupied by large *Juncus* plants. The fence will be installed on the hillside. Photo taken on 07/15/16.

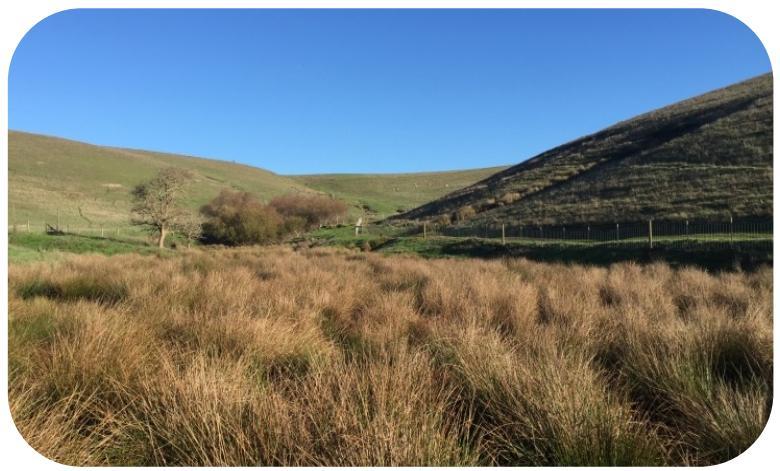
View of old pond site and the new fence installed along the hillside. Photo taken on 11/16/16.

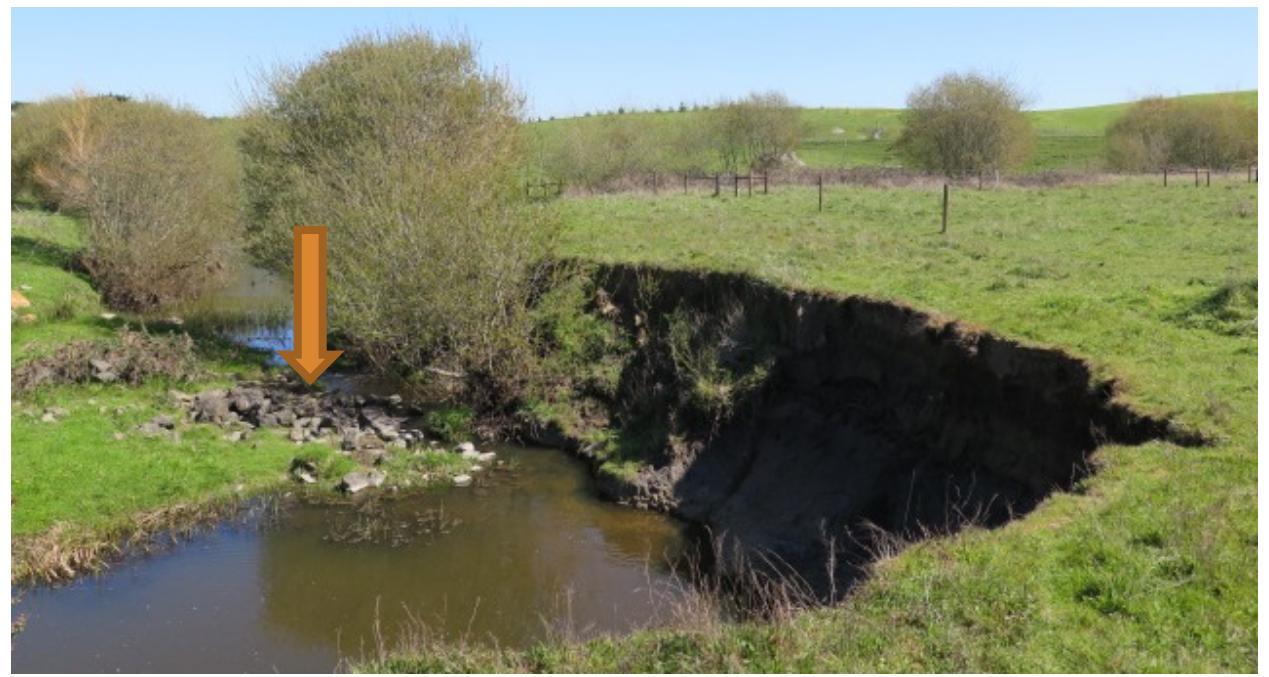
*Figure 1. View of project site including the pile of rip rap (left side of the photo, with orange arrow) and the eroding bank (right side of photo). The rip rap was removed in this project.*

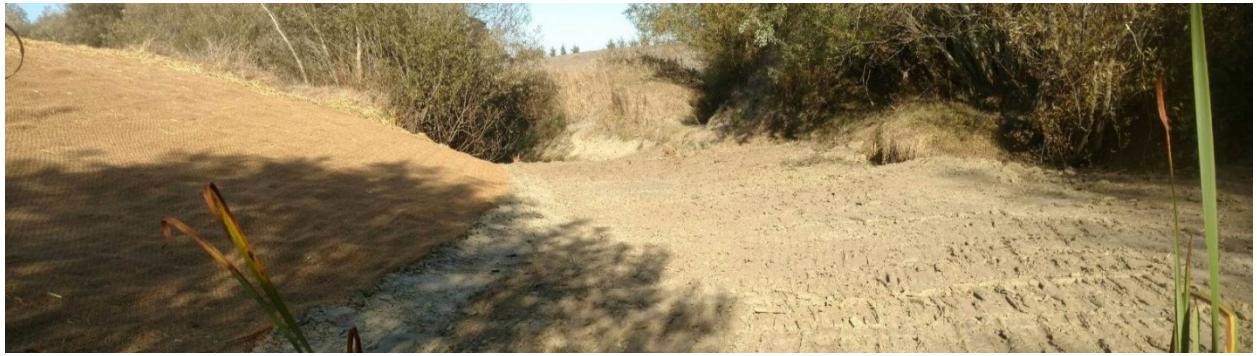
*Figure 2. Civil Engineer reviewing earthwork completed by contractor. Photo taken looking upstream with the rehabilitated rip rap site on the left side of the photo.*

MRCD secured a contractor and restricted the construction window to late summer in order to avoid summer pools in Stemple Creek and winter storms. Construction started September 12, 2016. The contractor removed the rip rock while a biologist oversaw the work to ensure wildlife safety and to help outline work area boundaries. The area where the rock was removed was then graded and erosion control fabric was installed to cover bare dirt (Figure 1). The work was finished on September 15, 2016. Table 1 summarizes the amount of rip rap removed and length of streambank protected. Figure 2 and 3 show the graded slope just after construction and then after the project's first winter.

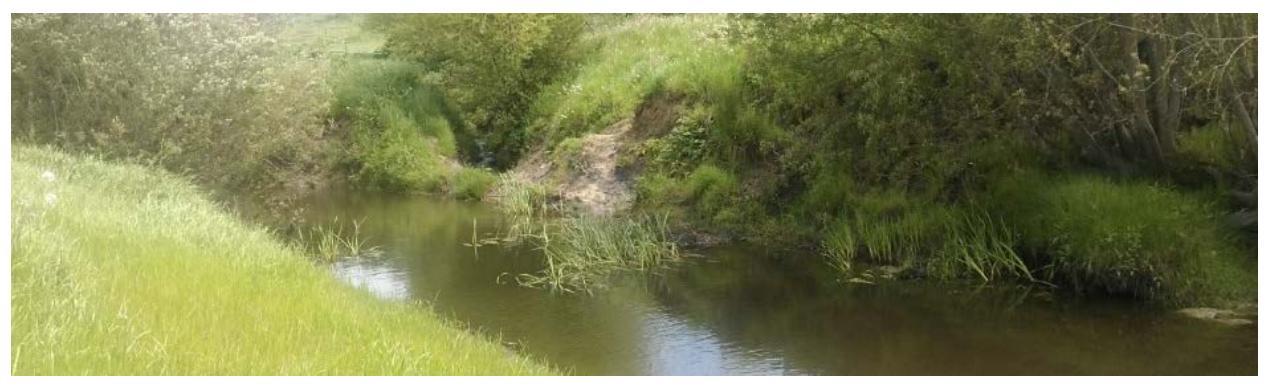
Figure 3. Smooth grass slope on the left is the graded area where the rip rap was removed. This photo was taken on 04/25/2017 after the first winter post-construction.

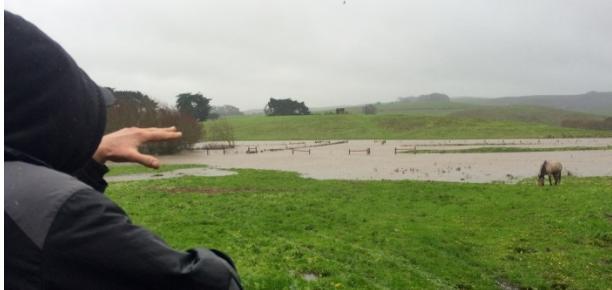
Figure 6. Stemple Creek at flood stage on 1/10/17. Photo is looking at the Upstream Site to be planted by STRAW.

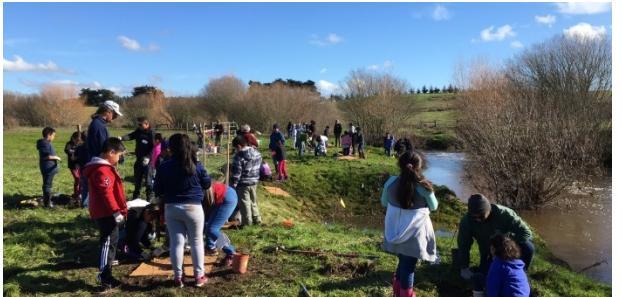
*Figure 5. The STRAW Program installing plants at the Downstream Site (01/24/17).*

Point Blue Conservation Science's Students and Teachers Restoring a Watershed (STRAW) Program installed the 40 willow stakes in the project plans; STRAW determined the ultimate location of the willow stakes at the 'Downstream Site' due to their expertise in planting eroding banks. In addition, MRCD, in partnership with MALT, STRAW installed 43 container plants at the Downstream Site, and STRAW planted two additional areas: Upstream Site (on mainstem Stemple Creek above the Downstream Site); and Upstream Tributary Site (upstream from the Downstream Site, Figure 4). To complete all plantings, STRAW scheduled three days in January, but the heavy winter rains of 2017 brought Stemple Creek flows to flood level (Figure 5), thus two planting days were postponed to March (Figure 6). Stemple Creek flooded after the January planting date, and again after the March planting dates, which required STRAW to return and clean up cages and debris. Exhibit A is a map of the Downstream Site willows staking locations and Exhibit B is STRAW's plant installation report for all three sites.

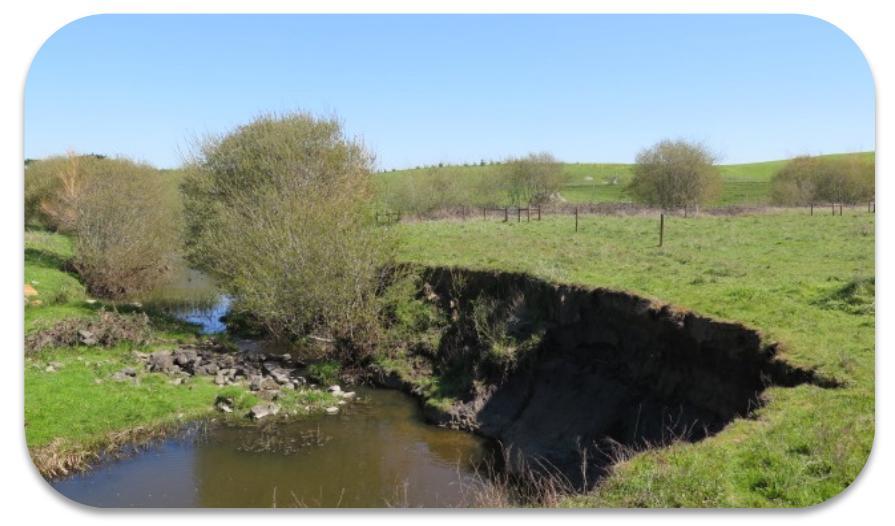
Pre-construction view when the project was first proposed (4/2015). The pile of rip rap (left) is visible just downstream of the large willow tree.

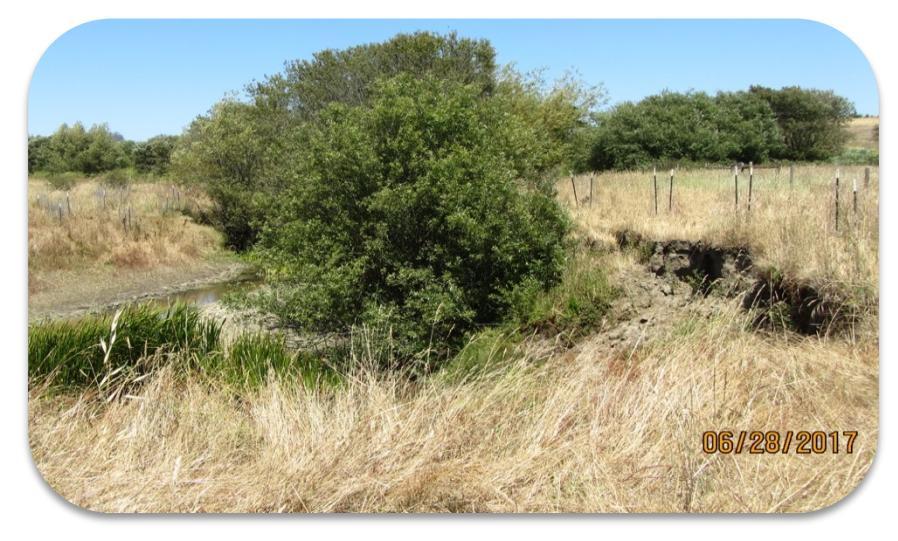
Post-construction (06/28/17) view of the removed rip rap and eroding bank. Tposts and coages are protecting native plant installations.

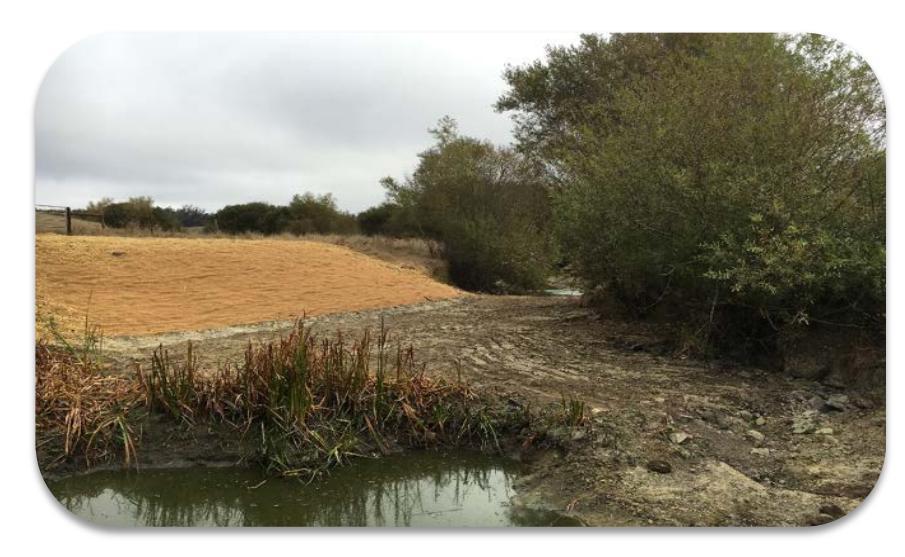
View looking upstream at the recently sloped grade (07/213/17) with erosion control blanket where the rip rap pile was removed. Willow stakes were installed later that fall.

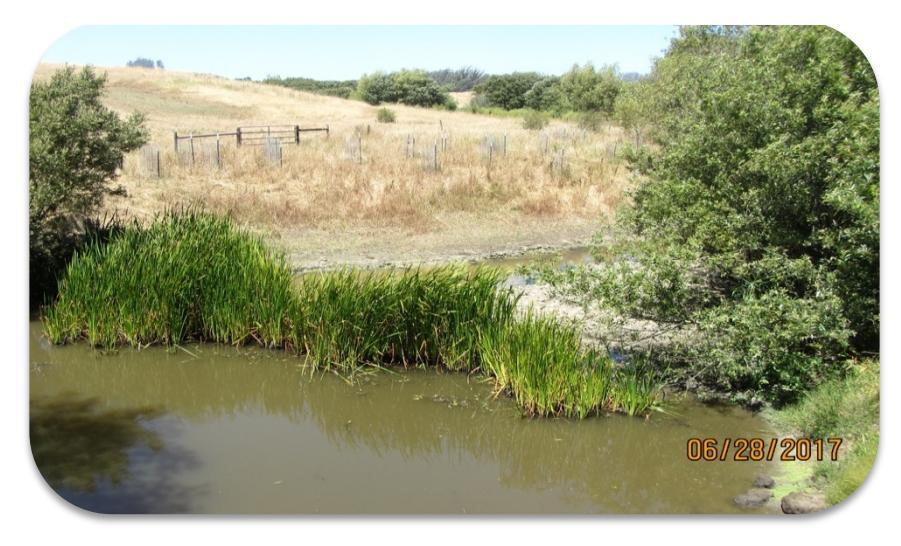
Post-construction (o6/28/17) photo of the removed rip rap pile. At top of bank, willow stakes with 3' spacing are difficult to see due to low vigor; the cages of the container plants on the bank within cages and t-posts are easy to see.

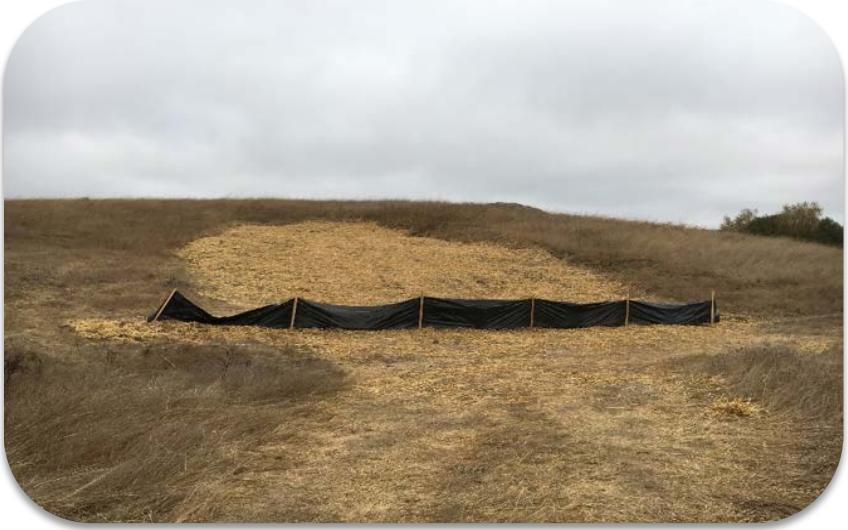
Construction site spoils pile placed above the 100-year storm mark (09/13/17).

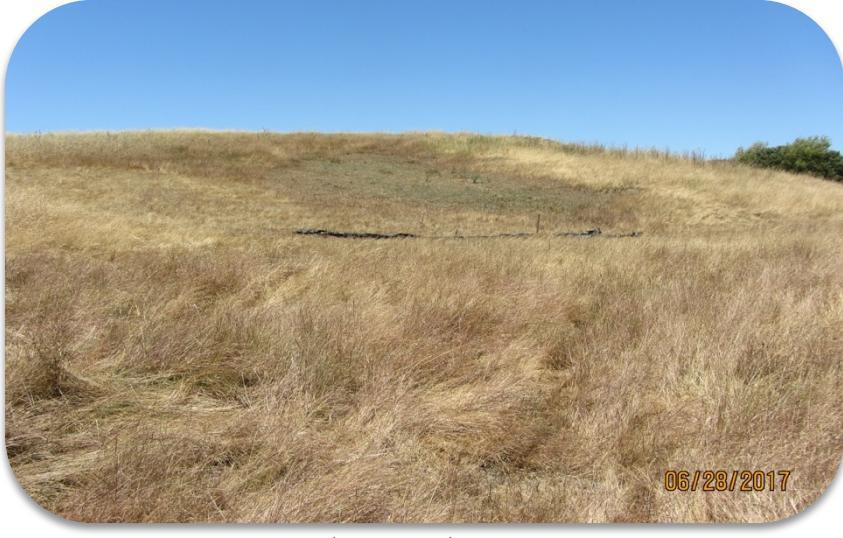
Post-construction (06/28/17) view of the spoils pile.

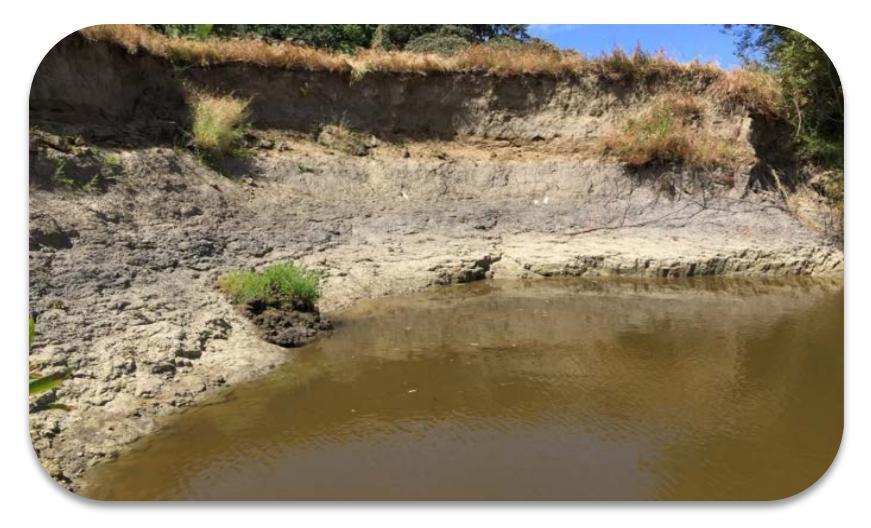
Pre-construction (7/2016) view of the steep bare eroding bank.

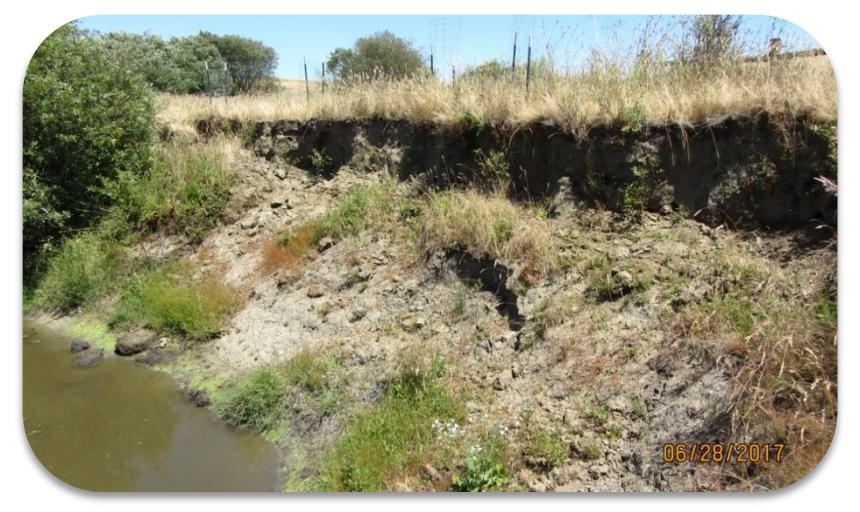
Post-construction (06/28/17) view of the eroding bank that is less steep and naturally revegetating.

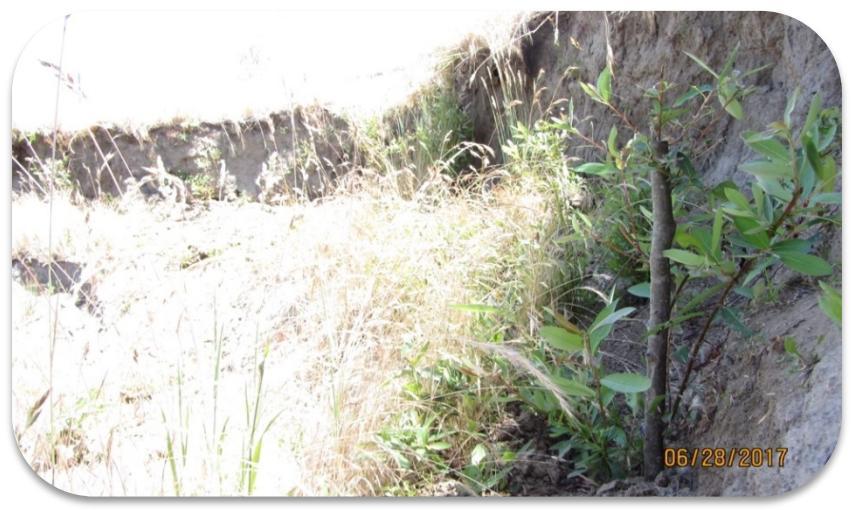
Close up of sprouting willow stake installed at the top of the eroding bank with 2'-4' spacing. These willow stakes at the top of bank had high vigor.

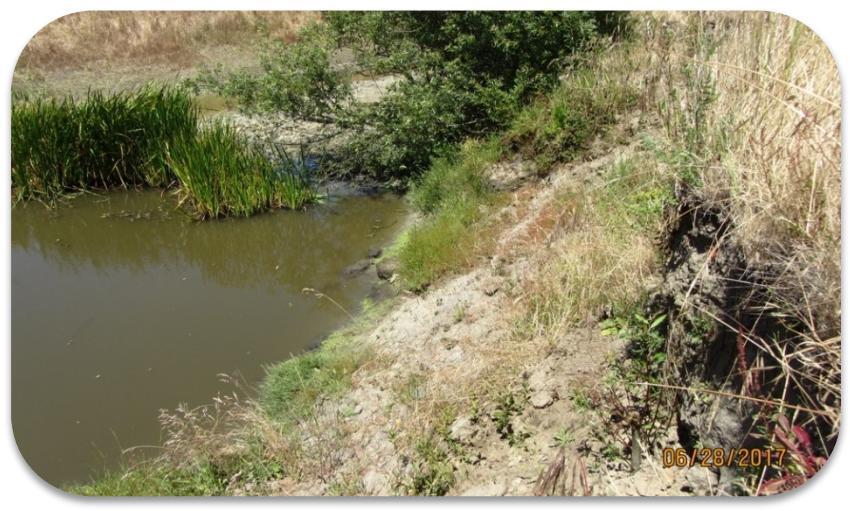
View of the row of willow stakes installed at the top of bank with about 2'-3' spacing (06/28/17). Several volunteer willows are taking root along the slope.

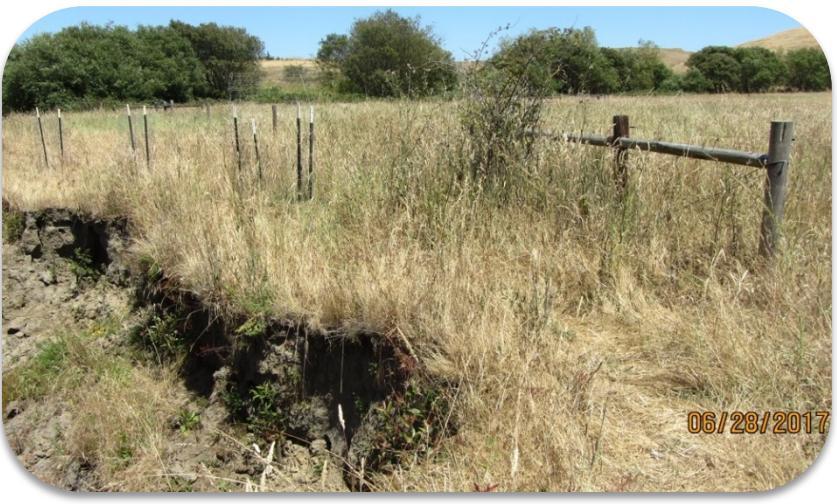
Post-construction (06/28/17) view of fence proximity (7') to eroding bank. Sprouting willow stakes are visible at top of eroding bank.

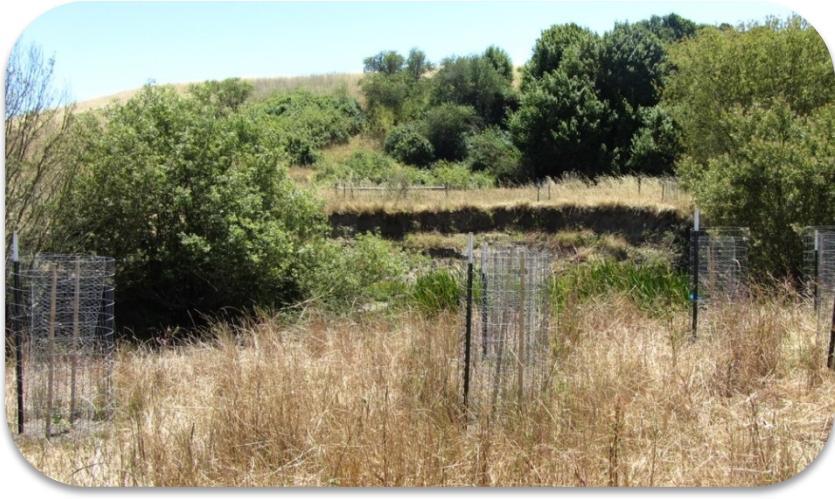
Post-construction view of container plantings with eroding bank in the background (06/28/17).

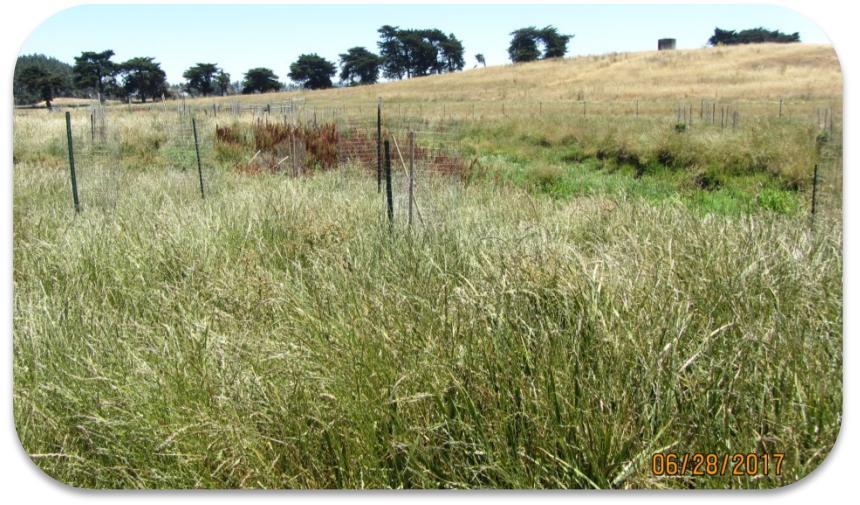
View of the Upstream Site planted by STRAW.

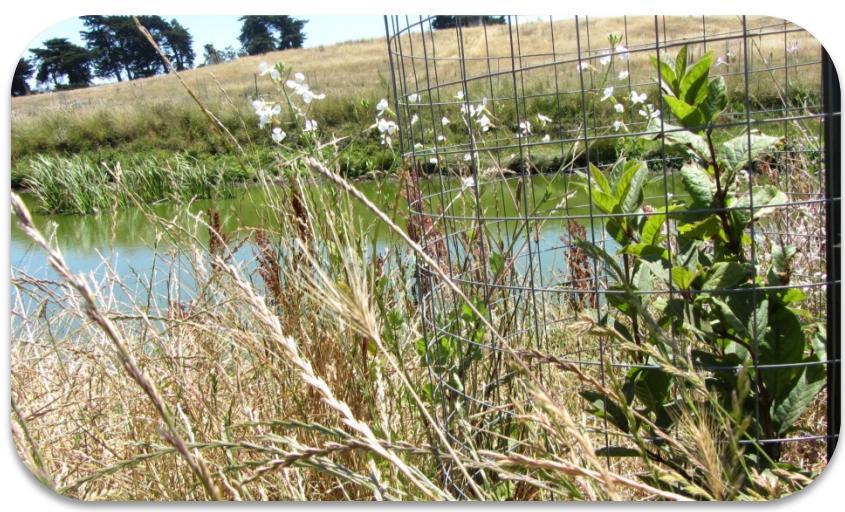
Close up of one of the native plants in the Upstream Site (06/28/17).

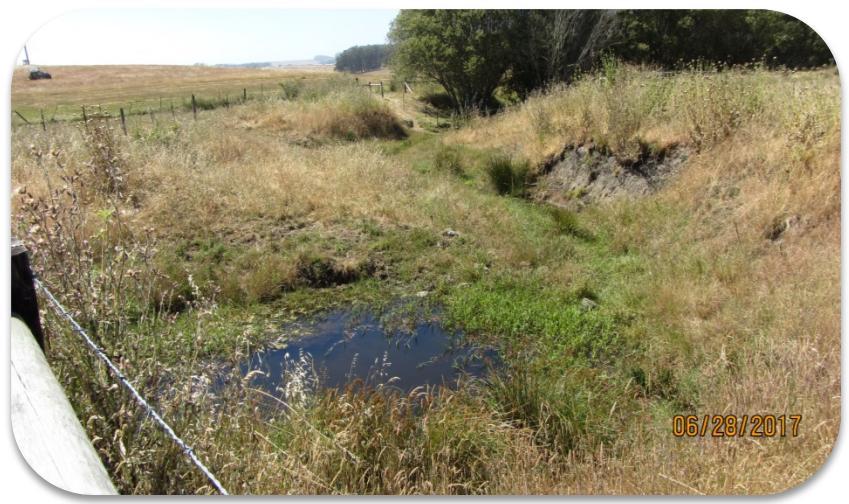
View of Upstream Tributary Site along the Tomales-Petaluma Road where STRAW installed 40 willow stakes with 5' spacing.

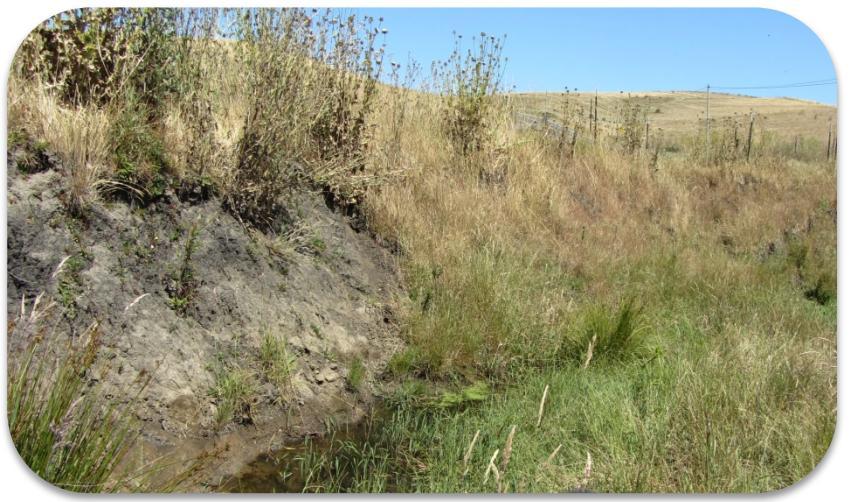
An eroding bank at the Upstream Tributary Site with several willow stakes installed that are sprouting with high vigor (06/28/17).

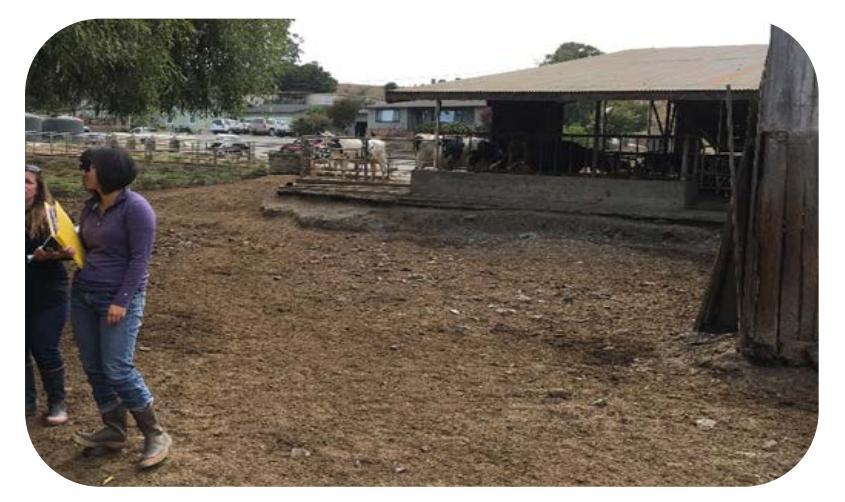
Pre-construction view of heavy use area with freestall barn in the back ground and corner of old hay barn at right (looking west).

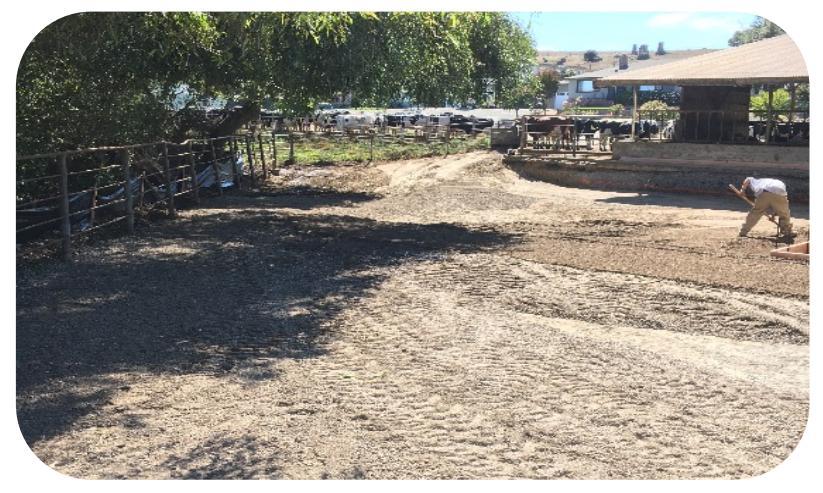
During construction view of heavy use area during import and spreading of the base rock with free-stall barn in the background. (08/2016).

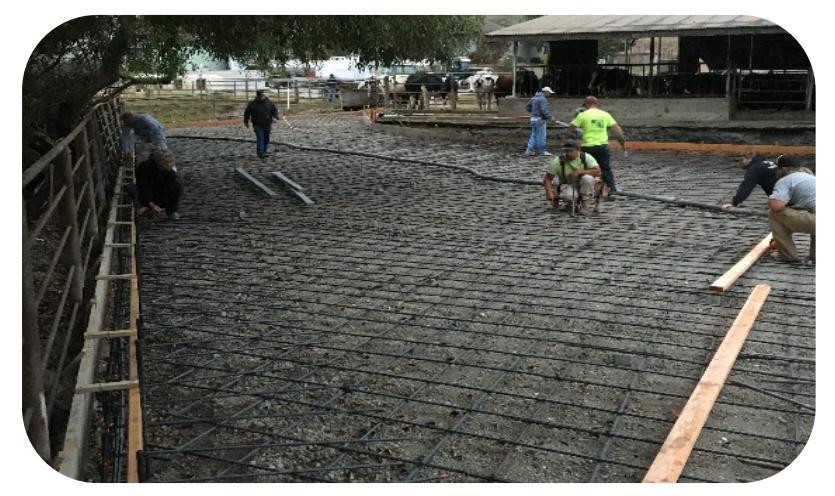
During construction photo of the installation of steel reinforcement bars on 1ft centers per NRCS standards (09/2016).

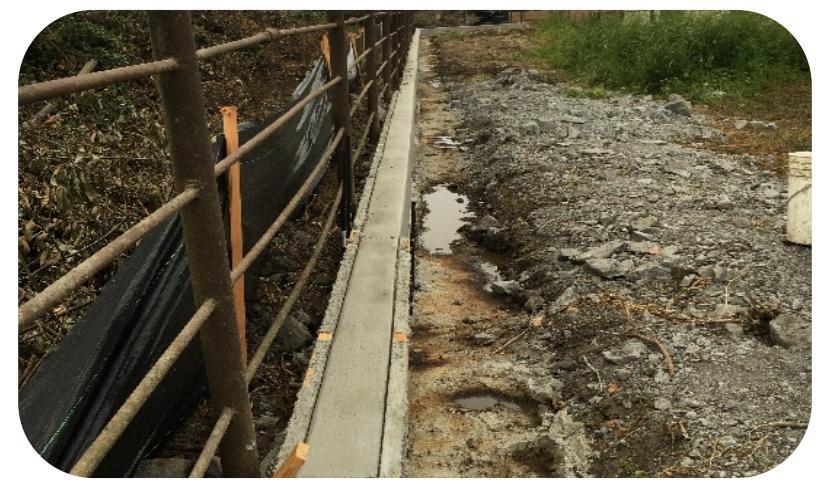
Pouring stand-alone concrete curb along fence line (09/2016).

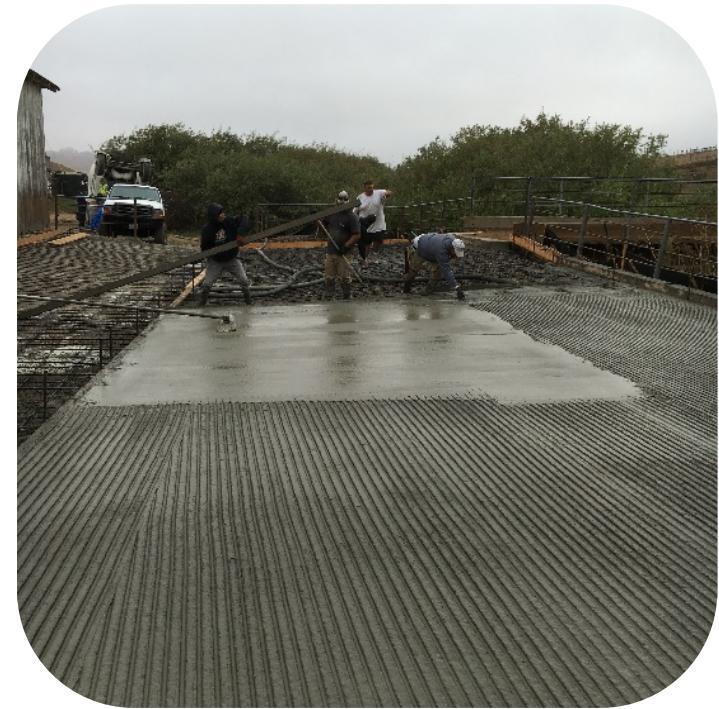
During construction view of pouring and grooving concrete pad (09/2016).

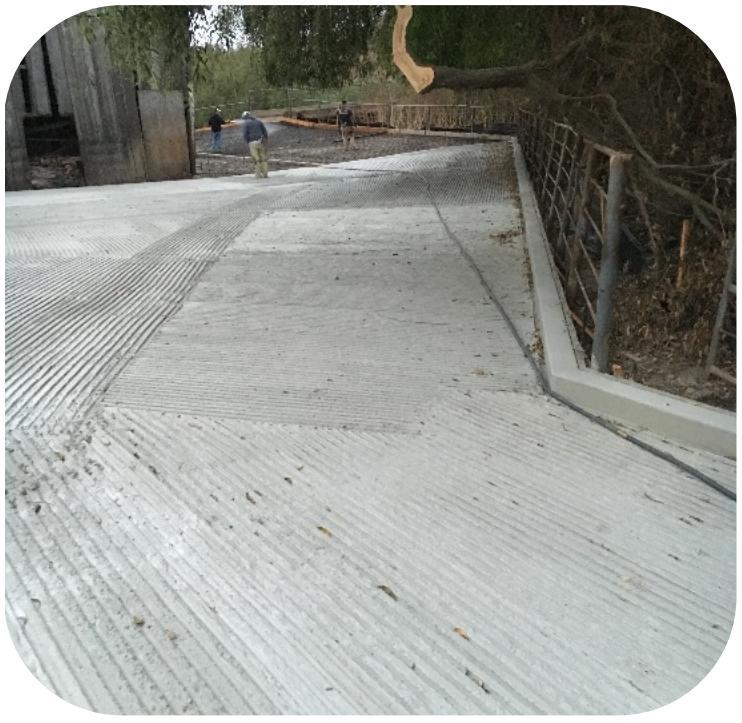
Pot-construction view of the finished grooved slab and curb following concrete pour (10/2016).

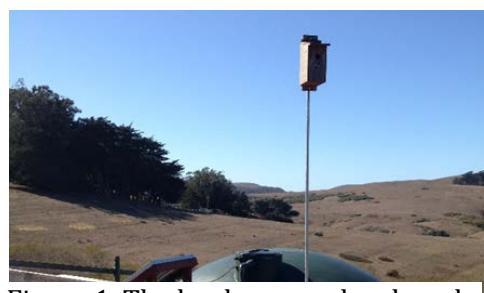
Figure 1. The landowners developed this spring with a tank and solar pump in preparation for the installation of the trough.

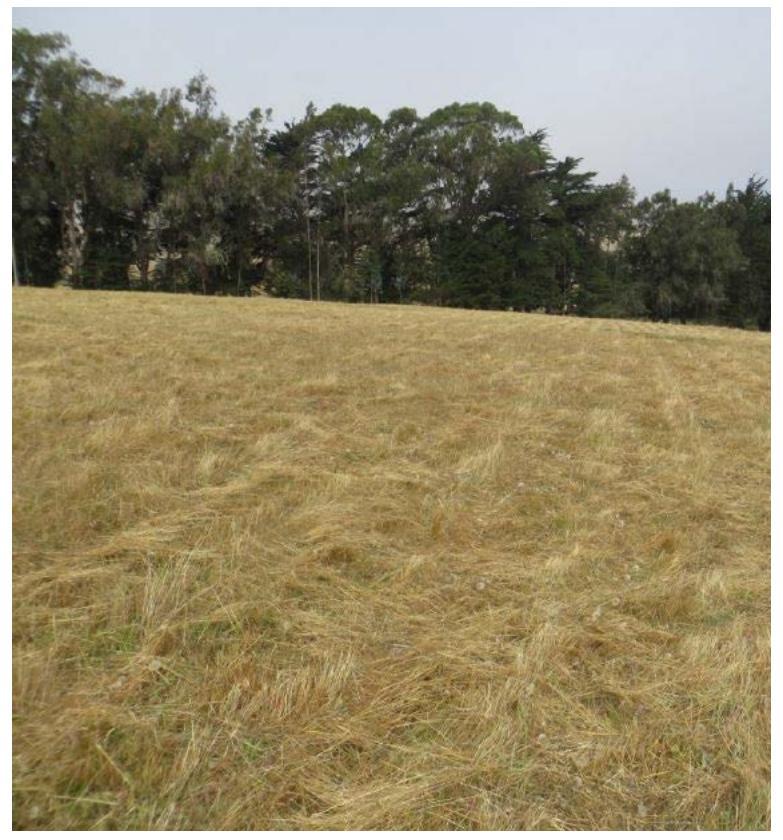
Figure 2. Pre-construction photo of trough location (07/15/16).
