MARIN COASTAL WATERSHEDS PERMIT COORDINATION PROGRAM ANNUAL REPORT 2016-2017

JULY 2017

# Marin Coastal Watersheds Permit Coordination Program

# **Annual Report Executive Summary**

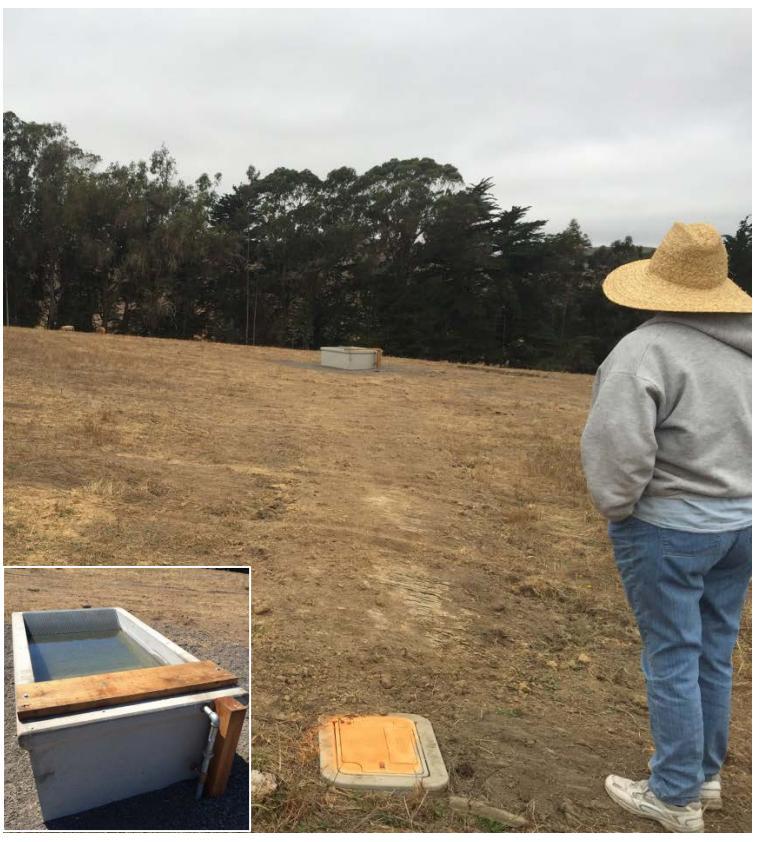
Figure 3. Post-construction photo of trough location (09/22/16).

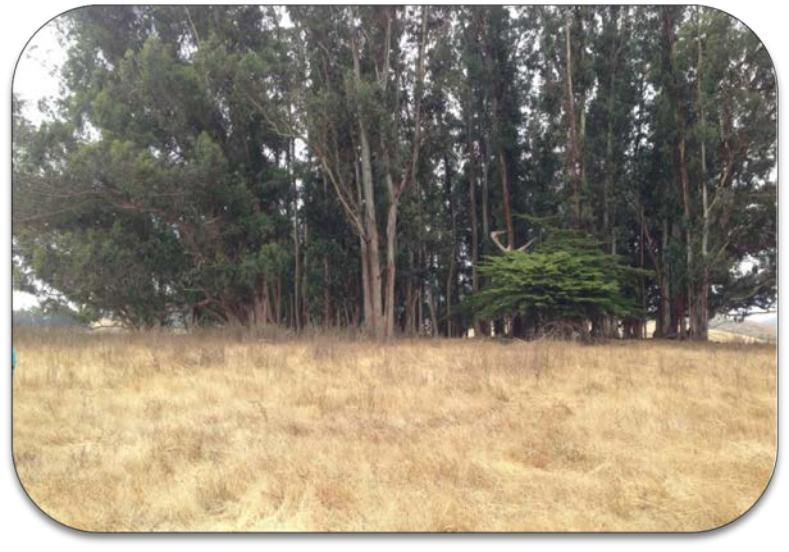
Pre-construction photo of tank location in the upland area north of the tributary to Walker Creek. Photo taken 07/2016.

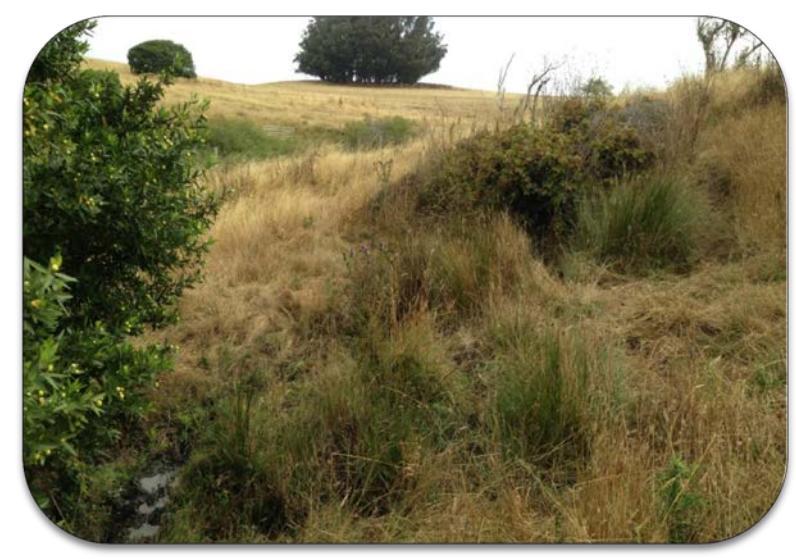
Pre-construction photo of spring development located at the far west side of the tributary. Photo taken before construction in 05/2016.

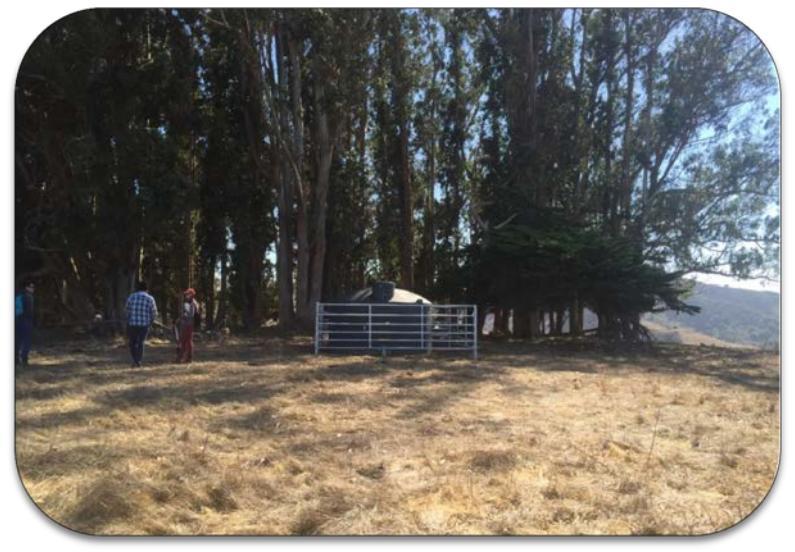
Post-construction photo of tank installed in the upland area north of the tributary to Walker Creek. Photo taken 10/2016.

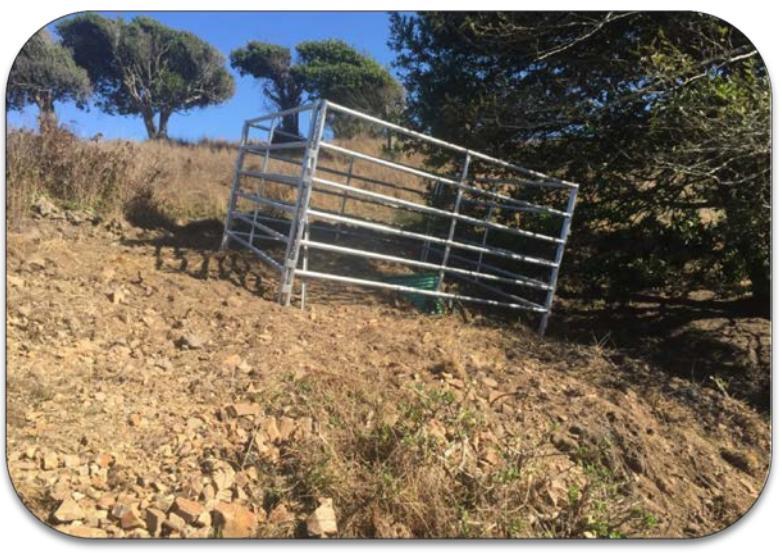
Post-construction photo of spring development located at the far west side of the tributary. Photo taken after construction in 10/2016.

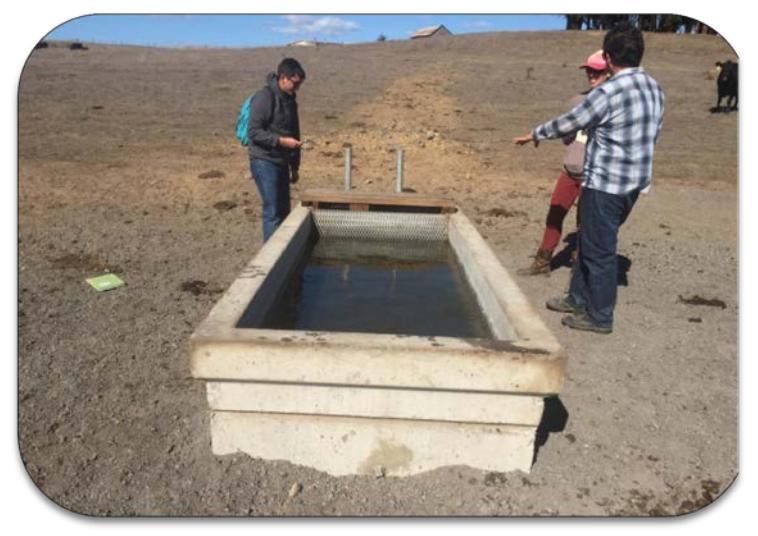
New trough and recently covered pipeline indicated by the line of hay on the ground in the background. Photo taken in 10/2016.

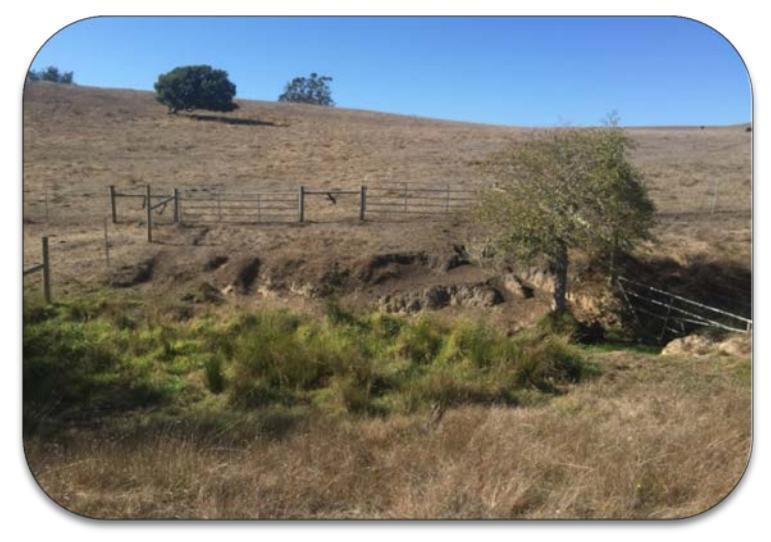
The Walker Creek tributary and the gate system installed for livestock access before the spring was developed. Photo taken in 10/2016.

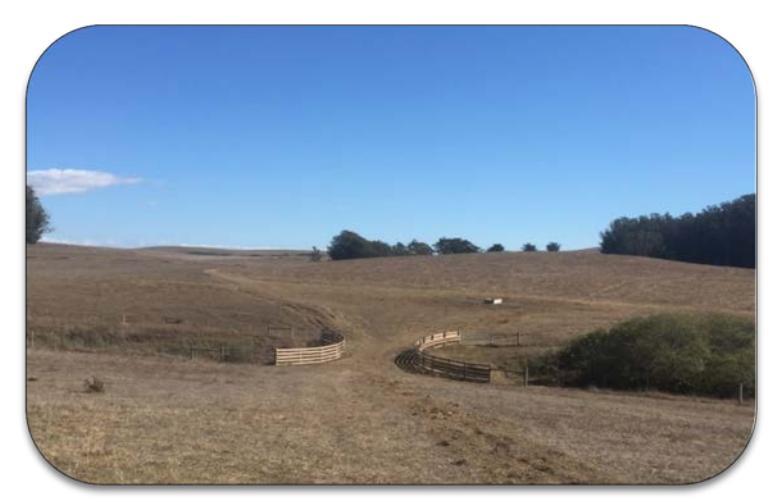
View of crossing over the tributary to Walker Creek and one of the newly installed troughs in the background. Photo taken in 10/2016.

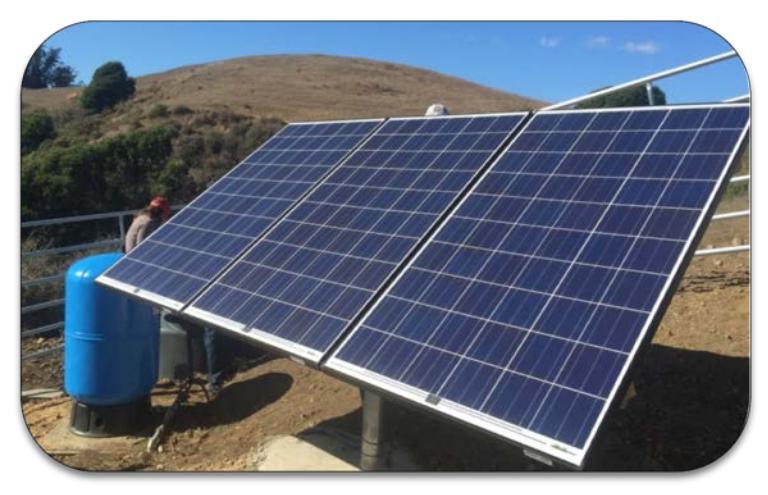
Photo of the installed solar panels and pressure tank used to pump the water from the spring to the tanks in the upland areas. Photo taken in 10/2016.

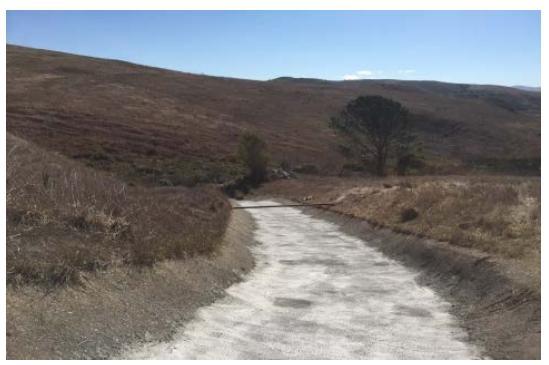
This Project Profile focuses on the management practices implemented through the COW Program; therefore, the spillway repair will not be discussed in detail in this report. The spillway repair (see photo to the right) was completed by the landowner without Marin Resource Conservation District's (RCD) assistance, yet the fix was critical to the overall project.

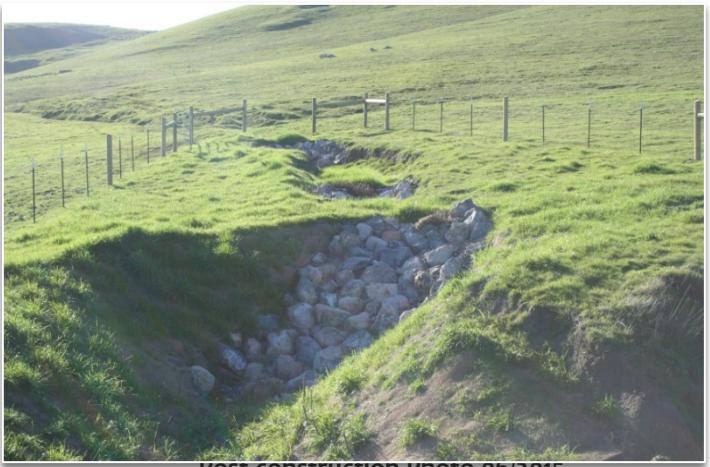
Post-construction Photo 06/2015

Downstream view after construction of the riparian fence, grade stabilization repairs and STRAW plantings of willow sprigs and *Juncus*.

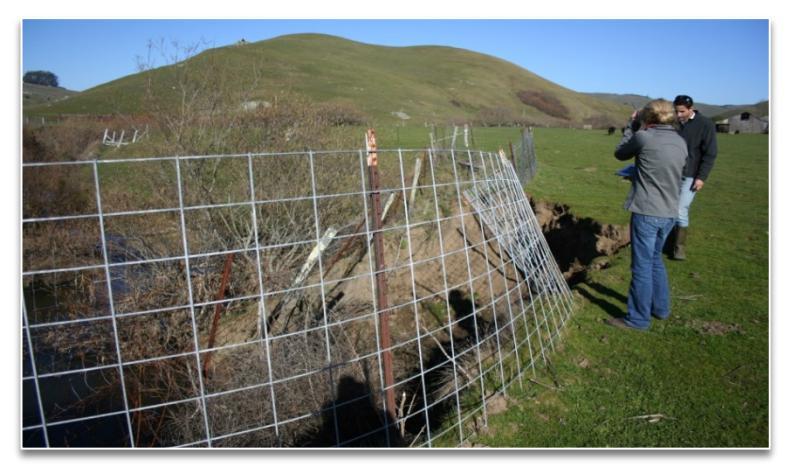
Pre-construction photo of project site area taken from top of bank. View looking down into slump, sidebank erosion before construction.

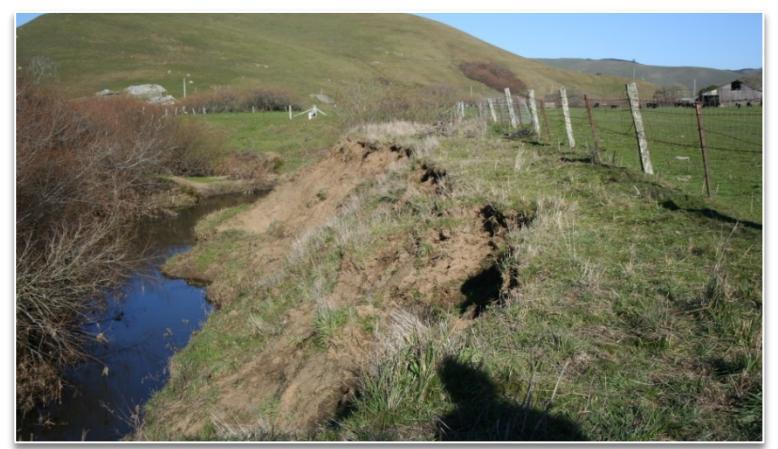
#### Pre-construction Photos 01/2012

Pre-construction photo of project site area taken from downstream. Upstream view of Chileno creek at project site before construction of streambank critical area planting and stabilization repairs.

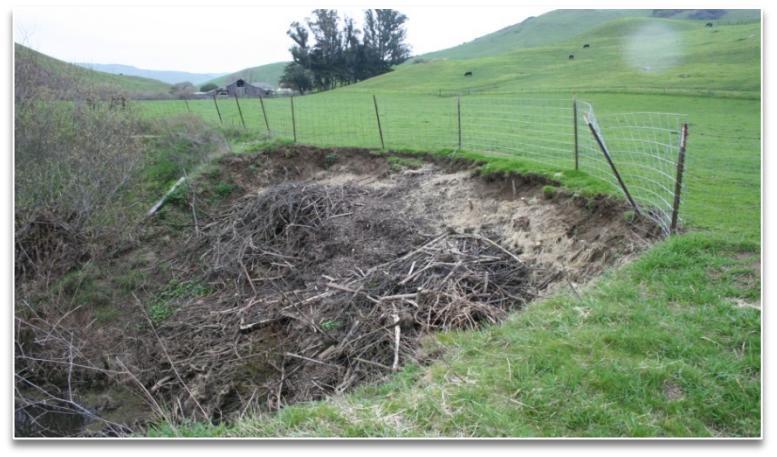
#### Post-construction Photos 1/2015

Post-construction photo of project site area taken from top bank. View displaying critical area planting of willow spig in slump, sidebank erosion.

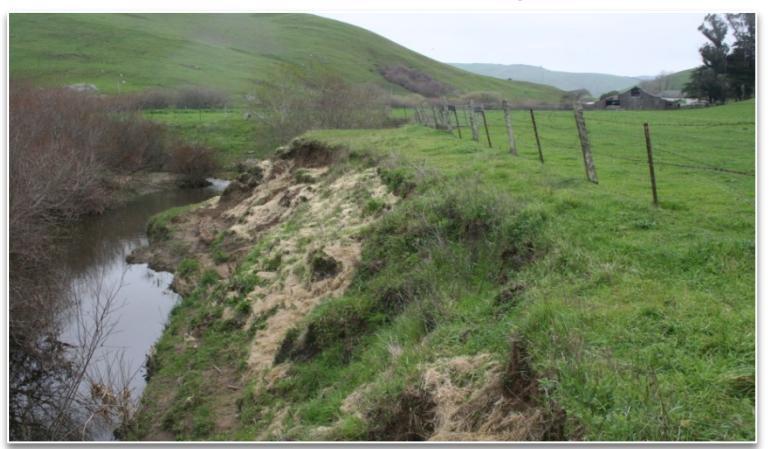
#### Post-construction Photos 1/2015

Post-construction photo of project site area taken from downstream.Project site after construction displaying the streambank critical area planting and the willow wattle streambank stabilization repair in the background.

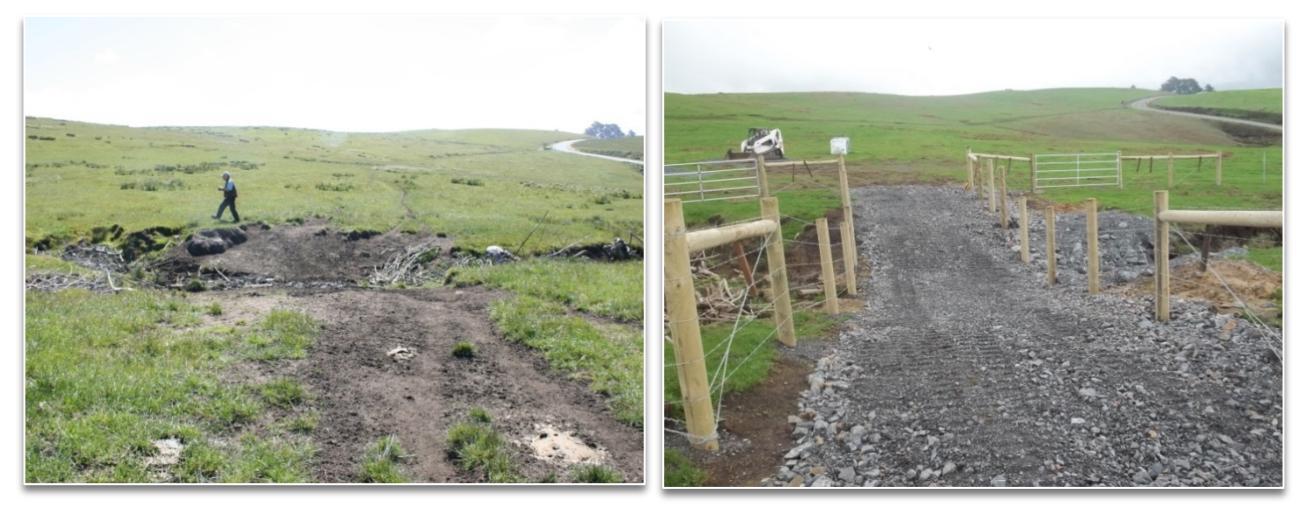
Pre-construction photo of mid- stream degraded stream crossing; view taken from Photo Point fence installation.

Post-construction photo of mid-stream project site one. This image shows the stream crossing and rock armored sidebanks below enclosed by a newly constructed fence line.

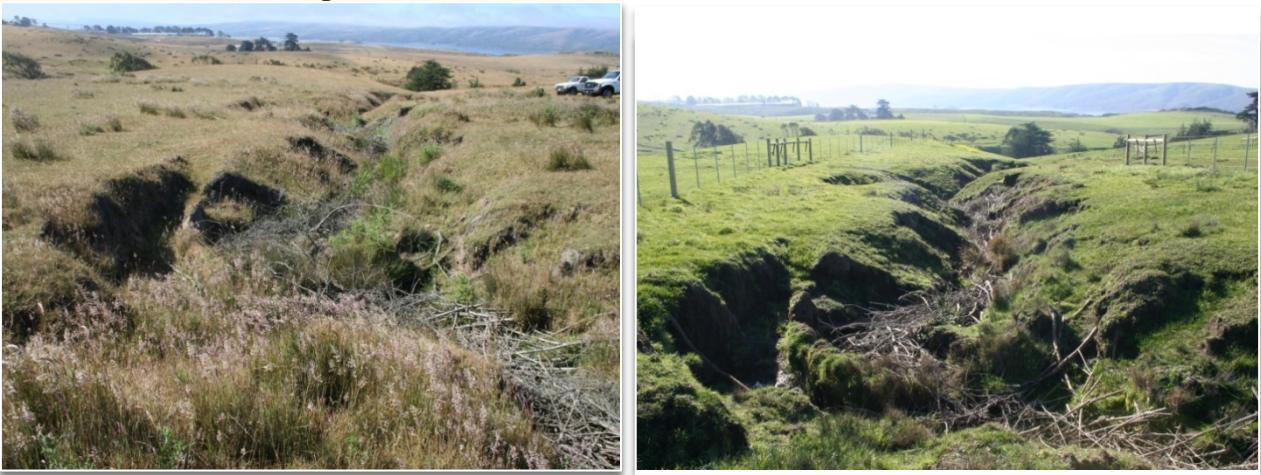
Pre-construction photo taken from a photo point. The image taken mid-stream looking downstream below stream crossing displaying unstable sidebanks from cattle trailing. Post-construction photo taken from a photo point , displaying riparian fencing encompassing the critical area planting.

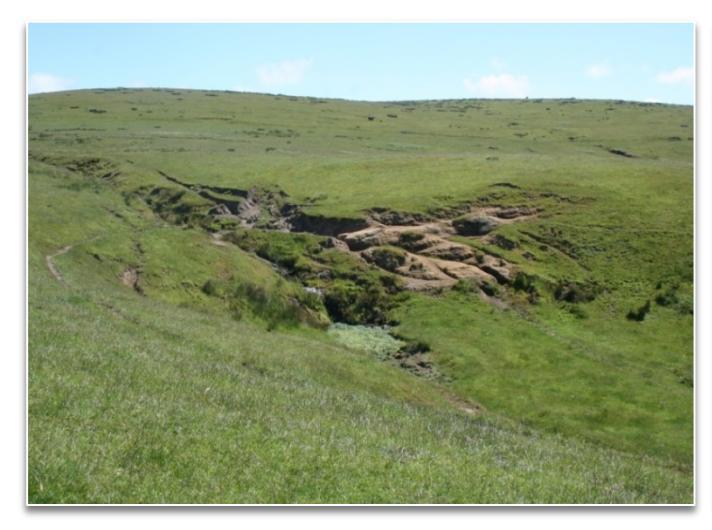
#### Before Project Photos 03/201

Pre-construction photo of landscape view. Project site area prior to construction.

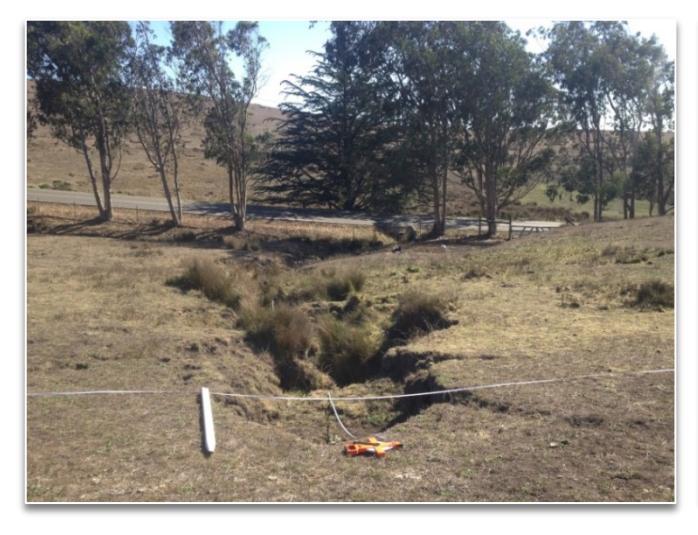
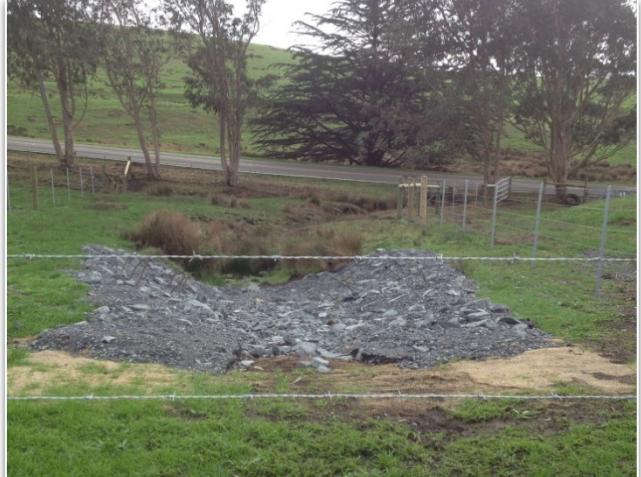
Pre-construction photo of site two taken from top of headcut looking down towards the culvert along Dillon Beach Rd. The photo displays the width and depth of the active headcut. Post-construction photo of site two taken from top of headcut repairs. The photo displays the reshaped rock lined waterway with a wide channel and shallow channel bottom surrounded by riparin fencing.

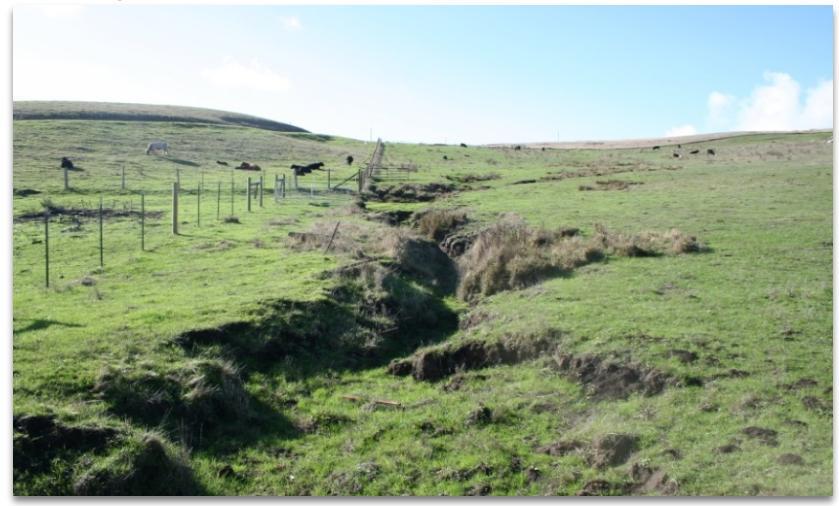
#### Pre-construction Photo 11/2012

Upstream view of western tributary before riparian fence, livestock crossing repairs were installed.

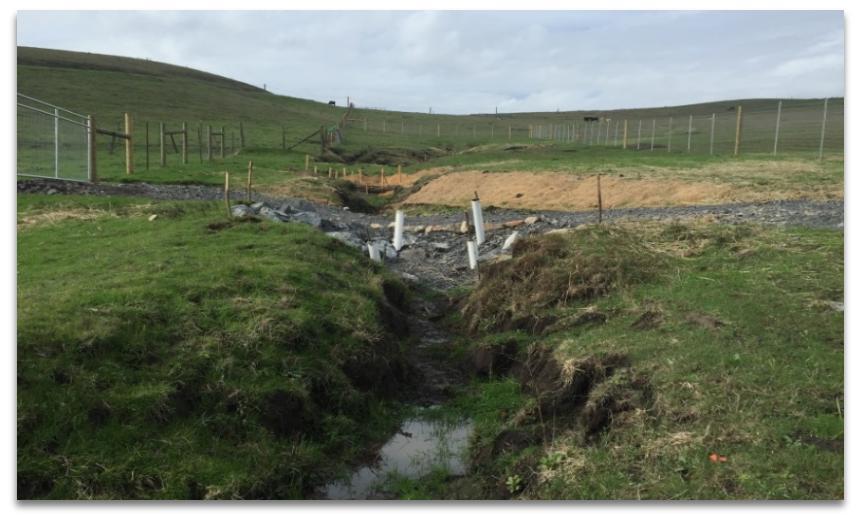
#### Vegetation Survival Monitoring 06/2017

Upstream view of western tributary , photo taken downstream of livestock crossing. Photo displaying dense vegetation and streambank recovery

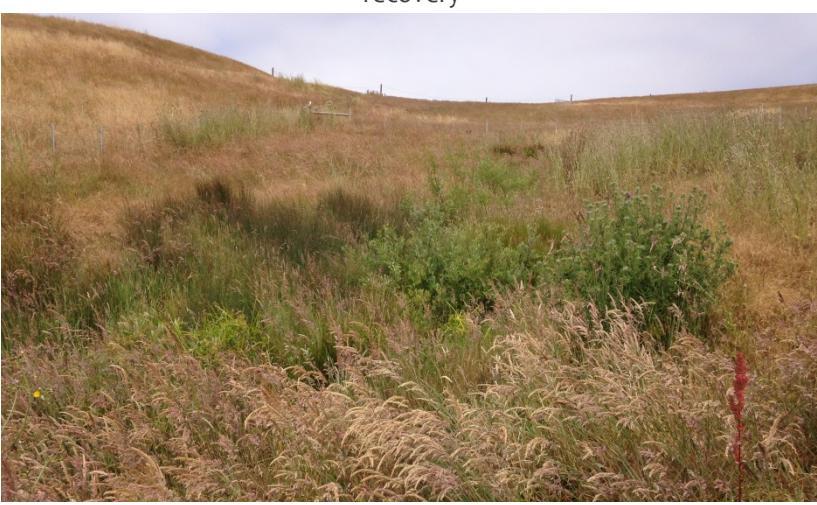
#### Post-construction Photo 11/2015

Upstream view of western tributary after construction of the following practices: riparian, fence and livestock crossing repairs.

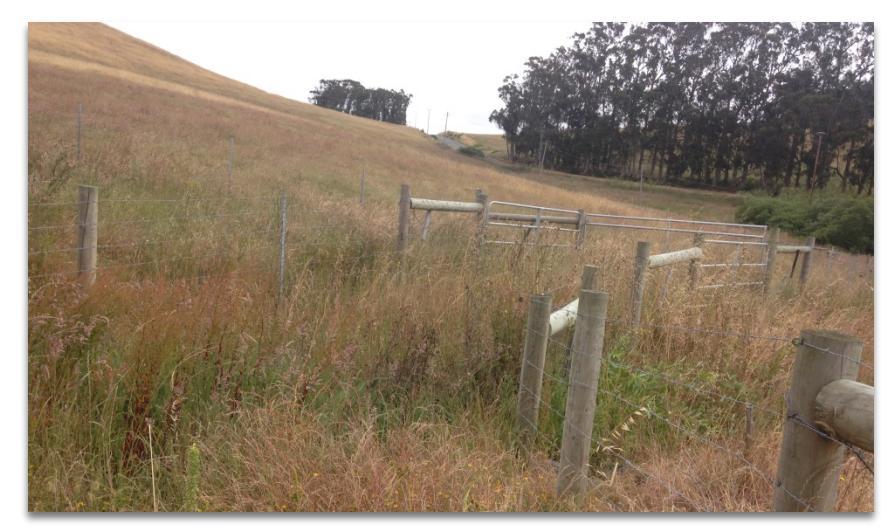
### Vegetation Survival Monitoring 06/2017

View of the livestock crossing through the western tributary, which is barely visible due to tick vegetation

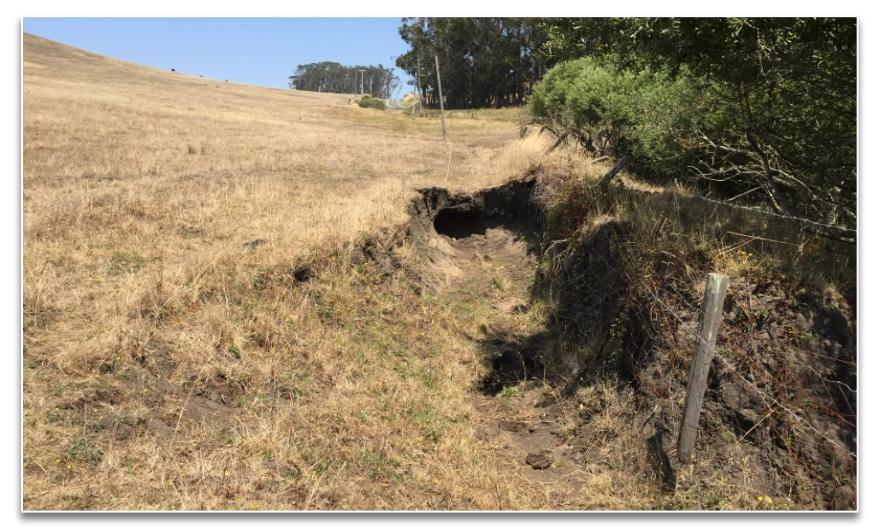
#### Pre-construction Photo 08/2015

Pre-construction photo of the active headcut adjacent to the berm before construction above Tomales Creek.

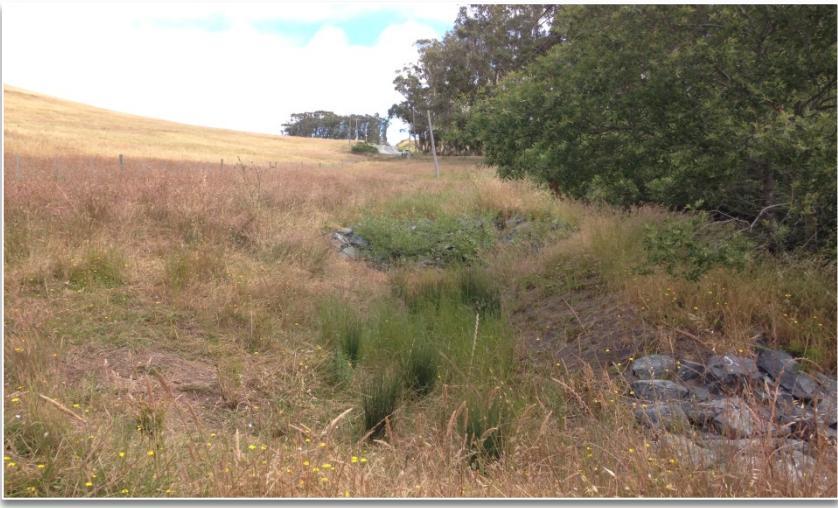
Vegetation Survival Monitoring Photo 06/2017

Vegetation Monitoring photo displaying headcut repairs tieing into the drainage swale surrounded by the regrowth of the willows and juncus.

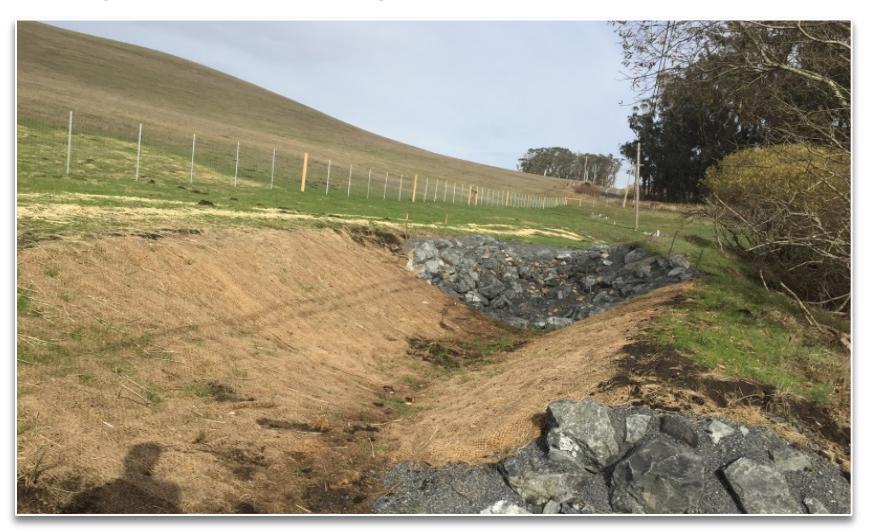
#### Post-construction Photo 12/2015

Post-construction project photo displaying headcut repair tieing into the drainage swale and and fencing .

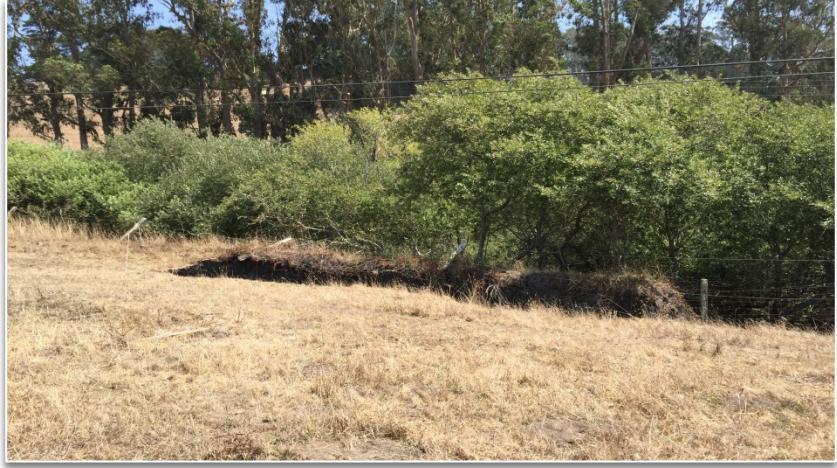
#### Pre-construction Photo 08/2015

Project site before construction showing the headcut and erosion along side and then curving into Tomales Creek.

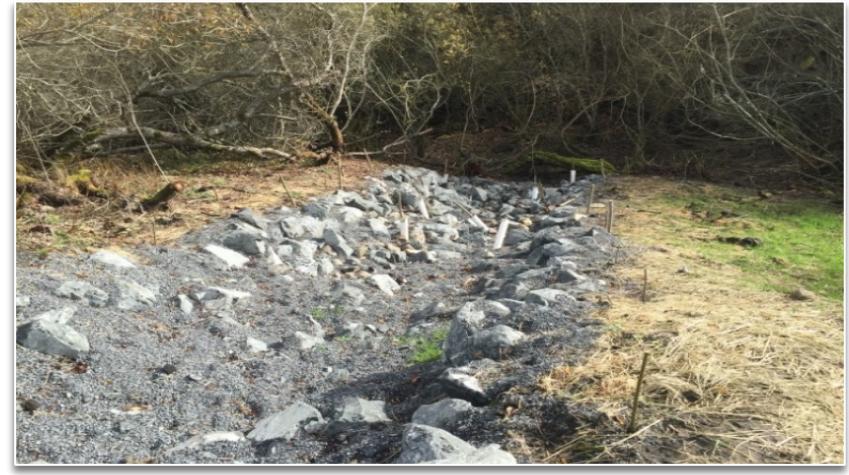
### Post-construction Photo 12/2015

View after construction of the rock channel headcut repair and STRAW plantings of willow sprigs.

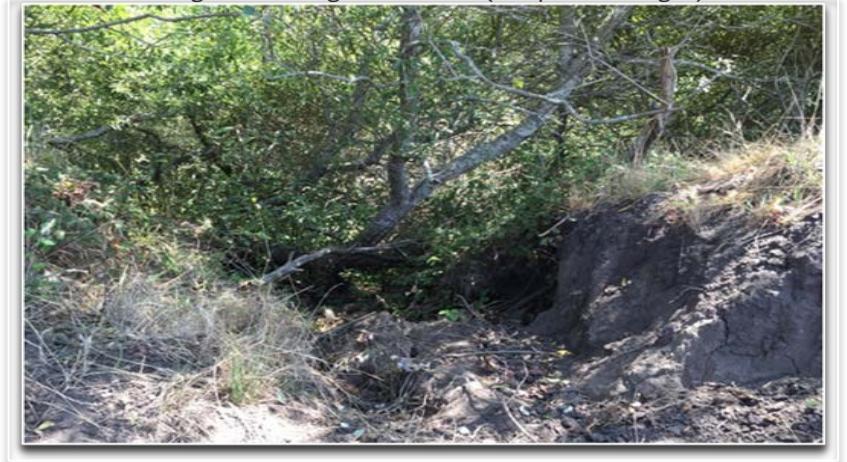
#### Pre-construction Photo 08/2015

View of the waterway curving into Tomales Creek due to headcut forming on the rangeland above (see photo to right).

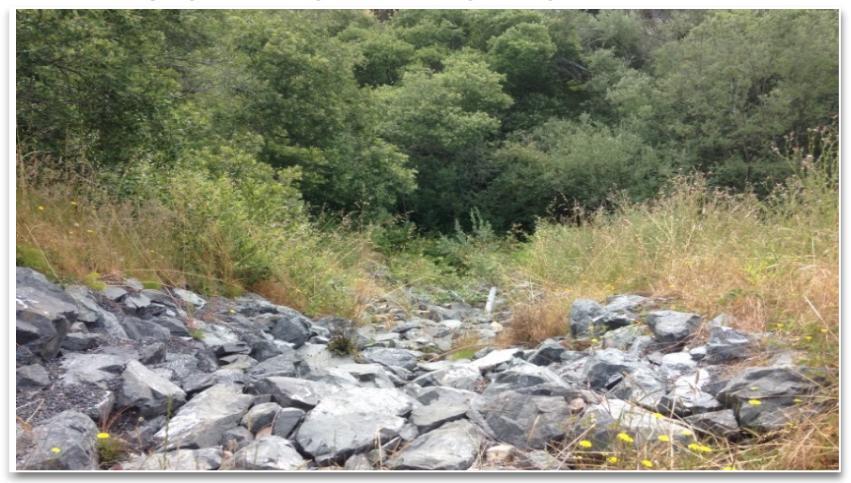
#### Vegetation Survival Monitoring 06/2017

Looking down the rock channel repair, vegetation survey monitoring documenting vigor and height of plantings along the stream.

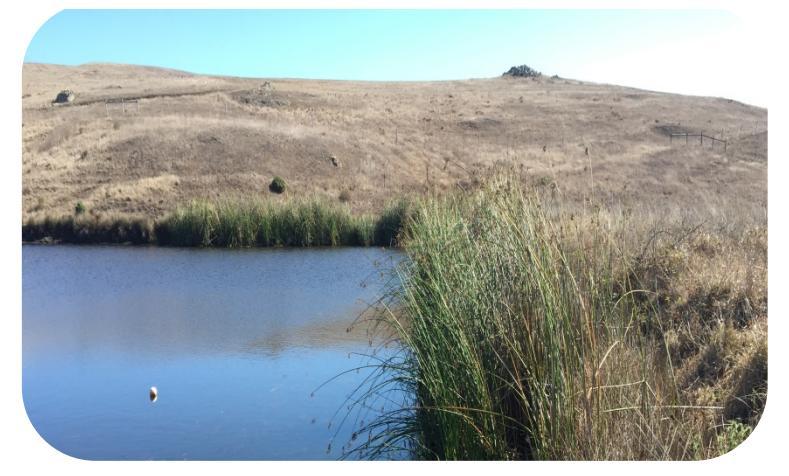
Pre-construction photo of the water development (10/2015)

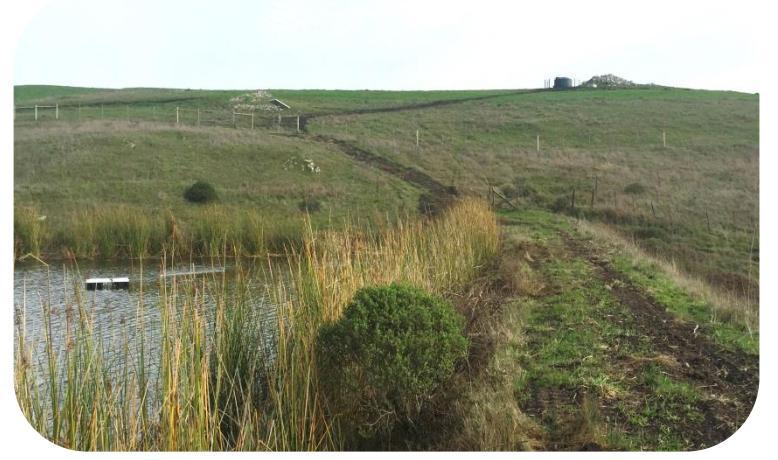
Post-construction photo of solar panel, tank and trough (12/2016). Only the tank is easy to locate near the rock outcropping at top of the hill.

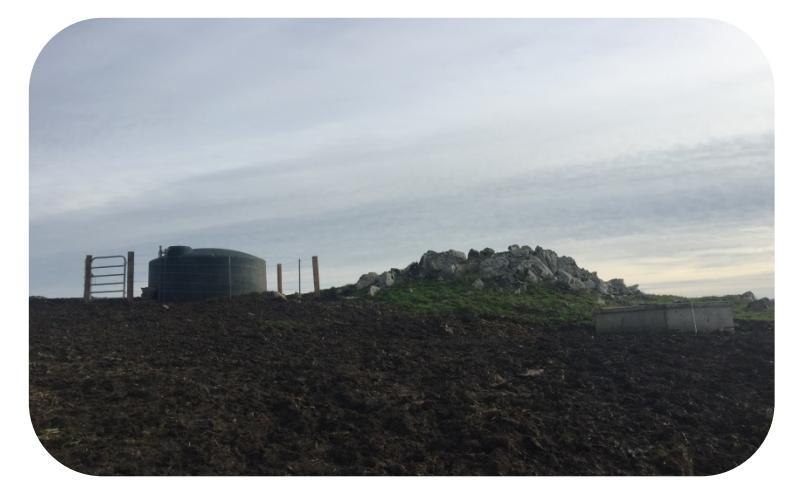
A close up post-construction photo of the tank and trough taken (12/2016).

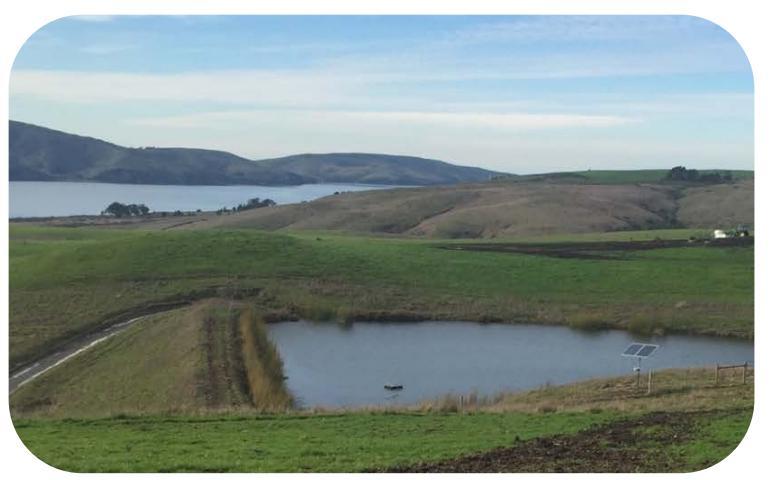
View of upper pond and spillway (to the left) with Tomales Bay is in the background. The new solar panel is on the right side of pond (12/2016).
