A Half Century of Stewardship: programmatic review of conservation by Marin RCD & partner organizations (1959-2009)

Marin Resource Conservation District
P.O. Box 1146, Point Reyes Station CA 94956
(415) 663-1170, <http://www.marinrcd.org/>

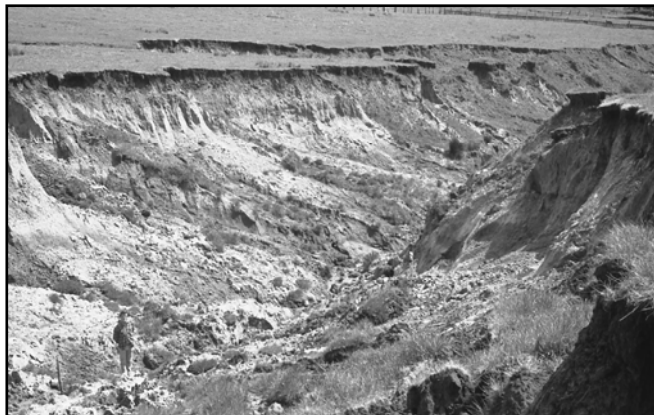
Stopping gully erosion like this was a motivation for forming the Marin RCD.

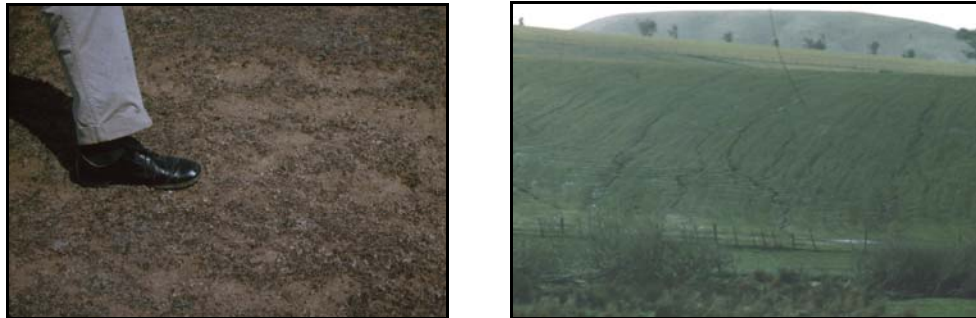
Figure 15: NRCS and Marin RCD educational material from the 1960s depicting examples of sheet erosion (left) and rill erosion (right).

Pasture Seeding is an integral component for minimizing the potential for sheet and rill erosion by maintaining greater than 60% cover (Singer et al. 1982) while enhancing productivity in pastures, rangeland or hay and silage fields (Bartolome et al. 2006). In 1961, Marin RCD purchased a Brillion pasture seeder to encourage seeding with appropriate technology. It was rented to landowners for ten years and donated to Tomales High School in 1971. In 1991, Marin RCD purchased a no-till drill which is still available for rent along with a soil aerator. The no-till drill seeder is an important tool in providing alternative options for pasture management. A technology transfer has slowly occurred as dairy operators recently purchased their own equipment after learning the improvements created by Marin RCD's no-till drill.

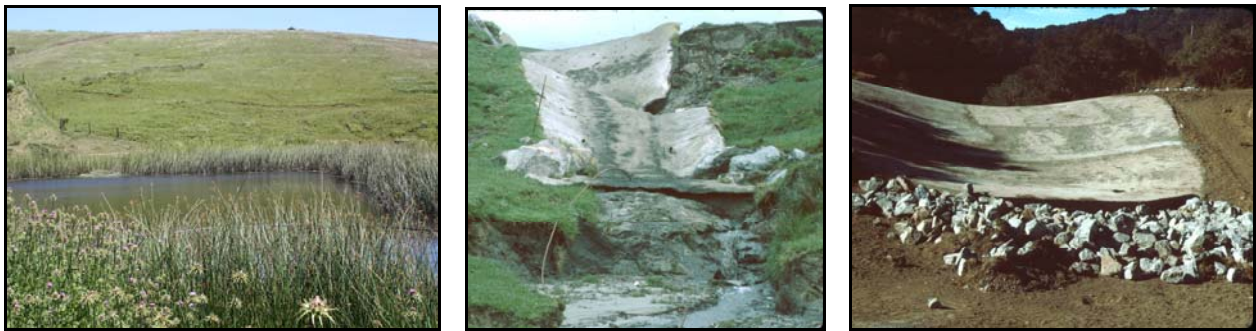
Figure 16: An example stockpond providing a critical source of clean water for ranch operations (left), failed spillway undermined by erosion caused by subsurface piping (middle) that was repaired by NRCS in 1985 and continues to function today (right). Photos by NRCS.

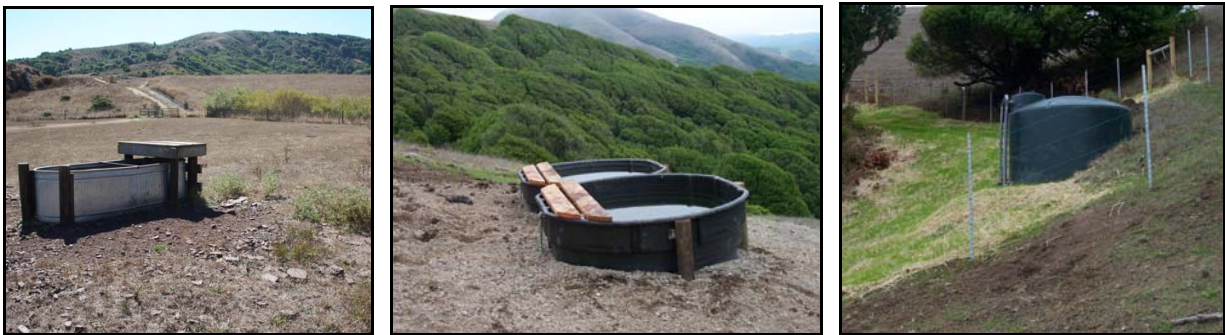
Figure 18: Watering facility examples in a flat combined with control fencing of the stream in background (left), and two troughs and tank combined with spring development (middle, right).

include both water troughs and tanks to help maintain water pressure within a system that consistently delivers water (Figure 18). This practice provides clean water for livestock that improves animal health, productivity and distribution as well as reducing erosion. This often entails placing water troughs on ridge tops in combination with feed racks and molasses, salt, Magnesium or other supplements to reduce livestock traffic in or near streams. Recent research has shown that meeting livestock water and supplement needs away from the stream reduced livestock time in the stream corridor and therein the risk of nonpoint source pollution while improving aquatic habitat in the stream (Tate 2011, George et al. 2007). Often these practices are implemented as the first step toward improving a degraded stream, followed by exclusionary or control fencing if necessary.

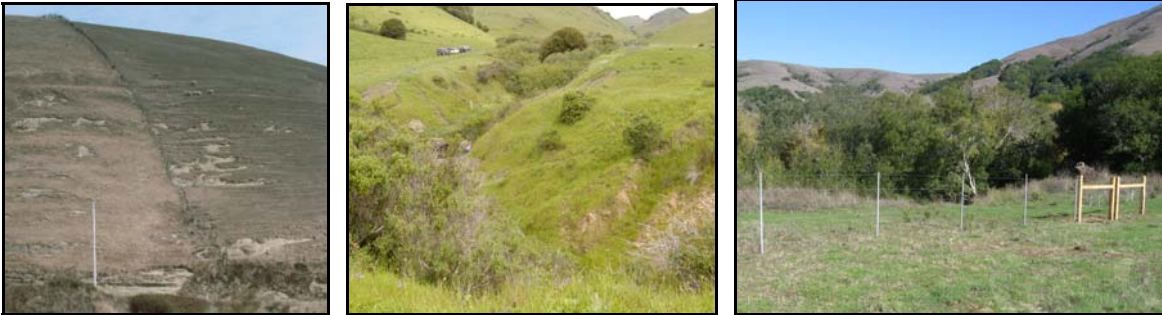
Figure 19: Examples of how fencing has been used to reduce erosion from uplands hillsides by subdividing pastures to change livestock distribution near unstable or sensitive areas (left), small gully tributaries (middle), and lowland floodplains with a new design where a small section is easily removed prior to flooding (right).

Fences are critical to ranch and livestock management and were one of the first practices planned by NRCS and Marin RCD (Figure 19). The 524 fences completed a total of 726,626 linear feet (137 miles) and were all designed to subdivide pastures or rangeland as cross-fencing (Figure 20, Table 4) with perimeter fencing excluded. This

infrastructure was an important component of conservation, prescribed grazing, and erosion control plans. A well planned fence can have numerous positive outcomes such as increased productivity, reduced soil erosion, and easier herd management. Considerable thought is given to avoid confining animals or creating new livestock trails unintentionally. About 32% of the total fencing was used to control or exclude livestock access to streams, gullies, wetlands, or other waterways for 228,432 feet (43 miles) in Marin County (Figure 26, Table 6 on page 44). Wildlife friendly and electric fencing are now commonly utilized and flood-friendly fencing is a current challenge.

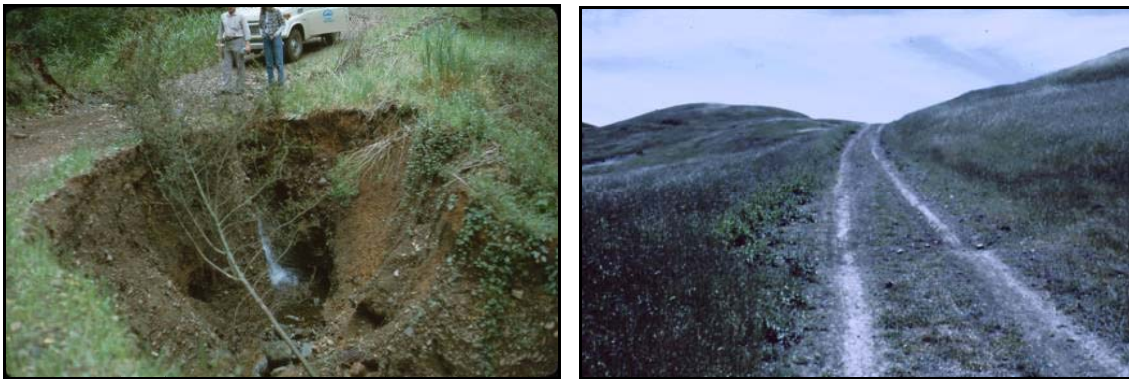
Figure 21: Examples of ranch road maintenance implemented in Lagunitas Creek Watershed following the 1982 flood in cooperation with Marin County Fire Department showing extensive erosion around a culvert outlet (left), and an upgraded road with out-sloped grade and water bar (right).

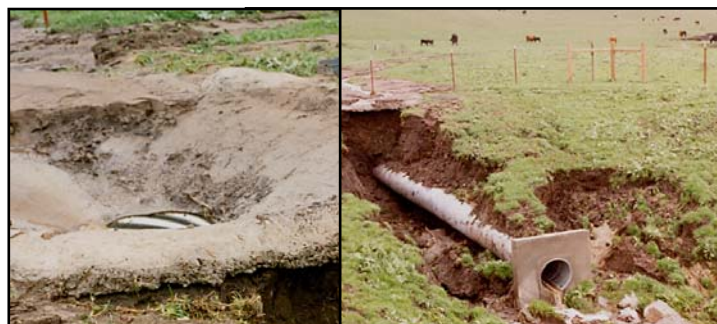
Sediment plugged inlet caused failure of Water Control Structure.

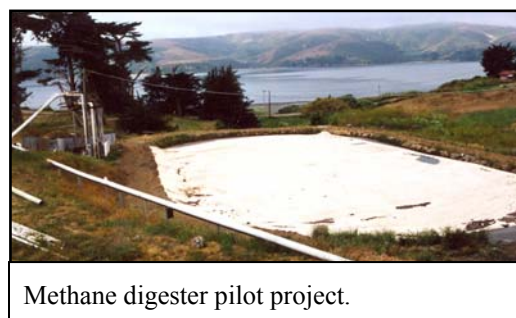
Methane digester pilot project.

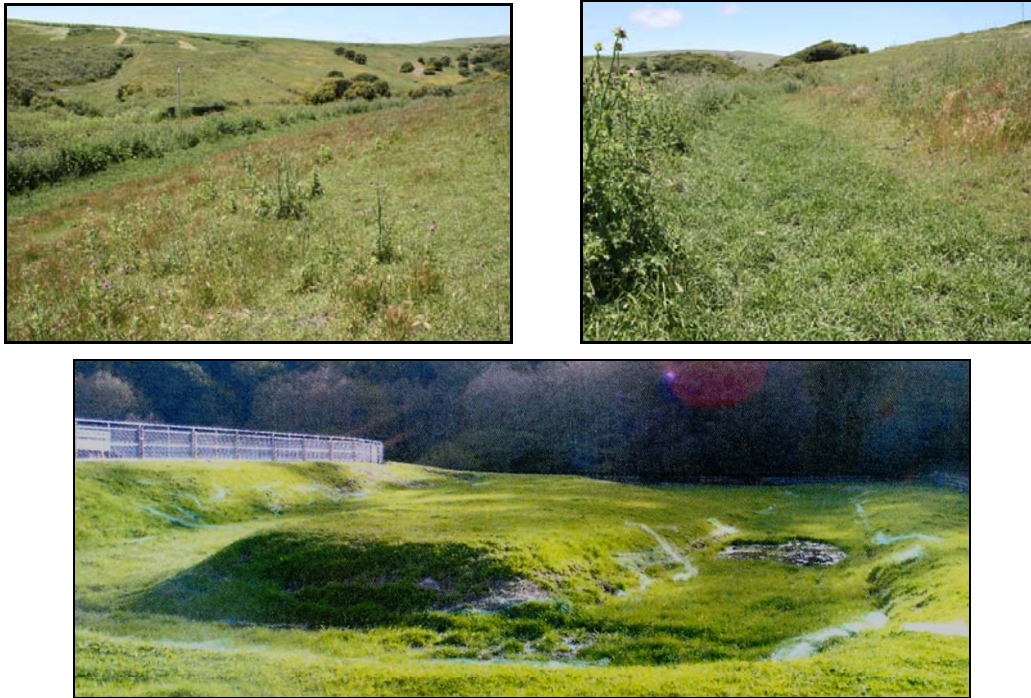
Figure 23: Examples of Filter Strips to treat surface water runoff from corrals depicting an overview of a hillside site with over 400 feet of laminar flow conditions following the contour (top), and a flat bottomland location where the site's treatment distance and laminar flow conditions were maximized (bottom). Designed by NRCS.

Filter Strips are wide ditches that maximize laminar flow conditions designed to collect sediment and filter pollutants from small drainages within the ranch or farm, such as stormwater runoff from corrals or dry lots. This practice was historically implemented to filter wastewater as an alternative to waste management systems. In cases where herd size grew, treatment capacity was often overwhelmed by the increased supply of manure. Marin RCD and partners have responded to these changing capacity requirements and challenges to installation at specific locations in order to provide maximum length with appropriate gradients on hillside and lowland locations (Figure 23). Filter strips provide an ideal option for high functioning vegetative buffers to reduce pathogens in stormwater runoff (Lewis et al. 2010, Lewis et al. 2009, Tate et al. 2006, Tate et al. 2004).

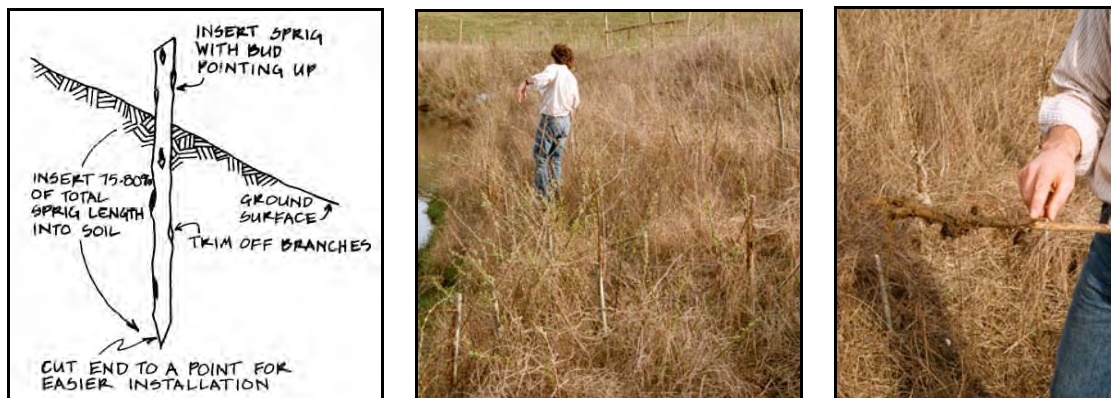
Figure 24: The specification for planting a willow cutting or sprig and surveying a newly planted site with some rabbit damage in 1988 (top). Design and photos by Prunuske Chatham, Inc.

Critical Area Planting incorporated revegetation technologies using willow that were tested in the 1960s and 70s to fix gully erosion by Marin landowners with the assistance of NRCS. In the 1980s, willow became regularly incorporated into Marin RCD practices as soft approaches that allow for shifting and settling of soil, but provide for long-term site stability (Figure 24). This includes tree planting as cuttings, sprigs or poles and “bioengineering” or “biotechnical” specifications of high density willow woven into a wall, mattress, wattle, or brush layer as living checkdams or headcut repairs as described in *Groundwork* (Prunuske 1987). These soft approaches to channel stabilization and streambank protection have been improved upon over the last 30 years by Marin RCD and its partners to now offer an effective, low cost option that has proven successful in Marin County conditions.

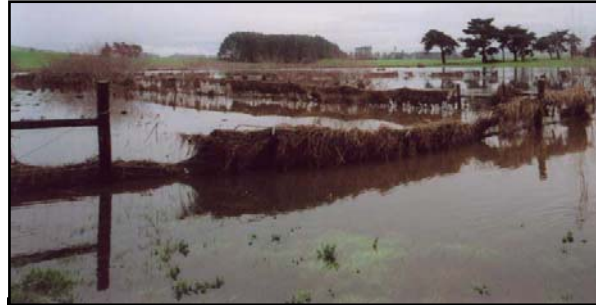
Debris trapped by fence in lower Stemple Creek following large storm. Photo by STRAW.

Fencing of waterways equals 43 miles and increased since 1989 (Figure 26) following early lessons at erosion control project sites where project success was less than expected or threatened due to uncontrolled livestock access. The fence location was originally placed near the stream in order to maximize pasture area and reduce the amount of grazing land lost. However, this led to failures when the streambank slumped during extreme flood years and weeds may be worse where vegetation management was not possible. As a result, control fences currently designed are placed back from the stream to maintain options for management within the riparian corridor for the landowner. Lowland areas such as Stemple Creek are particularly troublesome because fences in the floodplain collect debris during large flood events and require maintenance. Current challenges include how to establish trees and shrubs along streams for landowners with reservations about invasive weed species and long-term maintenance.

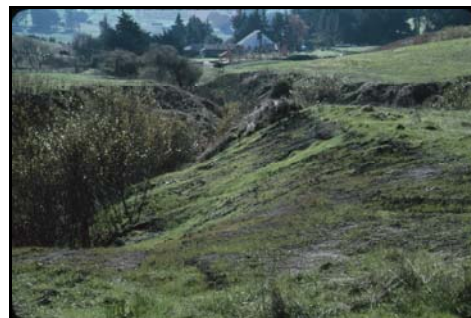
Figure 27: Some of the “worst erosion in Marin County” inherited by a new landowner in the Walker Creek Watershed when channel stabilization and revegetation began in 1970 in addition to removing cattle from the property (top left), nine years later streambanks are clearly more stable with trees establishing (top right), the project leader posing with successful plantings (bottom left), and 35 years later the gully is completely stable with diverse habitat including arroyo willow, shining willow, red alder and numerous shrub species (right). Designed by NRCS.

Channel Stabilization and control of gully erosion processes have been an important part of sustaining water quality and sustainable agriculture in Marin County over the last 50 years (Figure 27). This practice came into use during the 1970s to address large existing gullies, and became a widespread practice during the 1980s to effectively transport rain water off agricultural land with minimal topsoil loss or sediment transport (Figure 26). Unstable gullies and channels contain headcuts indicative of future erosion potential so locating and fixing them before they cross a stability threshold and unravel into larger gully systems has been a focus of Marin RCD and its partners with over 133,120 feet (25 miles) of channel stabilized including 668 Grade Stabilization Structures and 472 headcut repairs implemented (Table 6).

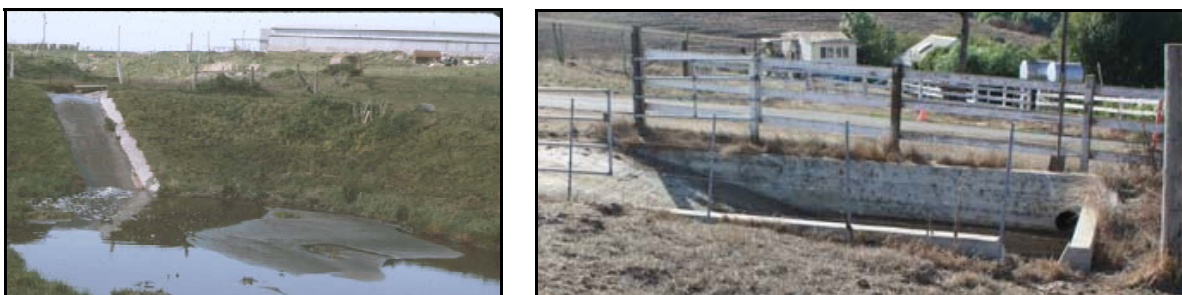
Figure 29: Examples of Sediment Basins depicting a large-scale design constructed in the 1980s (left), and a smaller version with a paved access ramp to facilitate maintenance built in 2005 (right).

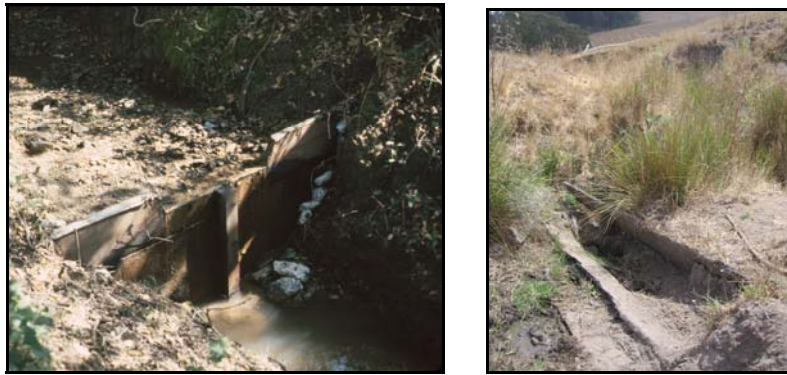
Figure 30: Examples of redwood board checkdams used as Grade Stabilization Structures with a recently constructed site in the 1980s (left), and a 30 year old site with deteriorated checkdam but vegetation such as *Juncus* has stabilized potential soil erosion (right). Designed by NRCS and Prunuske Chatham.

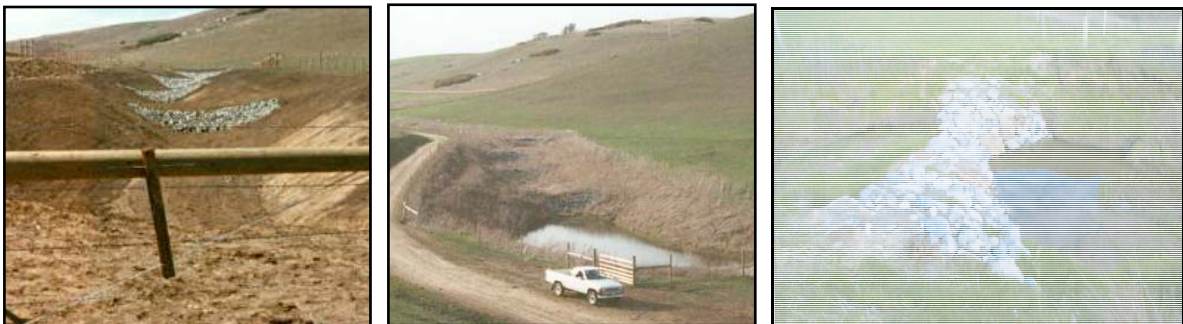
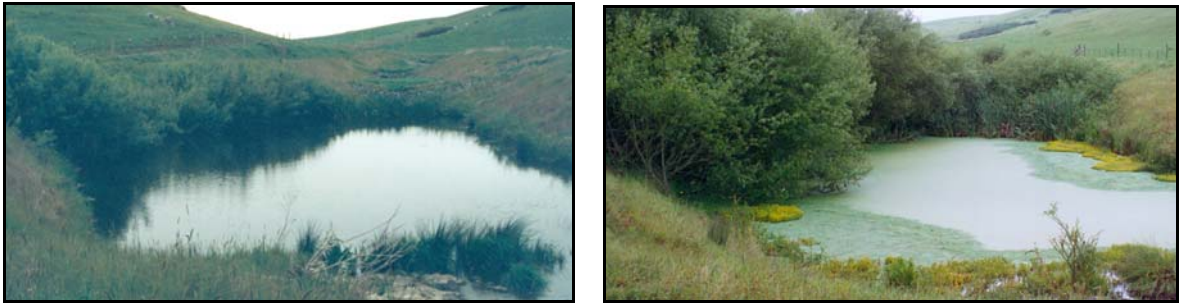
Figure 31: A series of seven small Grade Stabilization Structures were installed in the gully as loose rock checkdams above a Sediment Basin in 1989 with preproject photo (top left), aerial view design (top right), immediately following construction (middle left), the site two years later (middle), checkdam structure functioning as designed (middle right), four years (bottom left), and six years later (bottom right). Designed by Prunuske Chatham and NRCS.

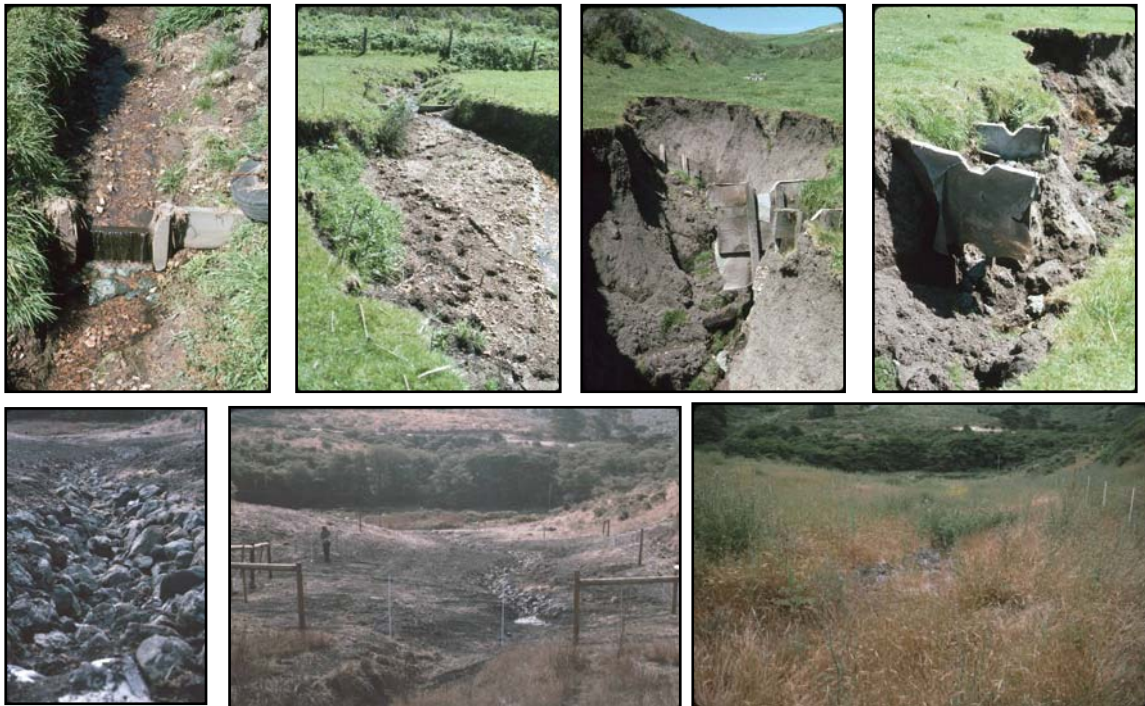
Figure 32: Photo monitoring of a grade stabilization project with functional redwood board checkdams before March 1986 storms (top left 2 photos), following March 1986 storms (top right 2 photos), the emergency repair installed a Lined Waterway with control fencing (bottom left 2 photos), and one year later in June 1987 (bottom right). Designed by NRCS.

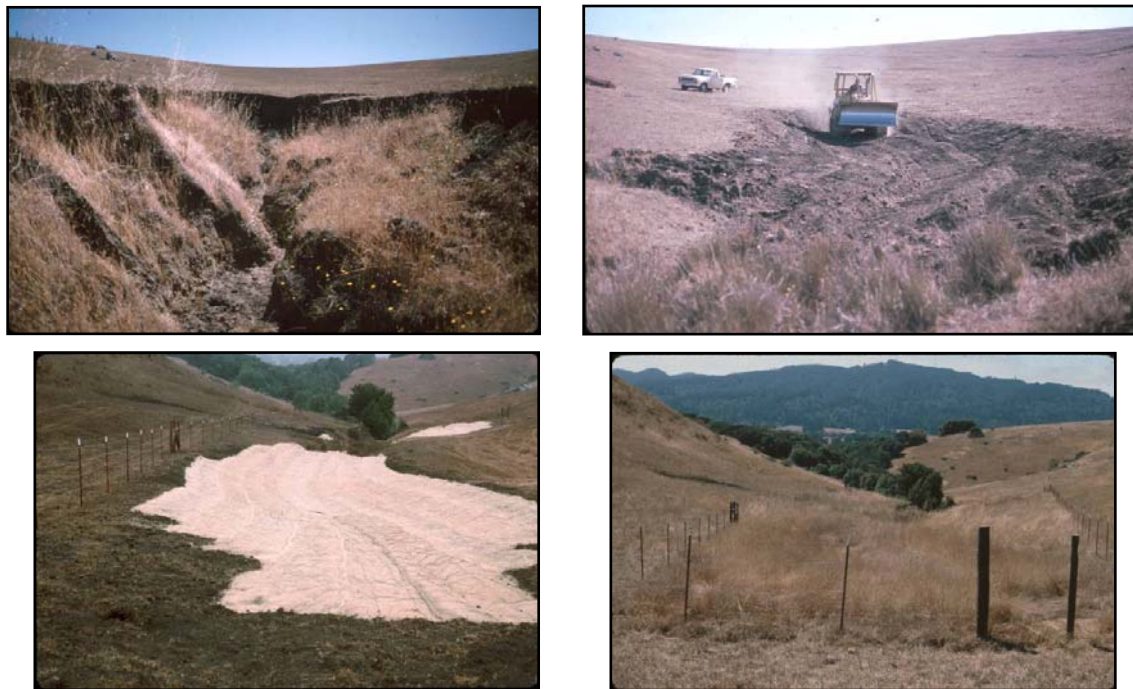
Figure 33: A Grassed Waterway practice installed in Lagunitas Creek Watershed in 1988. Designed by NRCS.

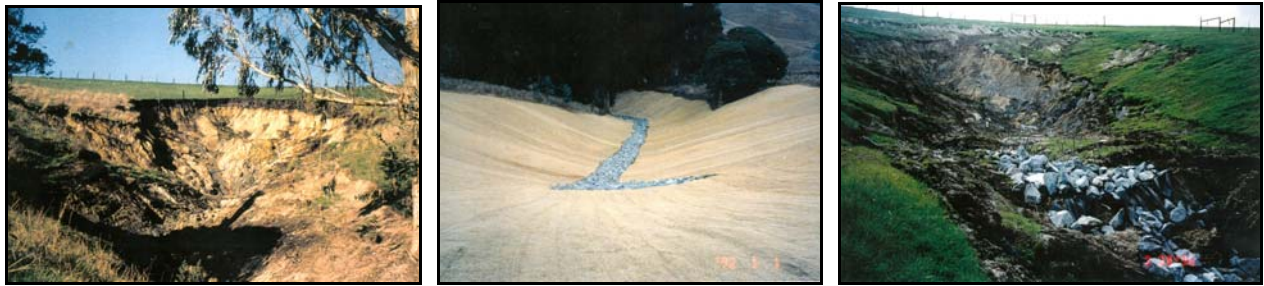
Figure 34: An eroding gully pre-project (left), after implementation of Lined Waterway and other practices in 1992 (middle), and four years later the site had unraveled (right).

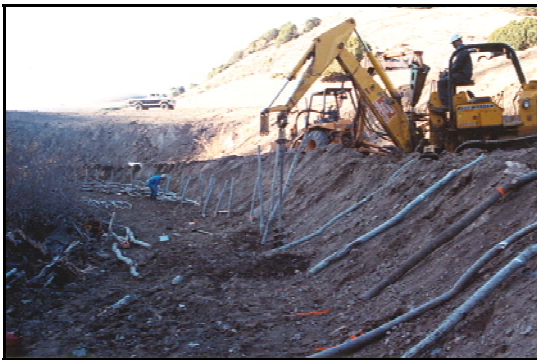
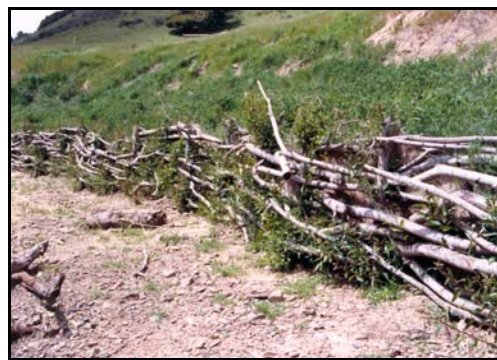
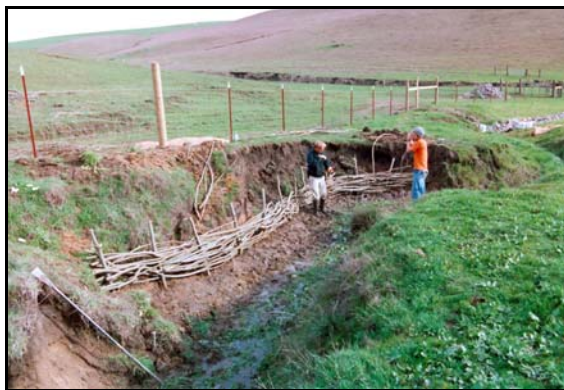
Figure 36: An example of the first willow walls constructed in 1990 in the Walker Creek Watershed (top), another later example constructed in 1994 (middle left), a recent design specification (middle right), and a recently constructed willow wall stabilizing the streambank toe below a threatened ranch road with willow fascine and revegetation using native grass seed, sedge/rush plugs, and shrubs in 2008 (bottom). Designs by Prunuske Chatham, Inc.

On smaller streams with less erosive power, completely soft approaches to streambank stabilization such as willow walls were also developed during the 1980s by Marin RCD and its partners. This technique has been perfected iteratively through the 1990s to offer the Streambank Stabilization practice a completely soft approach applicable to most creeks in Marin County. Since 2000, willow walls (Figure 36), willow revetment, willow wattles and brush mattresses were further adapted to repair larger unstable streambanks (Prunuske et al. 1987, PCI 2010). In total, over 78 willow biotechnical treatments have been installed totaling approximately 3,157 feet. Lessons learned include using straight and pliable branches, tying them down together, and completely backfilling soil behind willow walls. Today, Marin school children commonly construct willow walls under the supervision of STRAW, Prunuske Chatham, Inc. and Marin RCD.

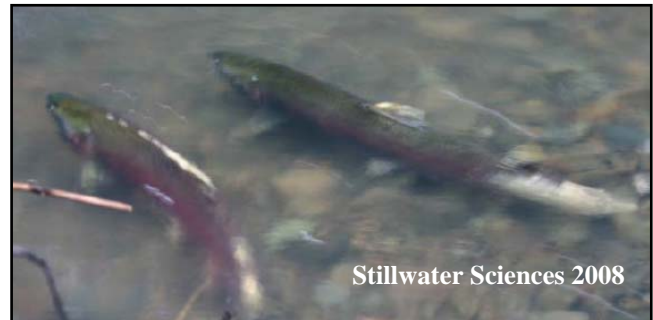
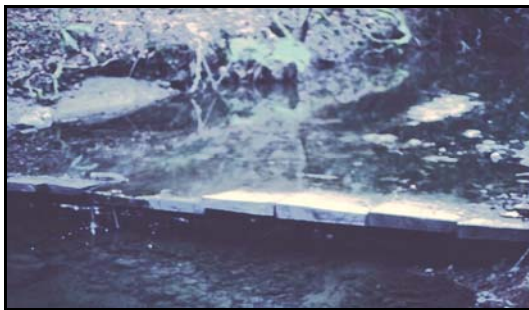
Figure 37: The first Stream Channel Improvement practice used a “Hewlett Ramp” design to confine high flows that scour deeper pools to improve habitat for steelhead and coho salmon. Designed by Prunuske Chatham, Inc and Trout Unlimited.

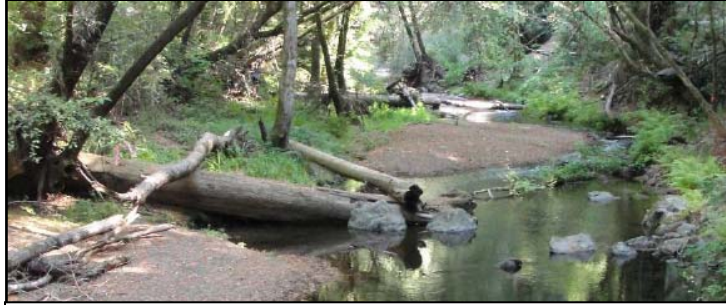
LWD placed in Lagunitas Creek by MMWD.

- Creek constriction: logs on both sides of the banks to constrict creek flow into the center of the channel.
- Obstruction logs: produce a perpendicular or angled barrier to creek flow.
- Divide log: uses a log parallel to the stream flow sometime accompanied by a perpendicular log to catch small woody debris.
- Channel-spanning log: uses one or two logs that cross the creek and force water under and over the logs.

Large woody debris (LWD) projects have been used to improve instream habitat and have been extensively implemented in Lagunitas Creek by MMWD (Andrew et al. 2010) to provide winter rearing habitat and refuge from high flood flows for juvenile coho salmon as described in Marin RCD's *Limiting Factors Analysis* (Stillwater Sciences 2008). The larger and more complex woody debris jams provided the best habitat for juvenile coho salmon because they created slackwater conditions throughout all stages of the hydrograph (Stillwater Sciences 2008) and cover from predation during the summer (Ferguson 2005). Four types of structures were used by MMWD in their LWD restoration program on Lagunitas Creek:

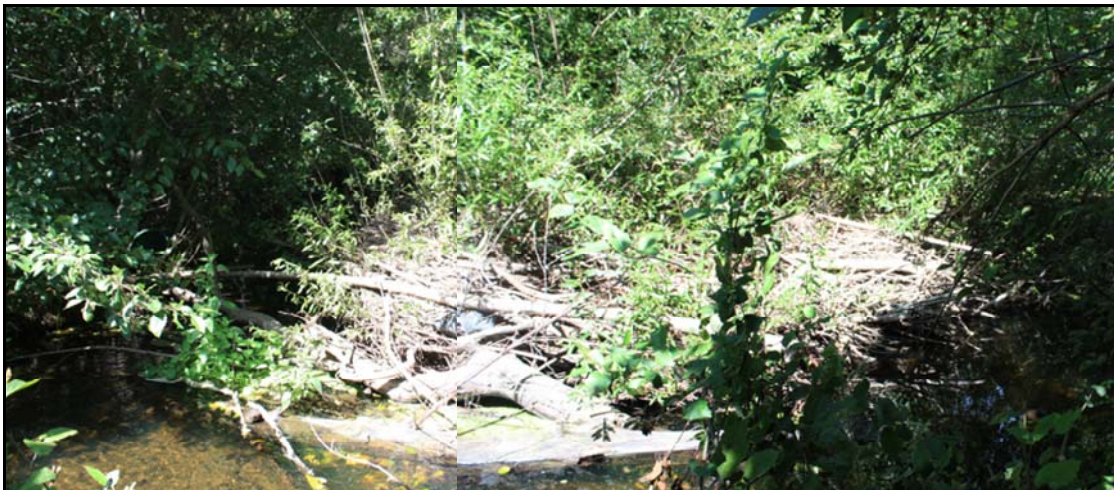
Figure 44: Walker Creek downstream of Marshall-Petaluma Road. depicting the aquatic habitat outcomes from streambank stabilization following 20 years with woody debris jam consisting of a conglomerate of a few pieces of LWD with numerous small debris held together by “living wood” from willow trees growing in to the channel (top), fish using cover and the 3+ feet deep pool created by the woody debris jam (bottom left), and a shallow pool without woody debris or the resulting stream channel complexity (bottom right).

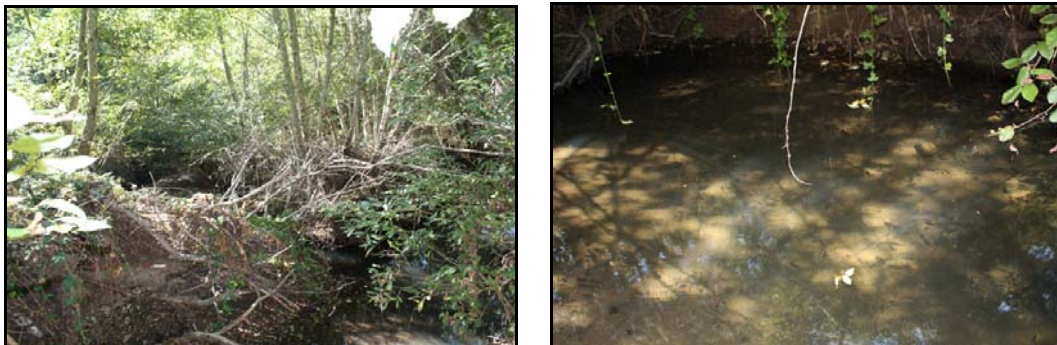
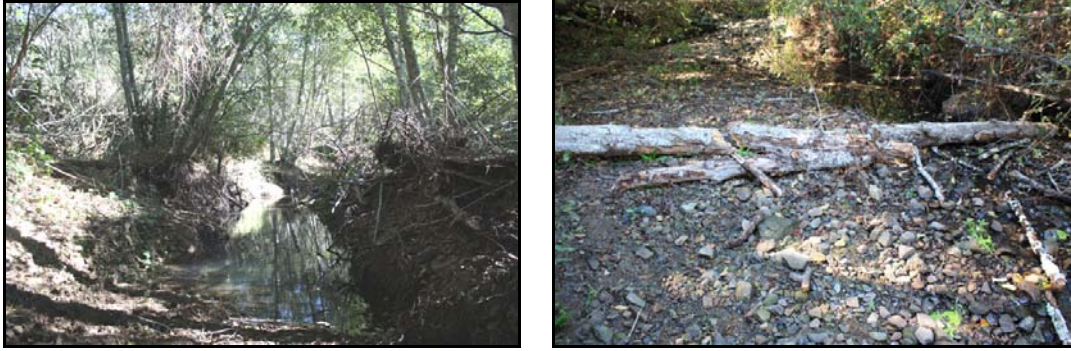
Figure 45: Salmon Creek 1990 willow wall project site where red alder and willow trees fell over in the stream with “living wood” collecting woody debris and creating aquatic habitat complexity with undercut banks and meanders in the channel (top left), a shallow pool with fine sediment indicating further improvements may be beneficial (top right), a narrow stream channel lined by willow, alder and woody debris shows the four feet of incision below trees that established soon after project implementation when the stream bed was higher (bottom left). A fallen dead log not connected to debris jams or living trees has had no affect on stream channel morphology (bottom right).

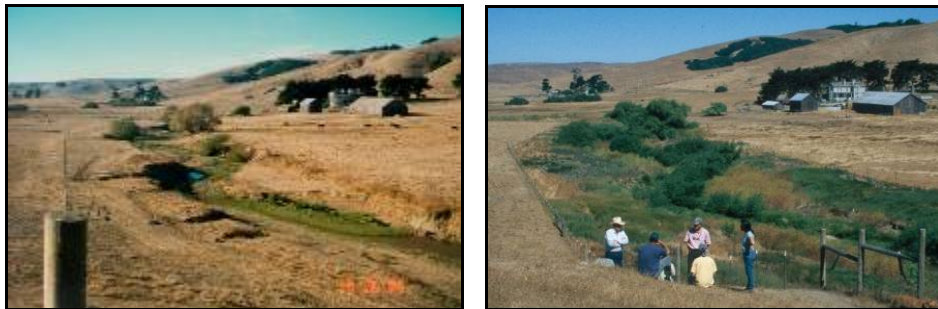
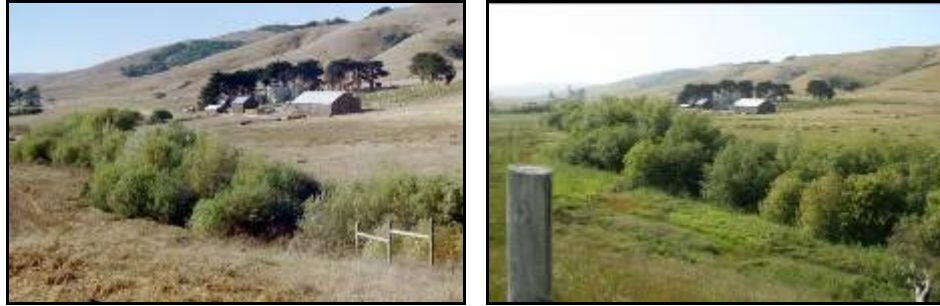
Figure 46: Photo-point sequence of riparian revegetation project site at a tributary to Walker Creek documents the vegetation response at zero (top left), two (top right), eight (bottom left), and twelve years (bottom right) since project implementation. Designed by Prunuske Chatham, Inc. Aerial photos and bird monitoring results are available in Appendix C.

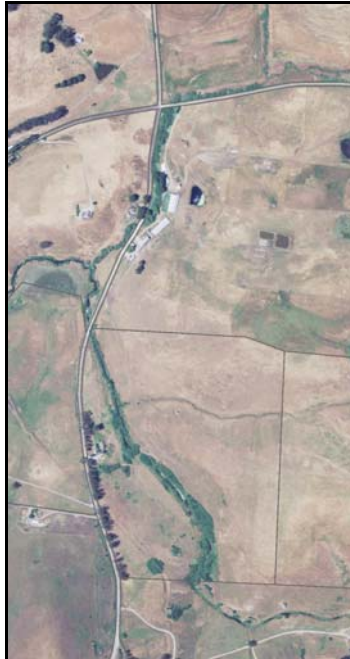
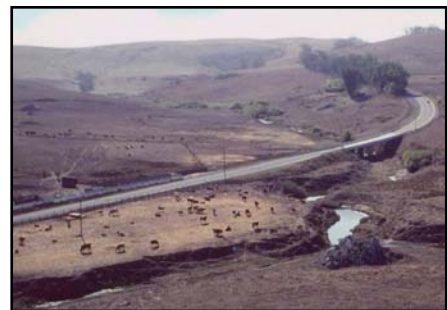
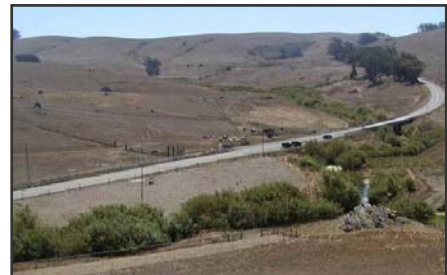
Figure 47: Stemple Creek enhancement project sites implemented from 1994 to 1999 were known to support Ca. freshwater shrimp. The aerial photos before conservation practices in 1984 (far left), compared to 15 years later in 2009 (middle left), a photo from the ranch house taken in 1994 (top right), and a follow up photo 10 years later in 2004 (bottom right).

trends in specific populations from Stemple (Figure 47) and Walker creeks have not been recently determined (Serpa 2010). Lagunitas Creek freshwater shrimp populations have been extensively monitored relative to other Marin County streams and a preliminary trend of decreasing abundance has been documented (Andrew et al. 2010).

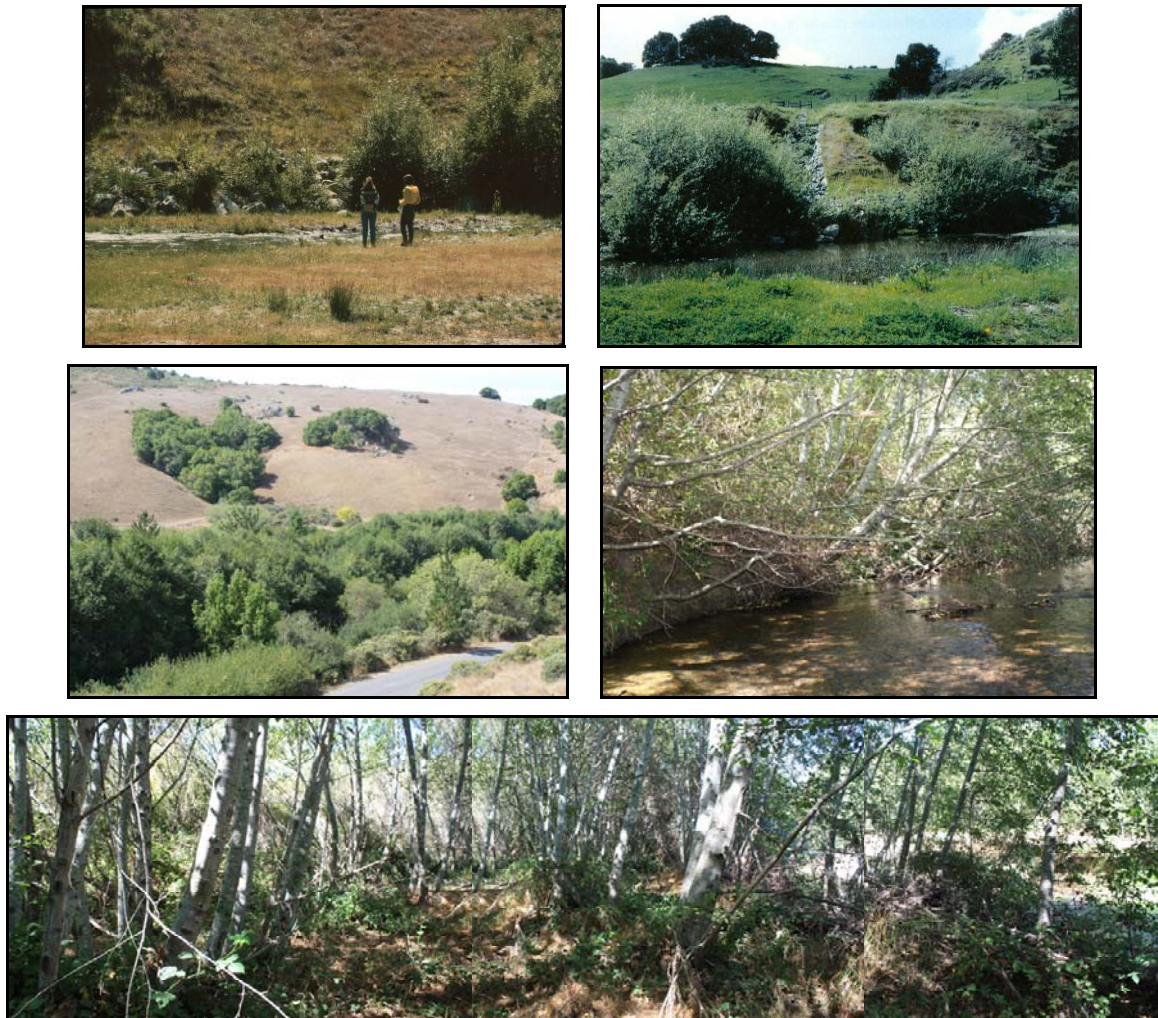
Figure 48: Two years after project implementation of bank stabilization, lined waterway and control fencing in 1991 (top left), four years later in 1993 with planted willows becoming thick and alder seedlings colonizing the vegetated boulder revetment (top right), 20 years later at the same location from above (middle left), alders falling over building floodplain behind them (middle right), and showing 30 feet of floodplain development with restored alder forest habitat (bottom).

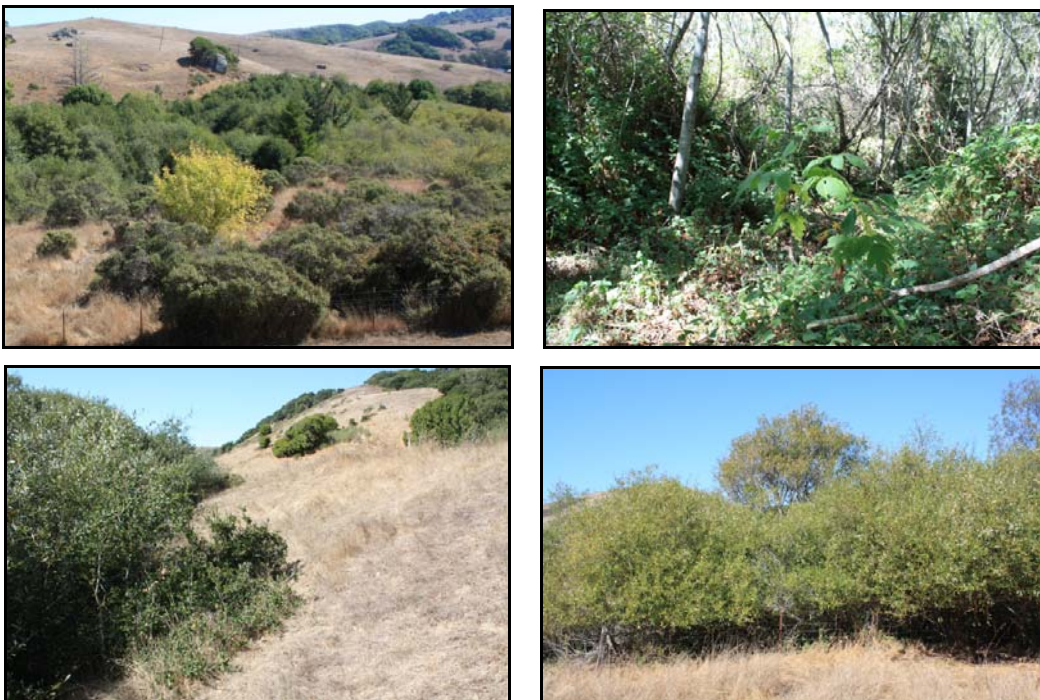
Figure 50: Examples of native tree species response to conservation after 20 years. A small old box elder tree (yellow leaves) was present when the project was implemented is now surrounded by coyote brush and Ca. blackberry (top left), one box elder seedling has successfully colonized the shaded floodplain (top right), a couple live oaks have established above browse height at a drier site (bottom left), and a planted shining willow is taller than arroyo willows (bottom right).

Direct planting approaches (i.e. active revegetation) have similarly increased in importance to ensure long-term riparian forest diversity and habitat quality at conservation project sites implemented by Marin RCD and its partners (Lennox 2007). Native species that colonize sites where they were not planted include California blackberry, coyote brush, arroyo willow and alder, if conditions are right. However, most native species need seed sources on site in order to reproduce and colonize after livestock are controlled and some rarely do even where mature individuals are present (Figure 50). The larger seeded tree species migrate shorter distances and often need animal vectors, such as acorns cached by scrub jays, while the smaller seed producing species are able to colonize faster without planting where livestock access was reduced, controlled or eliminated (i.e. passive revegetation options) (Lennox 2007).

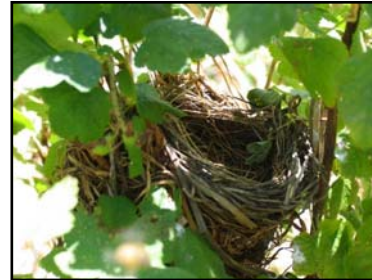
A five-year old planted currant shrub already used for nesting (photo by STRAW).

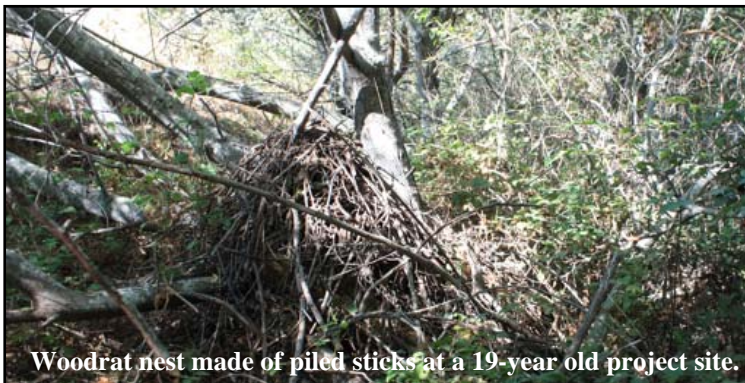
Woodrat nest made of piled sticks at a 19-year old project site.

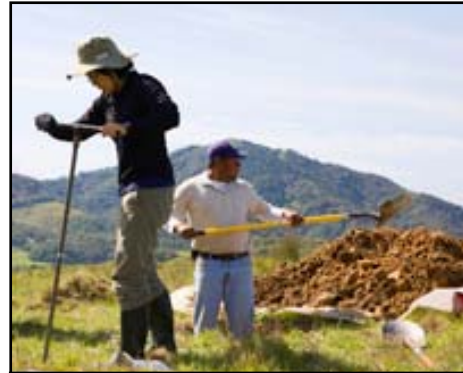
Researchers sampling rangeland soil.
Photo by Paige Green (MALT).

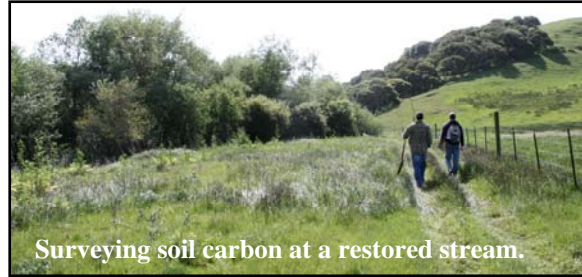
Surveying soil carbon at a restored stream.

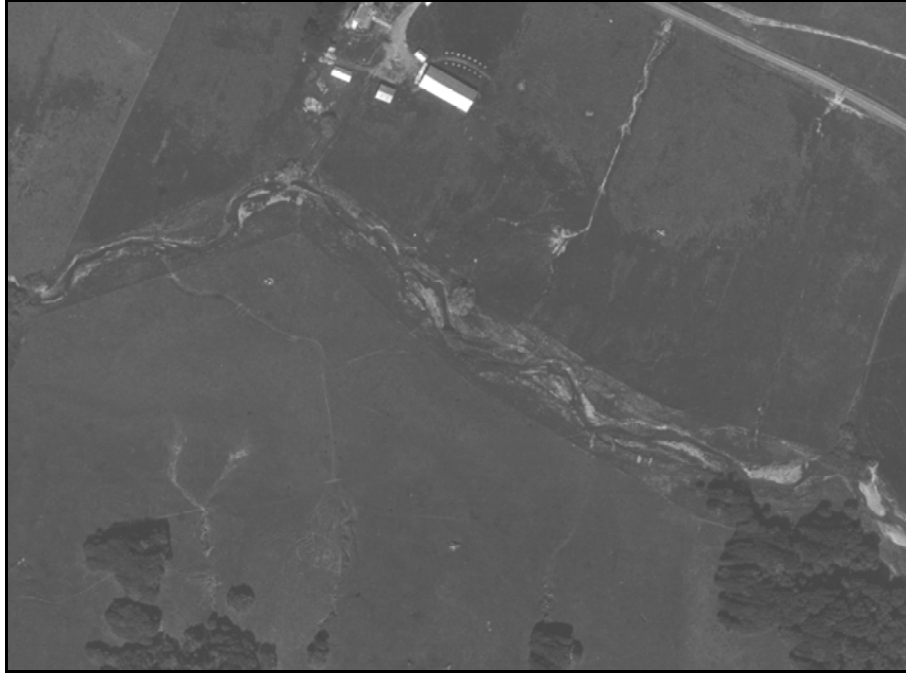
Aerial photo from 1997 (below) following livestock control fencing and extensive riparian revegetation with native trees, shrubs and grasses.

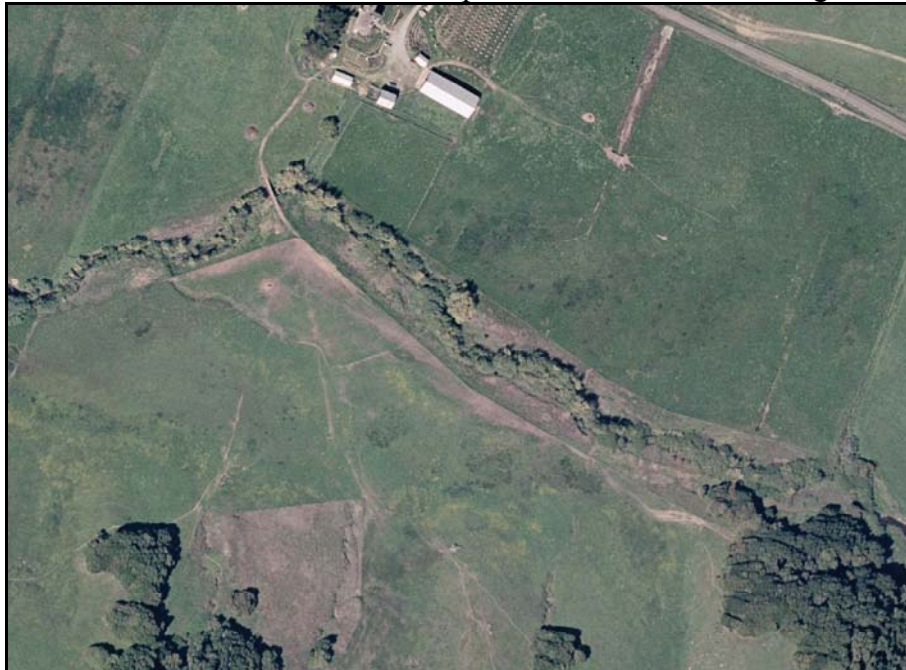
By 2004 (below), the bridge was installed and multiple gullies also received control fencing with revegetation. Woody vegetation has become established along the stream and more bare soil is evident outside of the riparian area's control fencing.

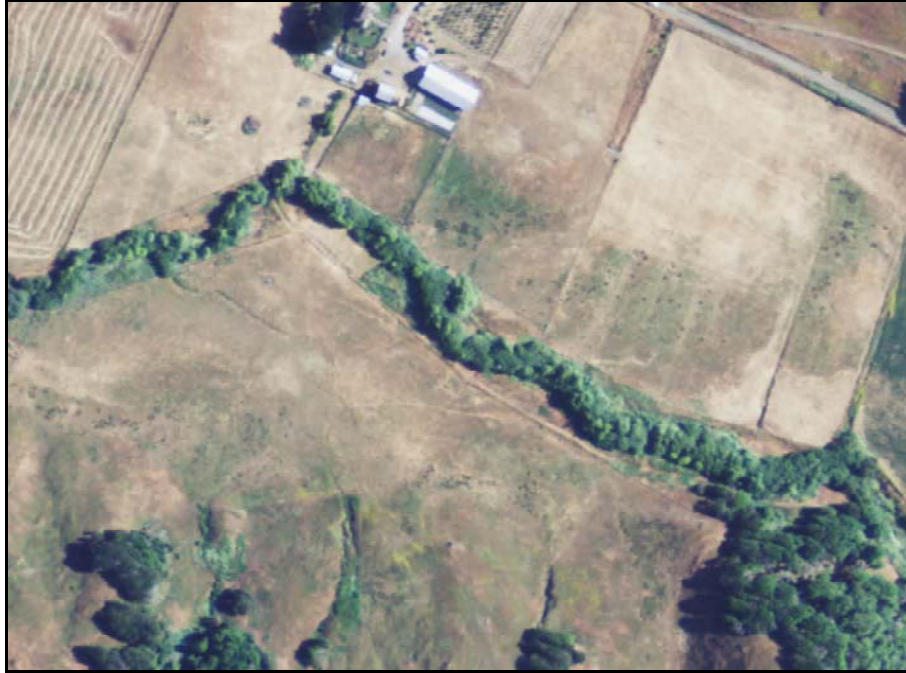
In 2009 (below), trees cover most of the stream and bare soil is not clearly visible on the ranch as Prescribed Grazing Plans show results. Over \$250,000 have been spent on conservation practices and projects at this ranch over the last 20 years.
