## **A Half Century of Stewardship: programmatic review of conservation by Marin RCD & partner organizations (1959-2009)**

Marin Resource Conservation District  
P.O. Box 1146, Point Reyes Station CA 94956  
(415) 663-1170, <http://www.marinrcd.org/>

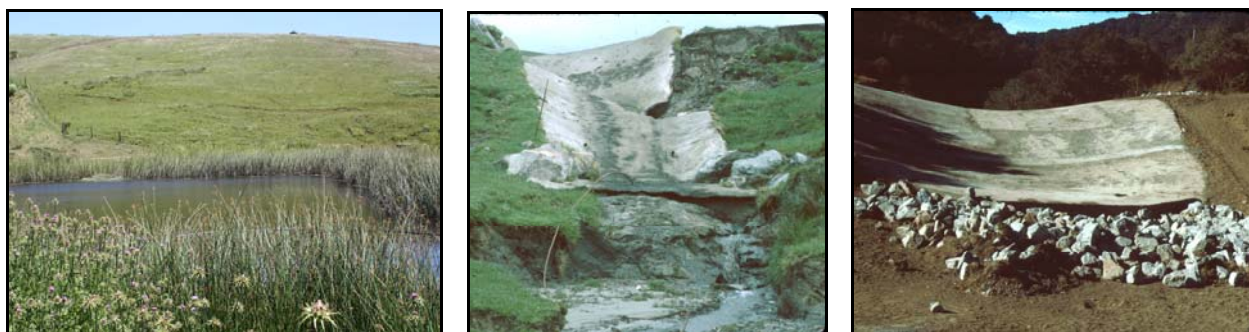
**Figure 16:** An example stockpond providing a critical source of clean water for ranch operations (left), failed spillway undermined by erosion caused by subsurface piping (middle) that was repaired by NRCS in 1985 and continues to function today (right). Photos by NRCS.

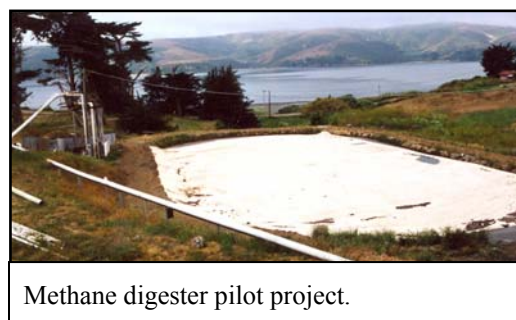
Methane digester pilot project.

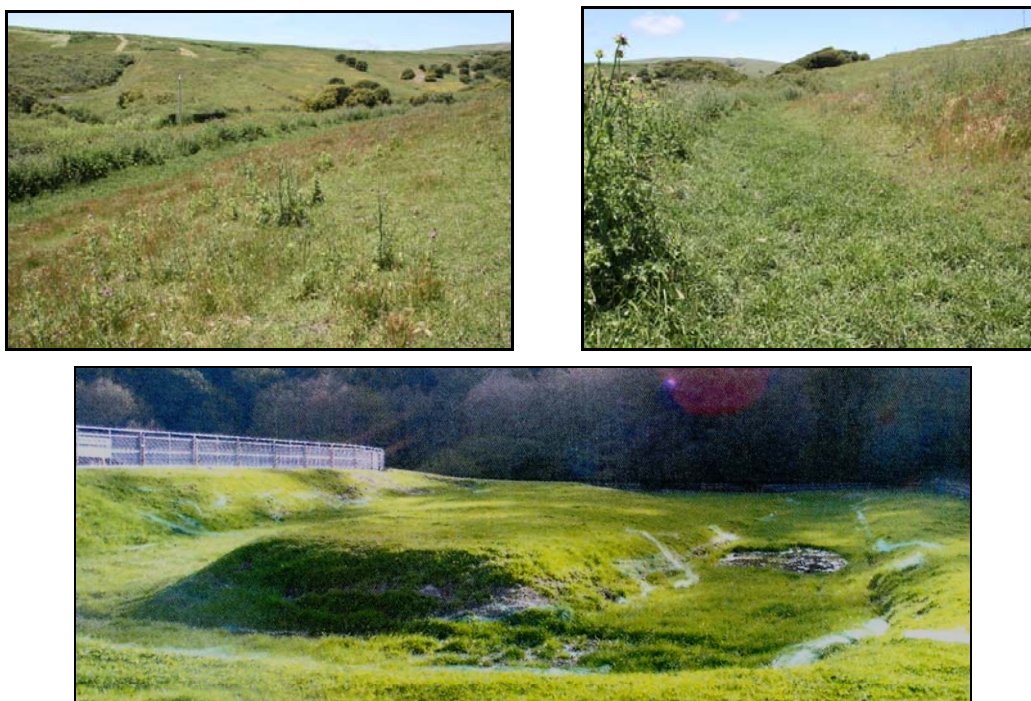
**Figure 23:** Examples of Filter Strips to treat surface water runoff from corrals depicting an overview of a hillside site with over 400 feet of laminar flow conditions following the contour (top), and a flat bottomland location where the site's treatment distance and laminar flow conditions were maximized (bottom). Designed by NRCS.

Filter Strips are wide ditches that maximize laminar flow conditions designed to collect sediment and filter pollutants from small drainages within the ranch or farm, such as stormwater runoff from corrals or dry lots. This practice was historically implemented to filter wastewater as an alternative to waste management systems. In cases where herd size grew, treatment capacity was often overwhelmed by the increased supply of manure. Marin RCD and partners have responded to these changing capacity requirements and challenges to installation at specific locations in order to provide maximum length with appropriate gradients on hillside and lowland locations (Figure 23). Filter strips provide an ideal option for high functioning vegetative buffers to reduce pathogens in stormwater runoff (Lewis et al. 2010, Lewis et al. 2009, Tate et al. 2006, Tate et al. 2004).

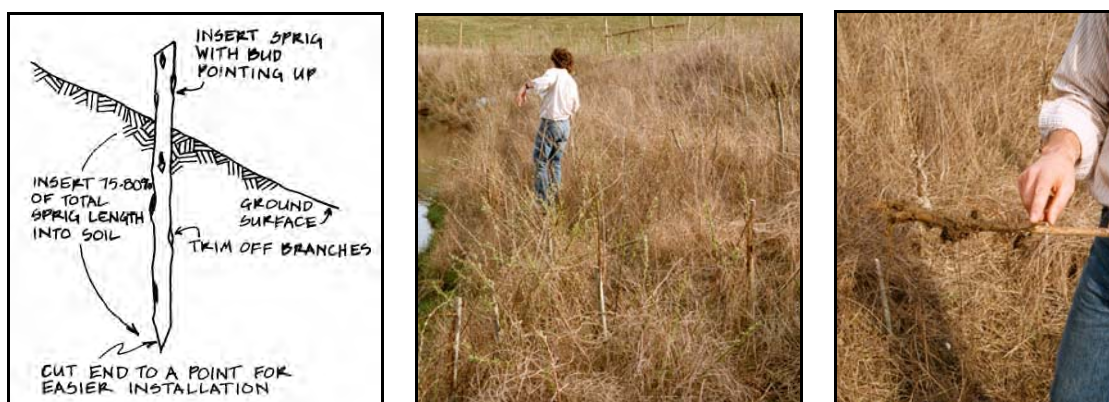
**Figure 24:** The specification for planting a willow cutting or sprig and surveying a newly planted site with some rabbit damage in 1988 (top). Design and photos by Prunuske Chatham, Inc.

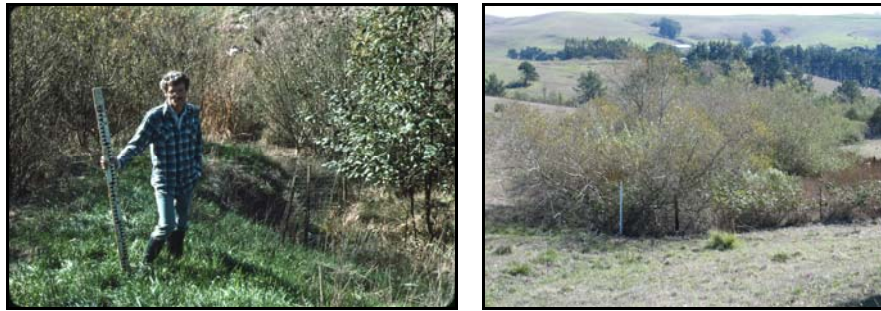
**Figure 27:** Some of the “worst erosion in Marin County” inherited by a new landowner in the Walker Creek Watershed when channel stabilization and revegetation began in 1970 in addition to removing cattle from the property (top left), nine years later streambanks are clearly more stable with trees establishing (top right), the project leader posing with successful plantings (bottom left), and 35 years later the gully is completely stable with diverse habitat including arroyo willow, shining willow, red alder and numerous shrub species (right). Designed by NRCS.

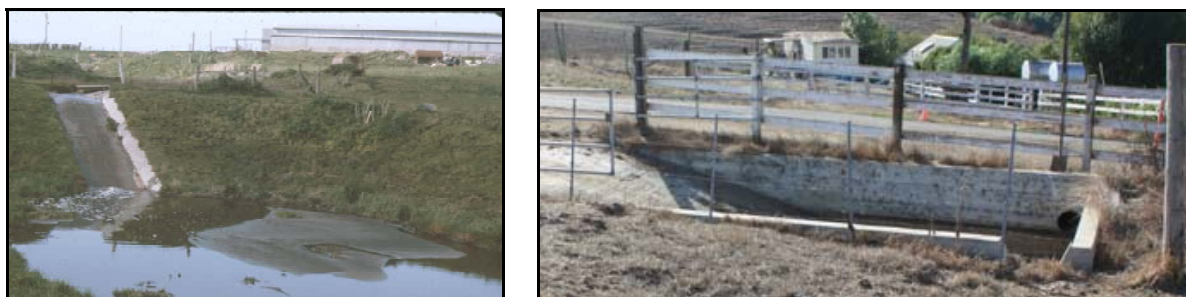
**Figure 29:** Examples of Sediment Basins depicting a large-scale design constructed in the 1980s (left), and a smaller version with a paved access ramp to facilitate maintenance built in 2005 (right).

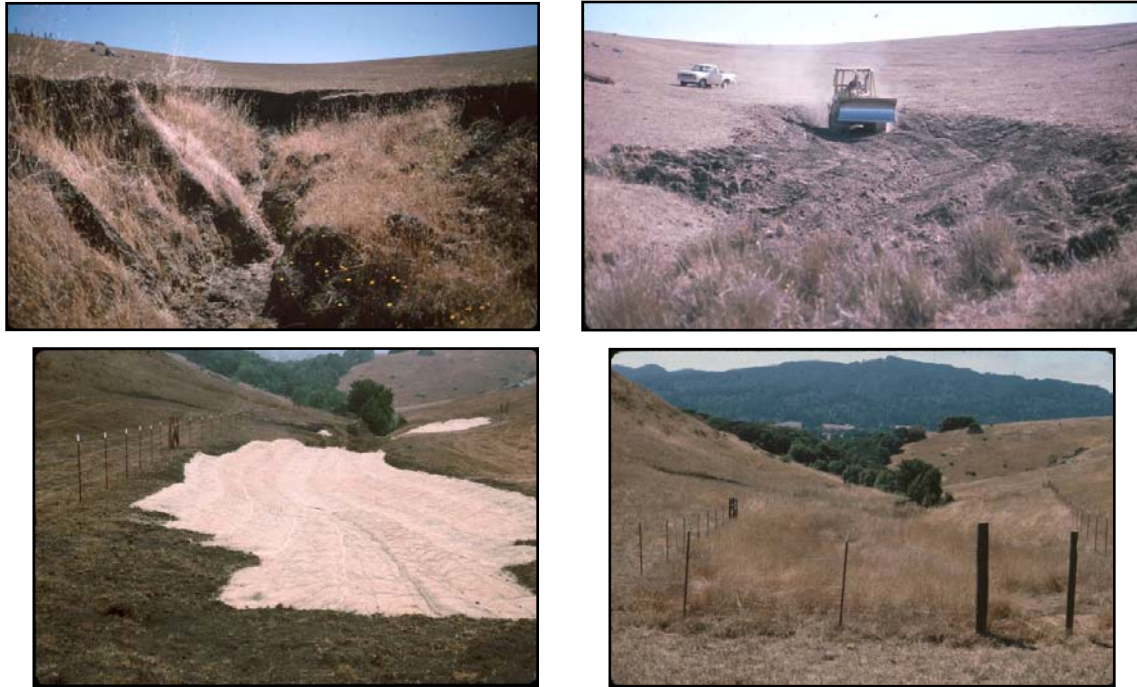
**Figure 33:** A Grassed Waterway practice installed in Lagunitas Creek Watershed in 1988. Designed by NRCS.

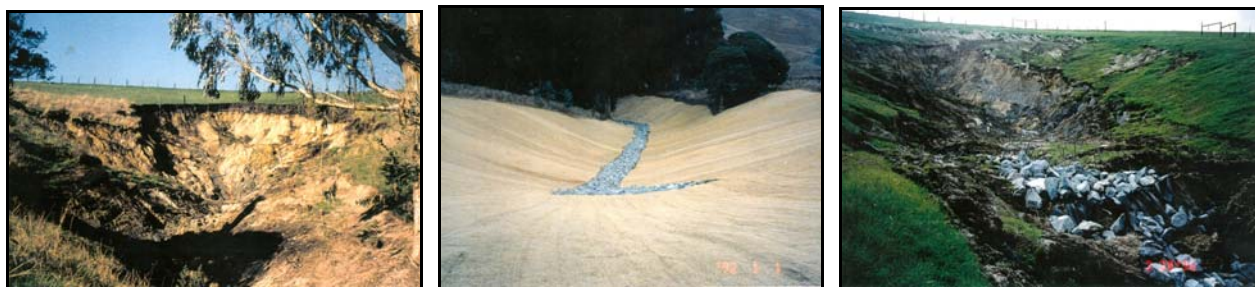
**Figure 34:** An eroding gully pre-project (left), after implementation of Lined Waterway and other practices in 1992 (middle), and four years later the site had unraveled (right).

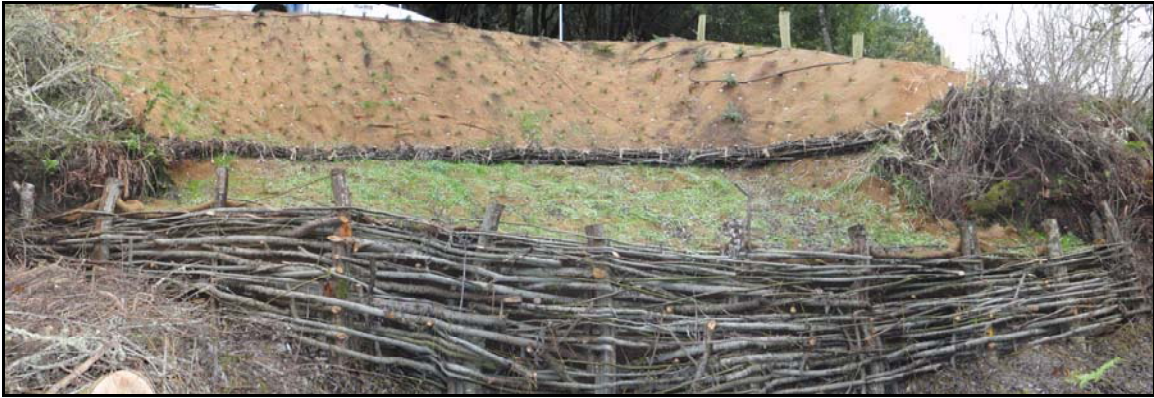
**Figure 36:** An example of the first willow walls constructed in 1990 in the Walker Creek Watershed (top), another later example constructed in 1994 (middle left), a recent design specification (middle right), and a recently constructed willow wall stabilizing the streambank toe below a threatened ranch road with willow fascine and revegetation using native grass seed, sedge/rush plugs, and shrubs in 2008 (bottom). Designs by Prunuske Chatham, Inc.

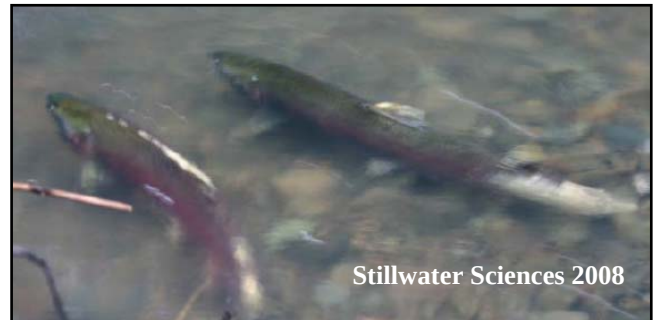
**Figure 37:** The first Stream Channel Improvement practice used a “Hewlett Ramp” design to confine high flows that scour deeper pools to improve habitat for steelhead and coho salmon. Designed by Prunuske Chatham, Inc and Trout Unlimited.

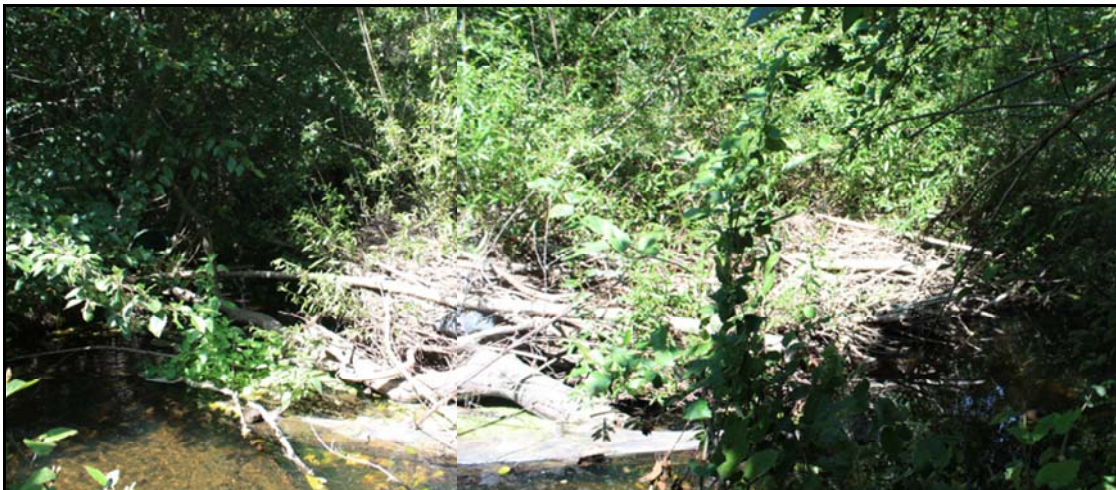
**Figure 44:** Walker Creek downstream of Marshall-Petaluma Road. depicting the aquatic habitat outcomes from streambank stabilization following 20 years with woody debris jam consisting of a conglomerate of a few pieces of LWD with numerous small debris held together by “living wood” from willow trees growing in to the channel (top), fish using cover and the 3+ feet deep pool created by the woody debris jam (bottom left), and a shallow pool without woody debris or the resulting stream channel complexity (bottom right).

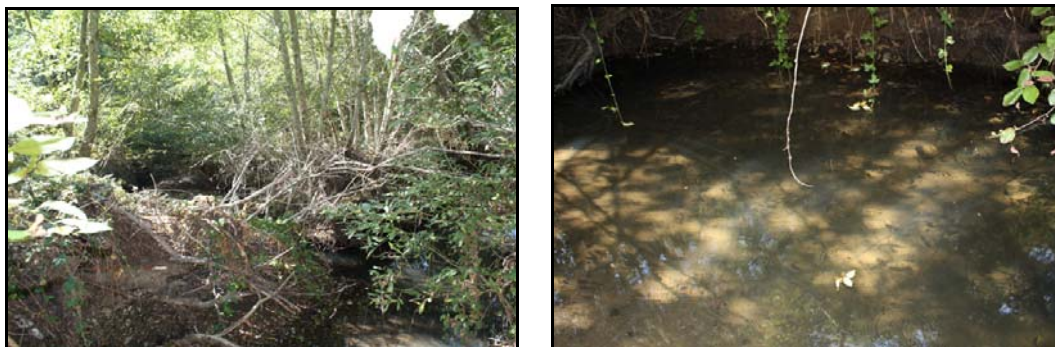
**Figure 45:** Salmon Creek 1990 willow wall project site where red alder and willow trees fell over in the stream with “living wood” collecting woody debris and creating aquatic habitat complexity with undercut banks and meanders in the channel (top left), a shallow pool with fine sediment indicating further improvements may be beneficial (top right), a narrow stream channel lined by willow, alder and woody debris shows the four feet of incision below trees that established soon after project implementation when the stream bed was higher (bottom left). A fallen dead log not connected to debris jams or living trees has had no affect on stream channel morphology (bottom right).

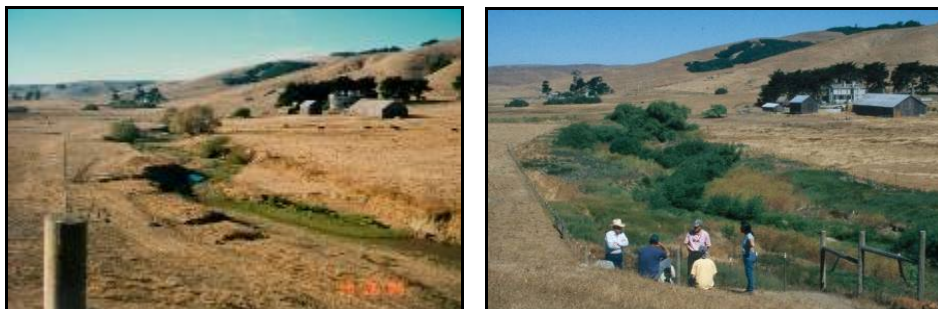
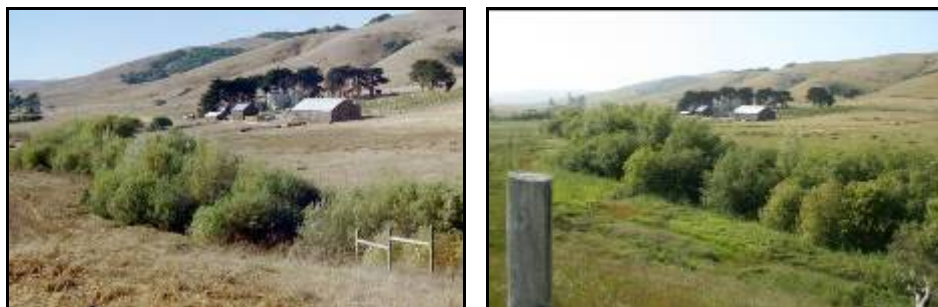
**Figure 46:** Photo-point sequence of riparian revegetation project site at a tributary to Walker Creek documents the vegetation response at zero (top left), two (top right), eight (bottom left), and twelve years (bottom right) since project implementation. Designed by Prunuske Chatham, Inc. Aerial photos and bird monitoring results are available in Appendix C.

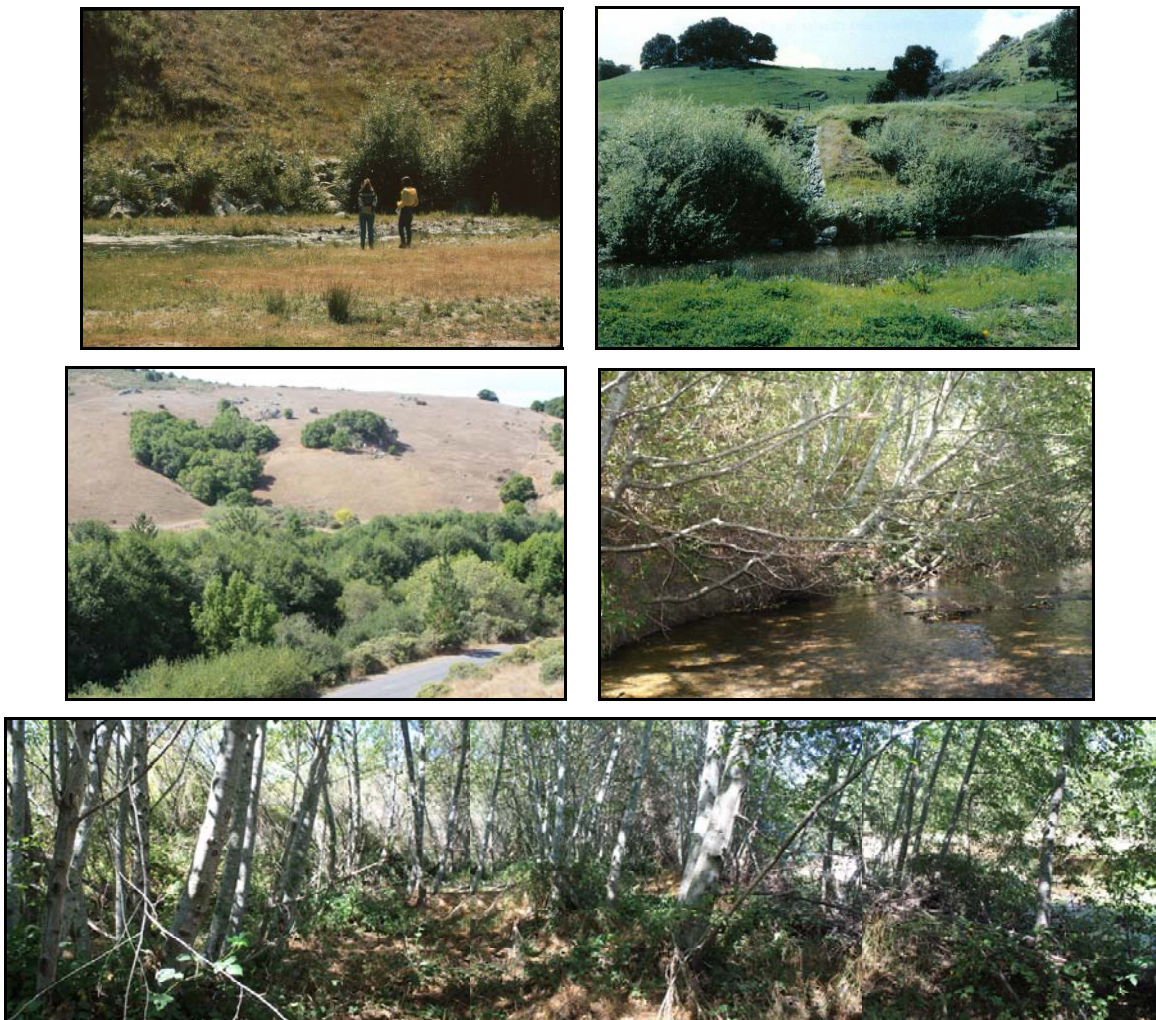
**Figure 48:** Two years after project implementation of bank stabilization, lined waterway and control fencing in 1991 (top left), four years later in 1993 with planted willows becoming thick and alder seedlings colonizing the vegetated boulder revetment (top right), 20 years later at the same location from above (middle left), alders falling over building floodplain behind them (middle right), and showing 30 feet of floodplain development with restored alder forest habitat (bottom).
